Long Point Region Conservation Authority

Teeterville Dam Safety Review and Condition Assessment

AECOM

March 2016

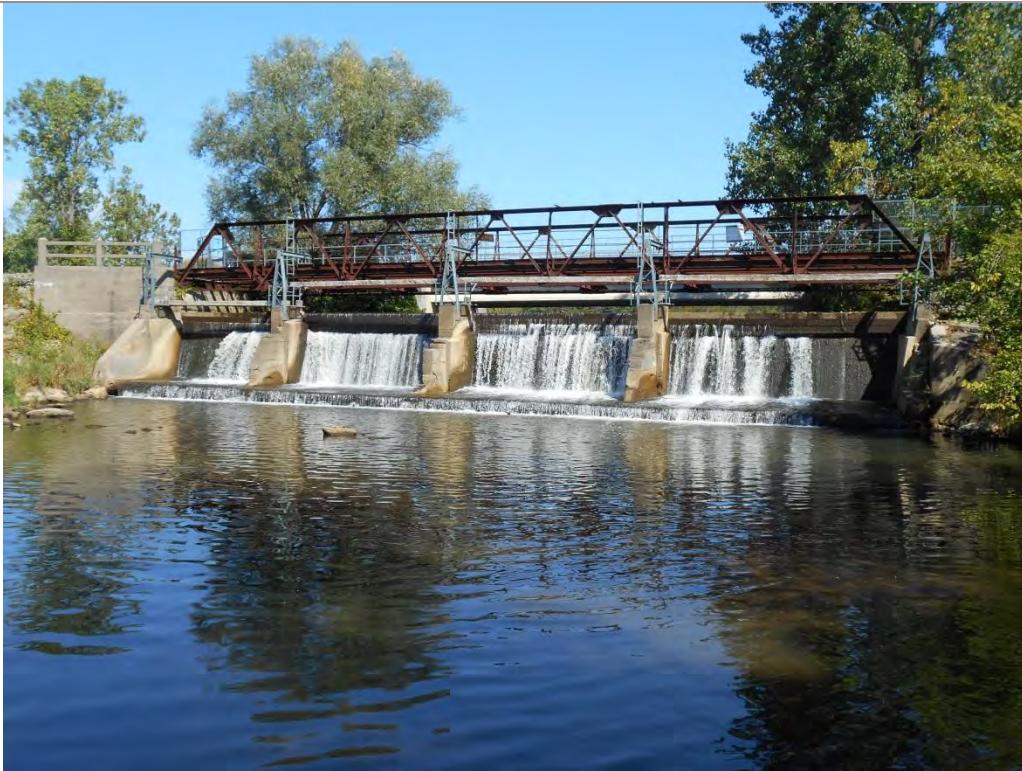
- Light erosion on the upstream embankments

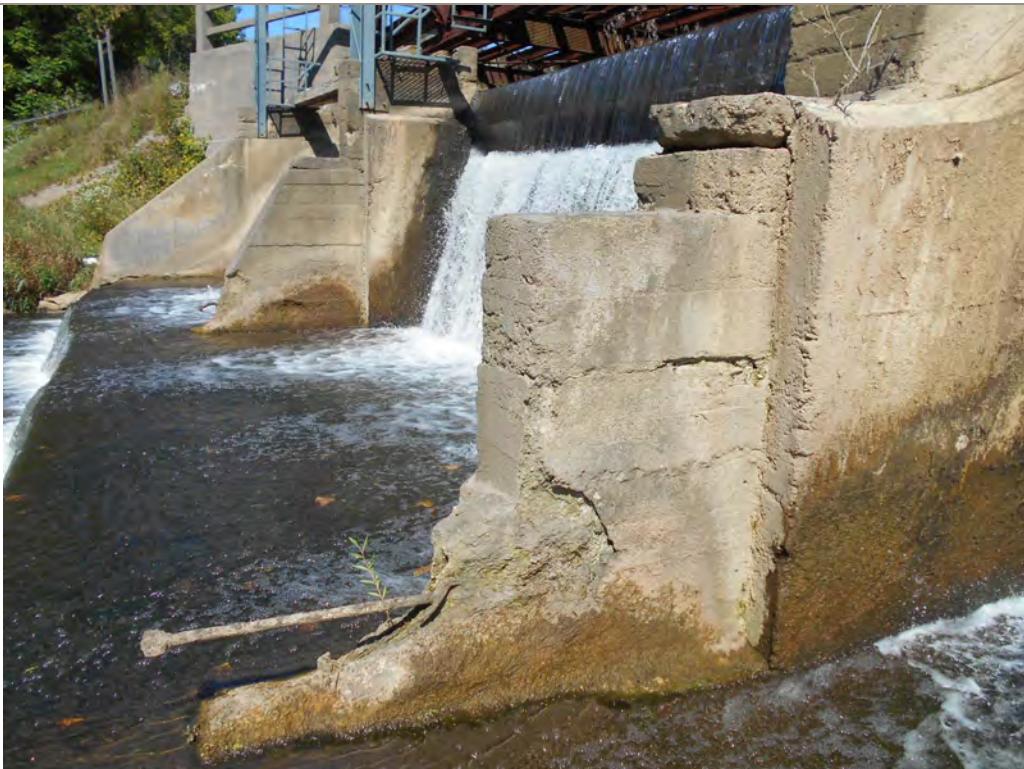
Photo 4: Concrete Deterioration at Middle Pier

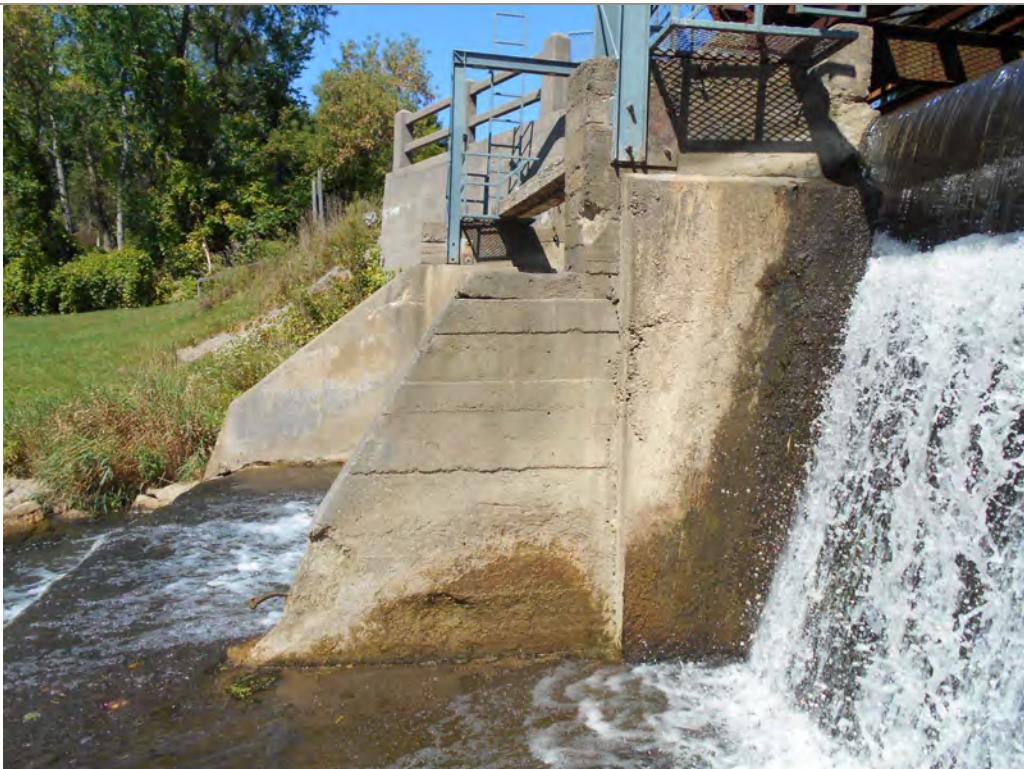
Photo 5: Scaling at North Pier

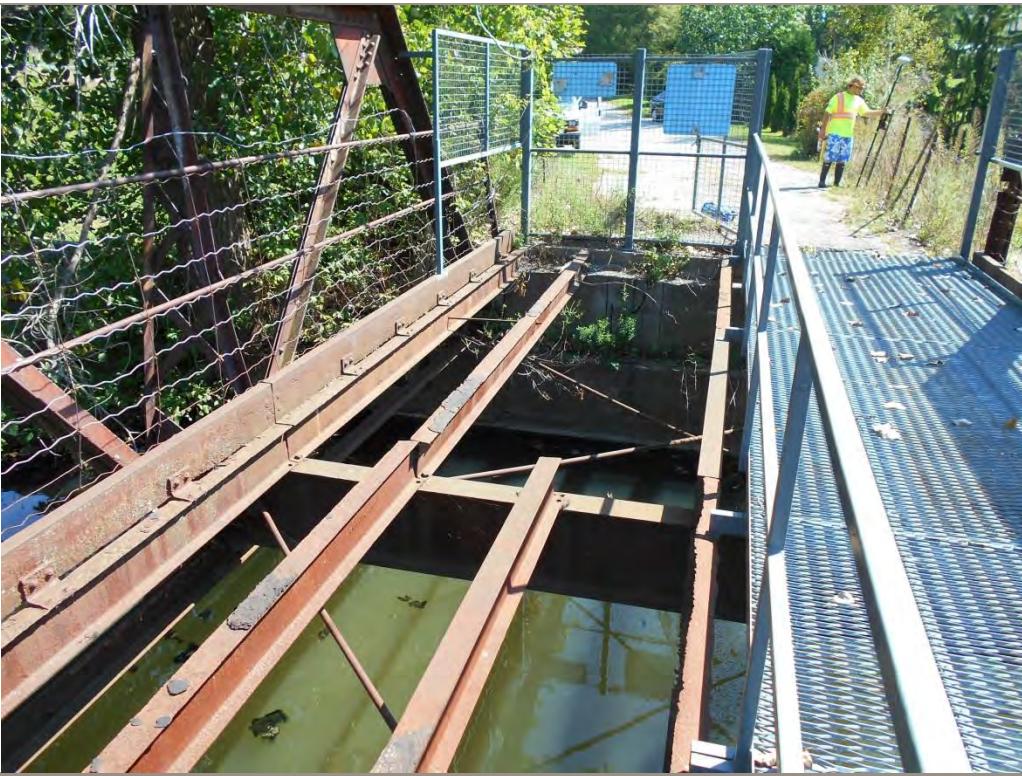
Photo 8: Missing Stringer on Bridge

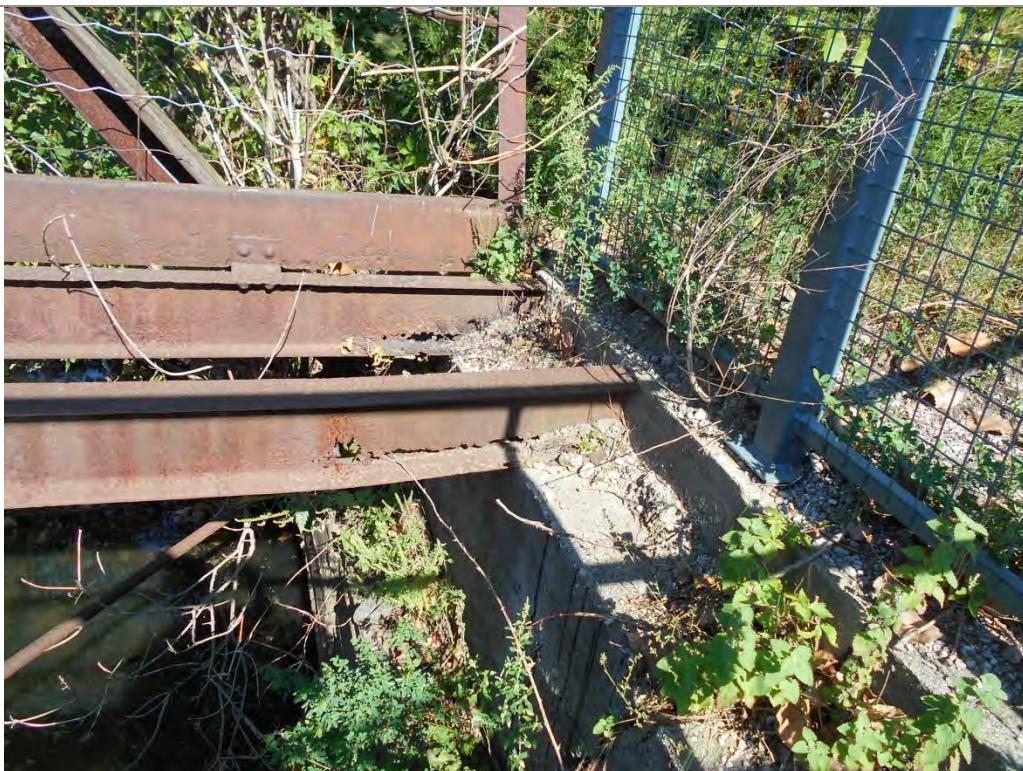
Photo 9: Failed Stringer

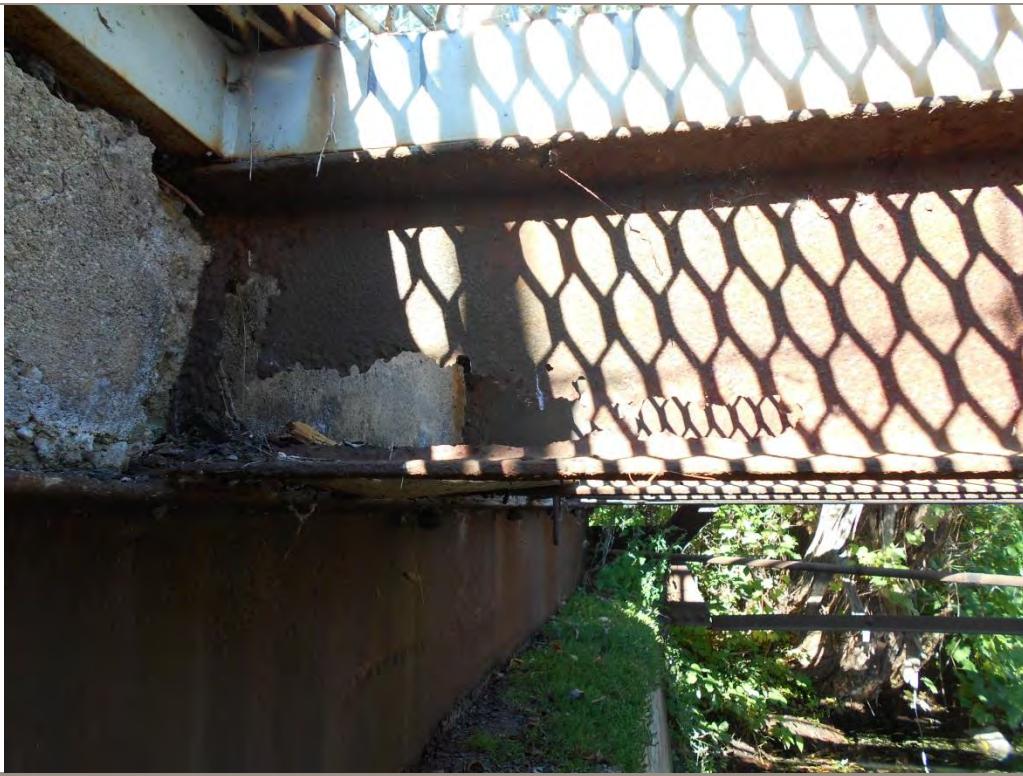
Photo 10: Loss of Web Section in Stringer

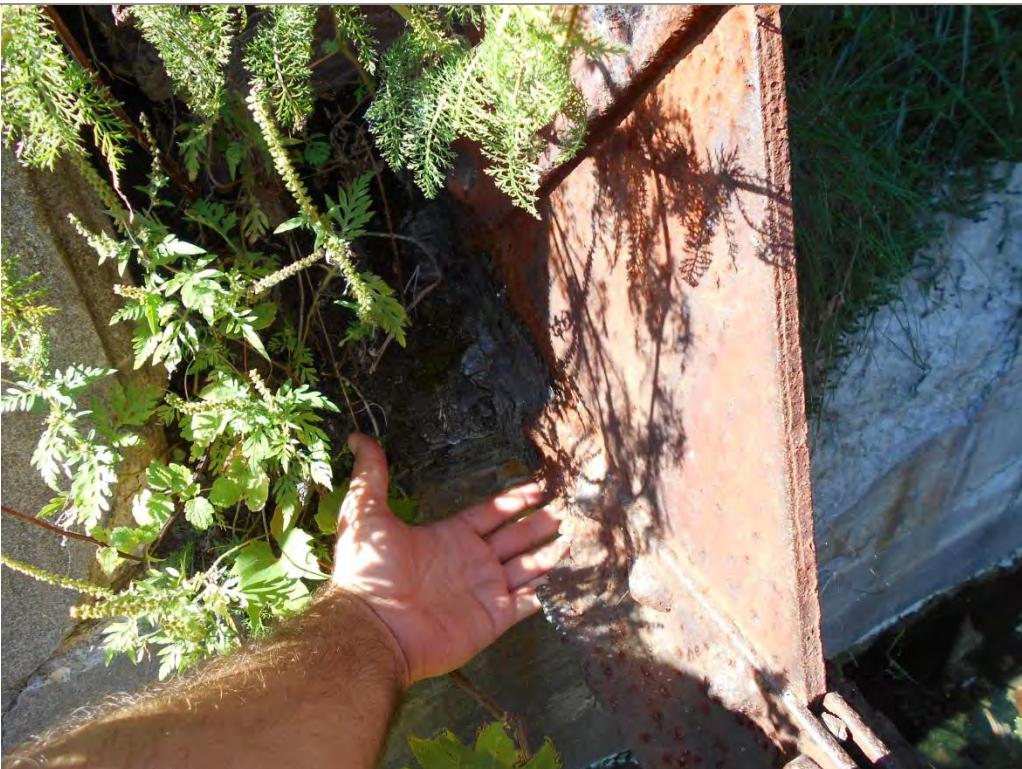
Photo 11: Loss of Section at Connection

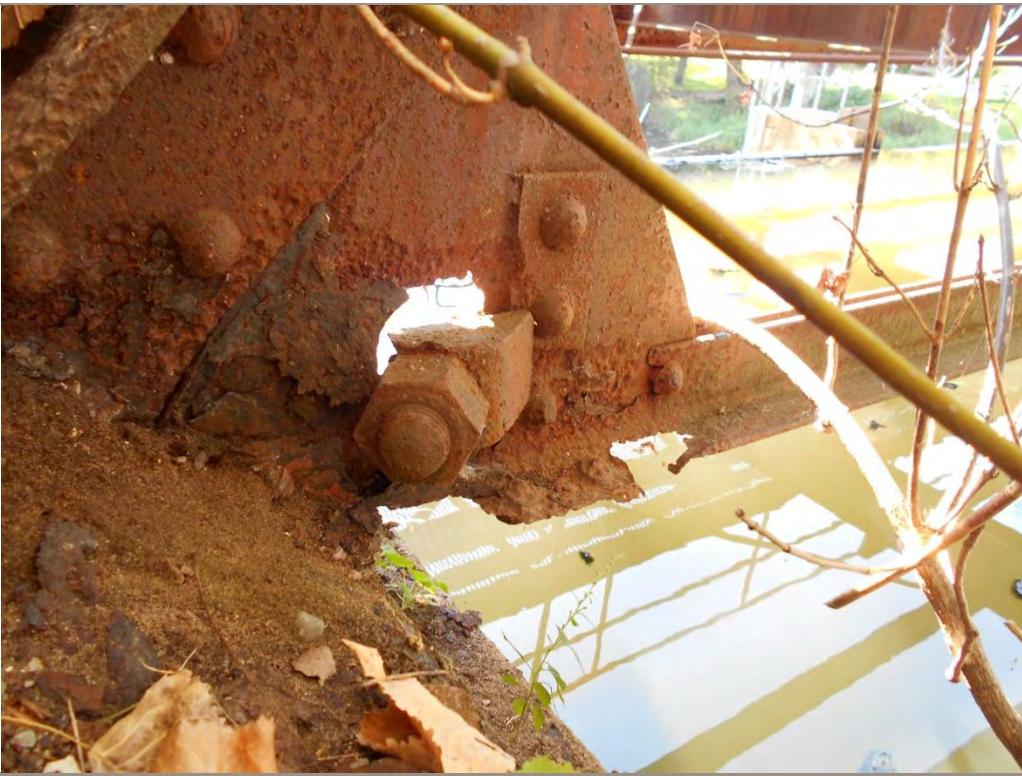
Photo 12: Deterioration at Connection

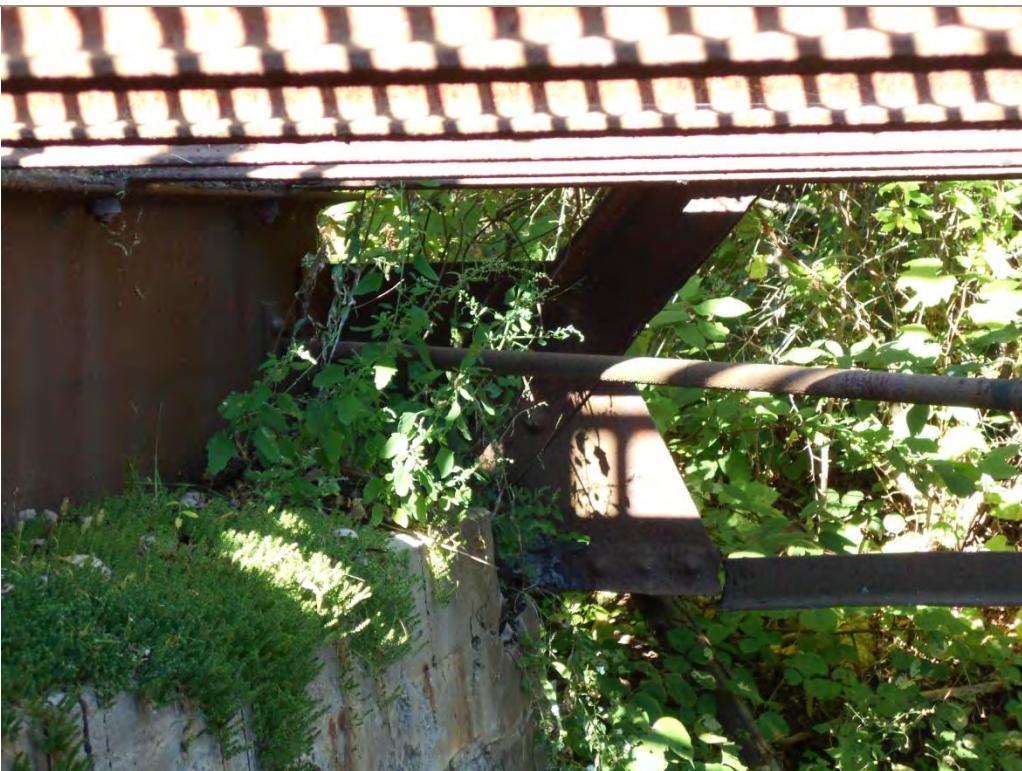
Photo 13: Failed Bottom Chord

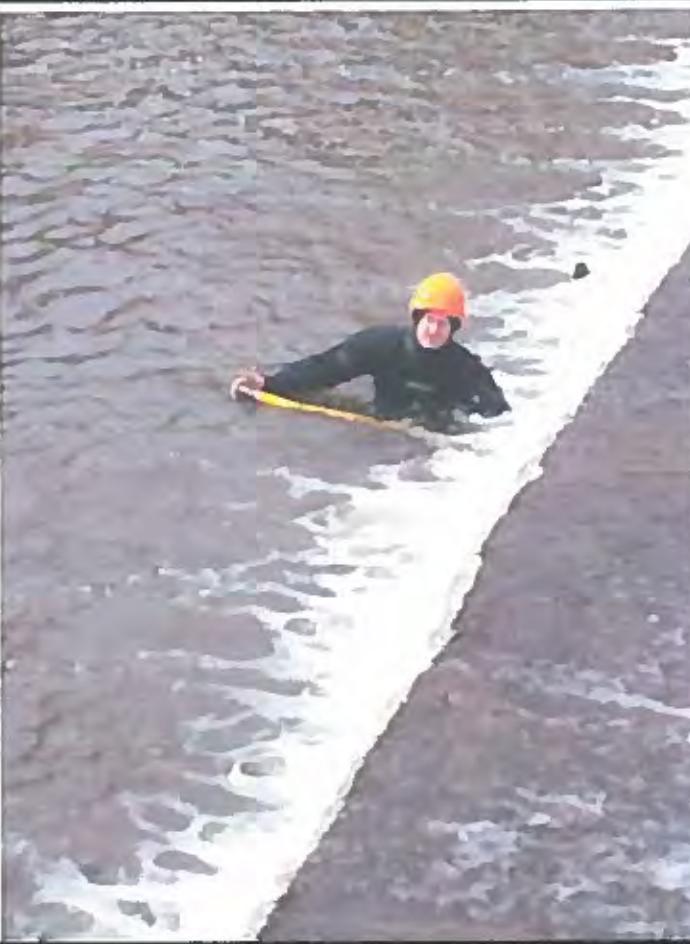
PHOTO # 11

Diver determining depth of undermining

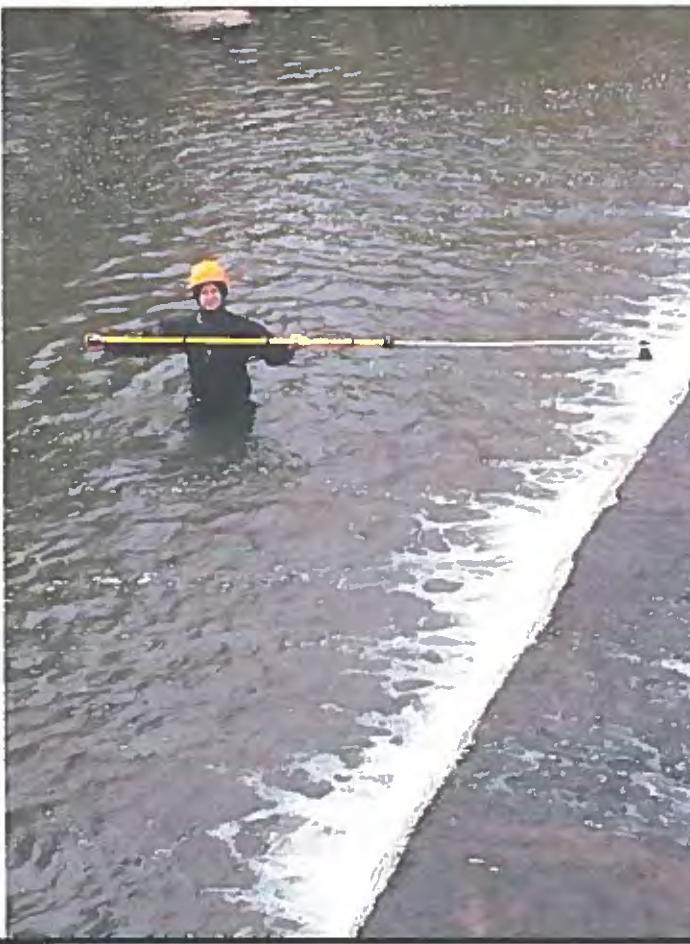
PHOTO # 12

Diver showing depth of undermining
