Cliff Evanitski
General Manager
Long Point Region Conservation Authority
4 Elm Street
Tillsonburg, Ontario
N4G 0C4

Dear Mr. Evanitski,

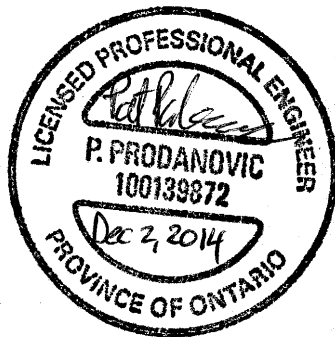
Pat Prodanovic, Ph.D., P.Eng.
Water Resources and Marine Engineer

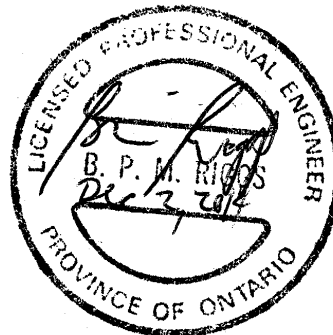
Brian Riggs, P.Eng.
Principal, Riggs Engineering Ltd

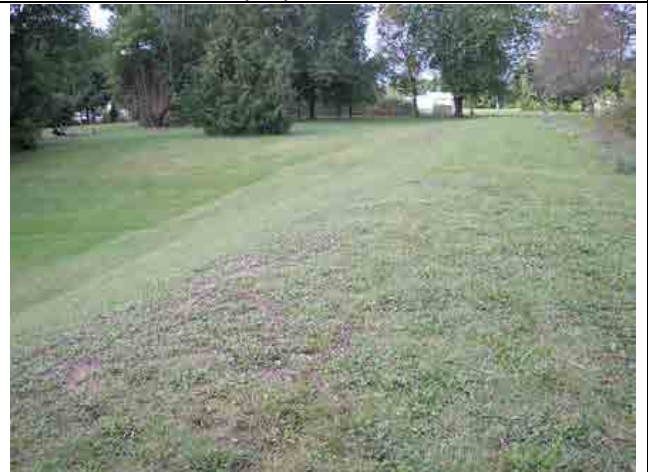
Photo #4 – Right downstream embankment, standing on right upstream wingwall, looking westward. Embankment appears in good condition.

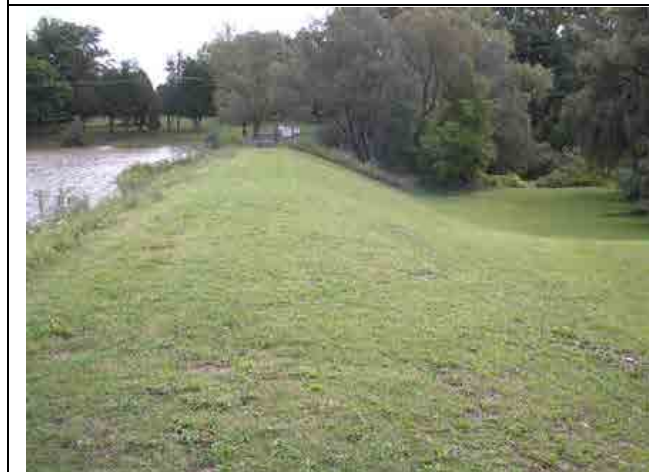
Photo #5 – Right embankment, looking towards the main structure. No evidence of cracking, seepage or loss of fill on the downstream side.

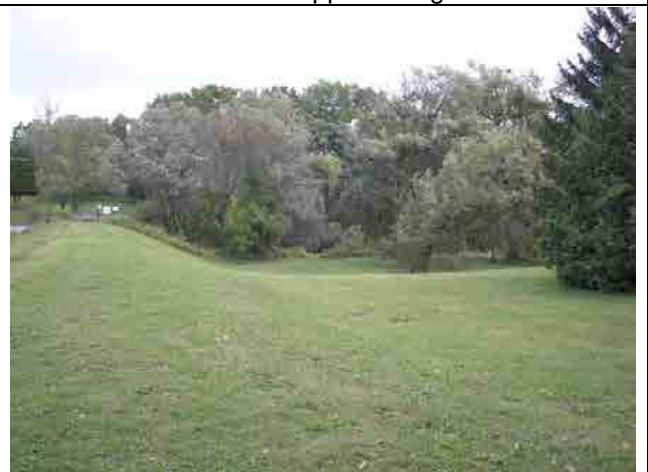
Photo #6 – Right downstream embankment. LPRCA staff notes that past dredge material was placed on top of embankment and adjacent downstream areas.

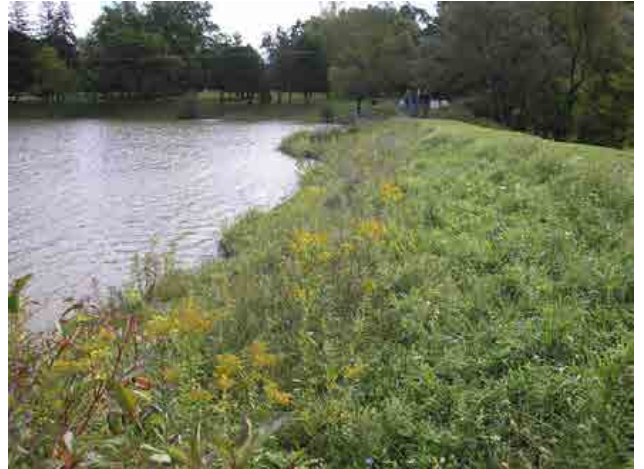
Photo #8 – Right upstream embankment, standing near the waterline and looking towards the main structures. Some erosion and steepened slopes noted near the waterline.

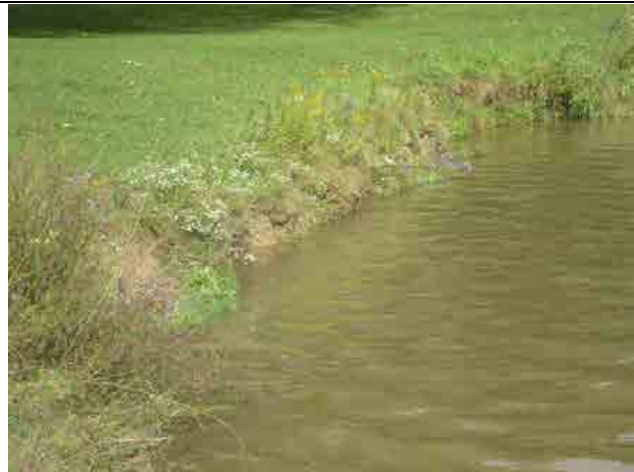
Photo #9 – Close up of the right slope on the right upstream embankment near the waterline.

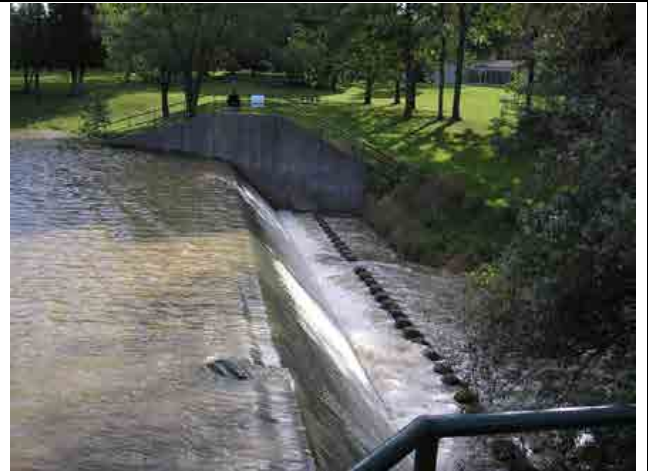
Photo #14 – Norwich Dam main spillway and stilling basin. Note minor damage to some of the baffle blocks.

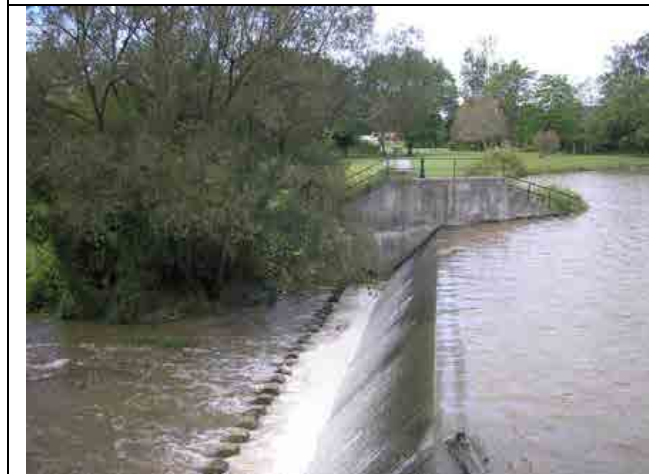
Photo #15 – Norwich Dam main spillway, looking towards the right wingwall. Note trees in close proximity to the right downstream wingwall.

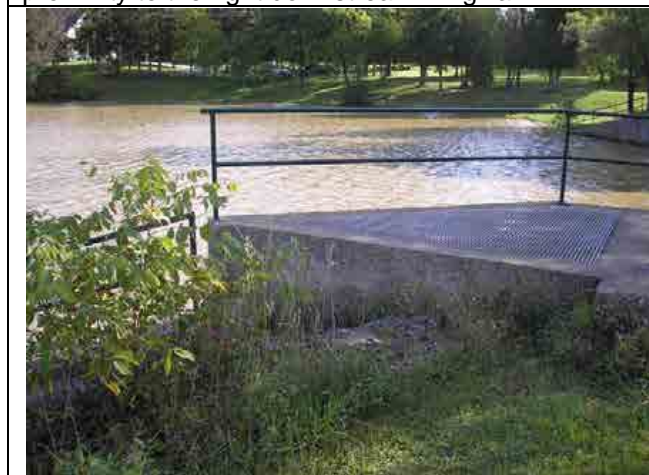
Photo #17 – Norwich Dam wetwell, located adjacent to the right wingwall on upstream face. Padlock on the steel grate noted as missing.

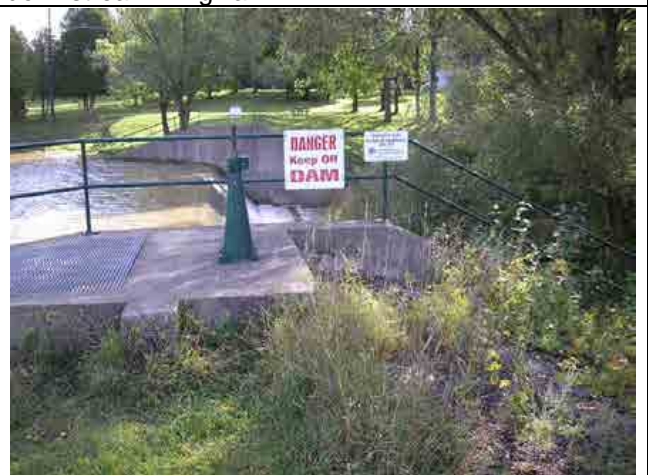
Photo #18 – Wetwell at right wingwall. Gate not tested during inspections. LPRCA staff notes gate is functional.

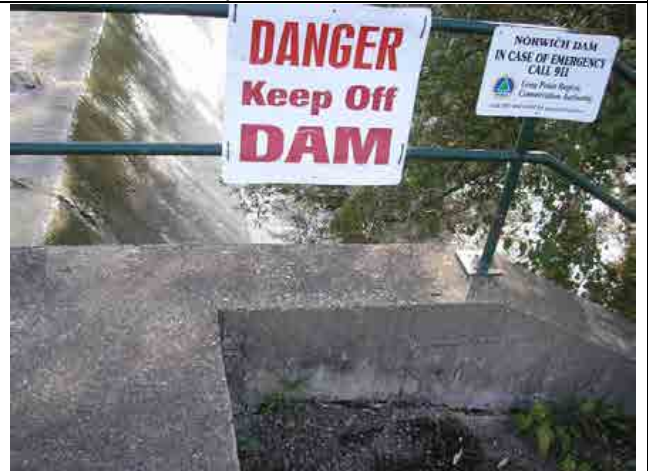
Photo #22 – Right downstream wingwall. Concrete appears in generally good condition. Some cracking noted at the wetwell-wingwall interface, on the downstream face.

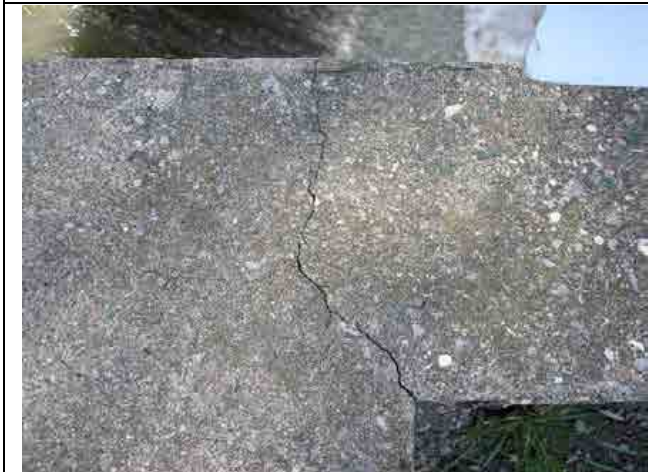
Photo #23 – Top view of the crack at the wetwell-wingwall interface, on the downstream face.

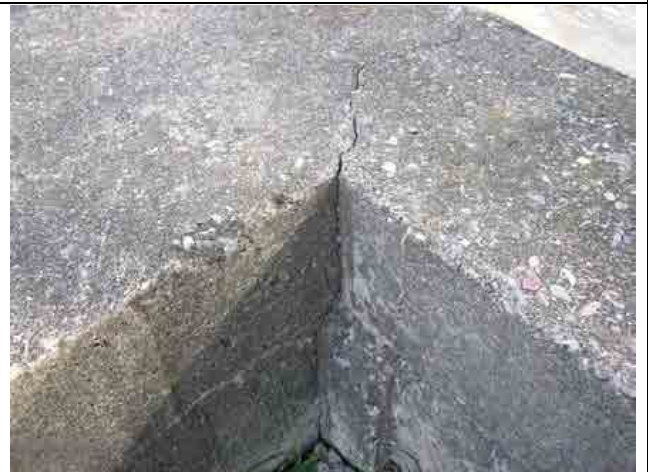
Photo #24 – Same crack on the wetwell-wingwall interface, isometric view.

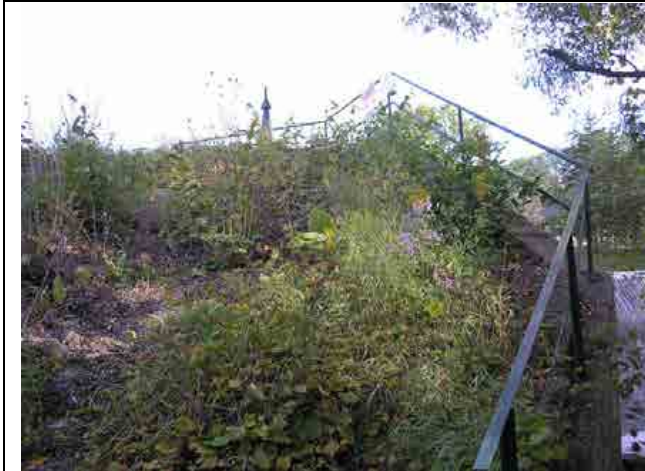
Photo #25 – Right downstream slope adjacent to right wingwall is vegetated with tall grasses. Note the handrail on top of wingwall.

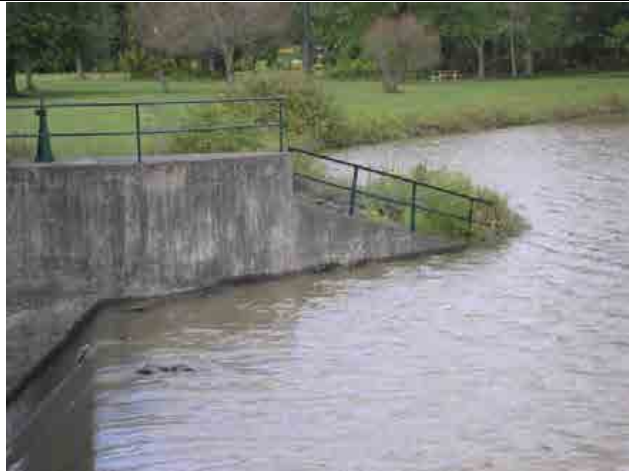
Photo #27 – Right upstream wingwall. Concrete appears in generally good condition.

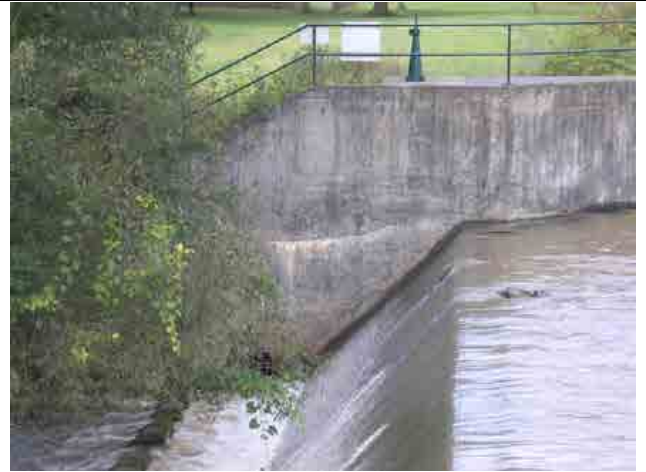
Photo #28 – Right downstream wingwall. Note signs of concrete deterioration.

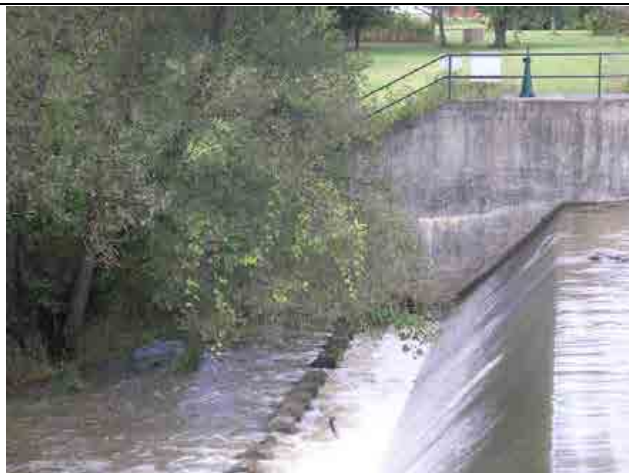
Photo #29 – Right downstream wingwall. Note the trees growing adjacent to stilling basin.

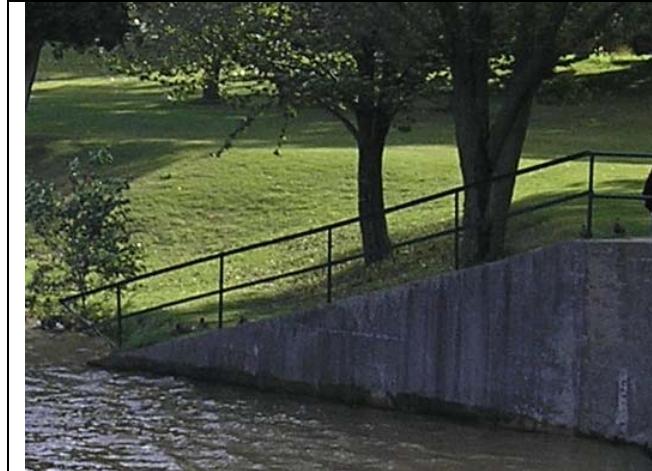
Photo #31 – Right upstream wingwall is in generally good condition.

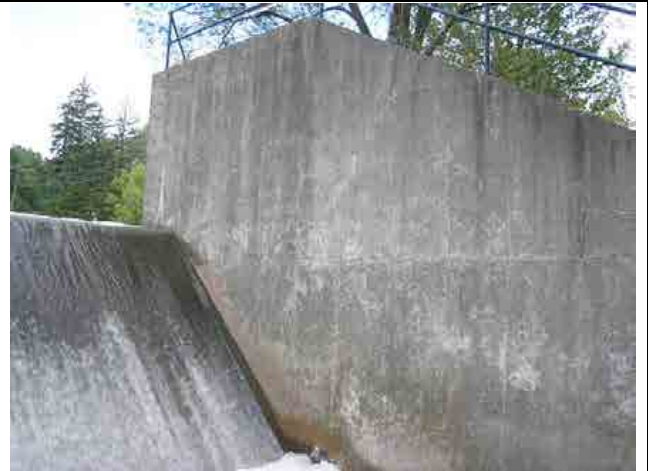
Photo #32 – Right downstream wingwall, in good condition.

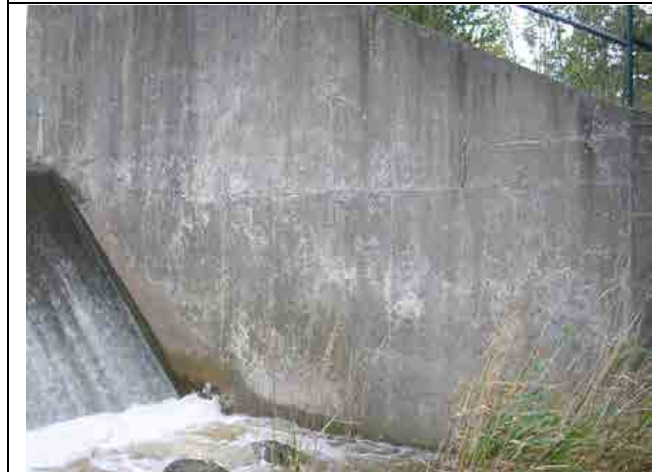
Photo #33 – Close up view of the right downstream wingwall.

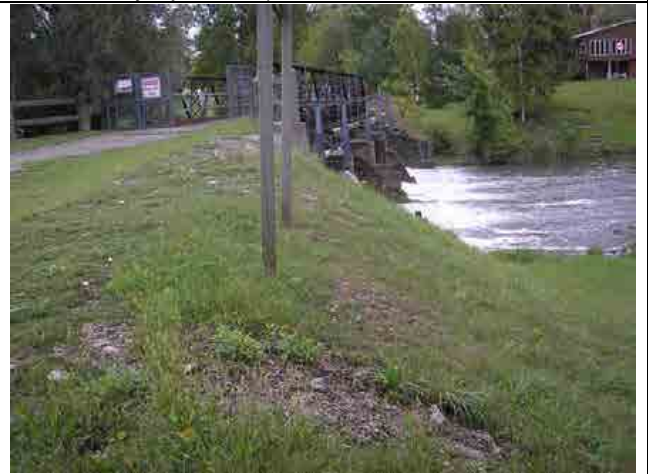
Photo #4 – Slope of the right downstream embankment appears in generally good condition, free of seepage.

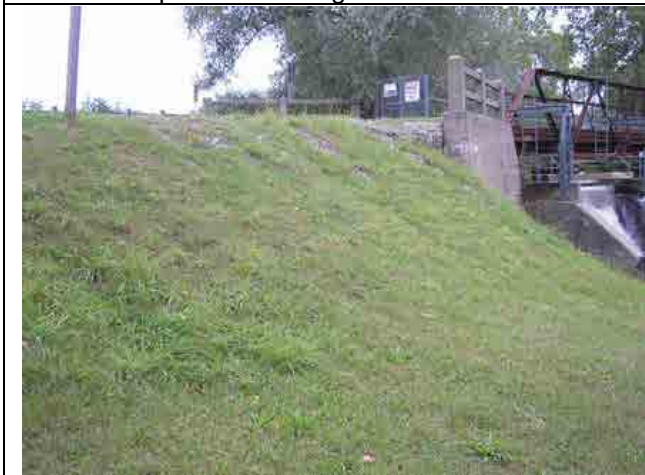
Photo #5 – Close up of the slope of the right downstream embankment.

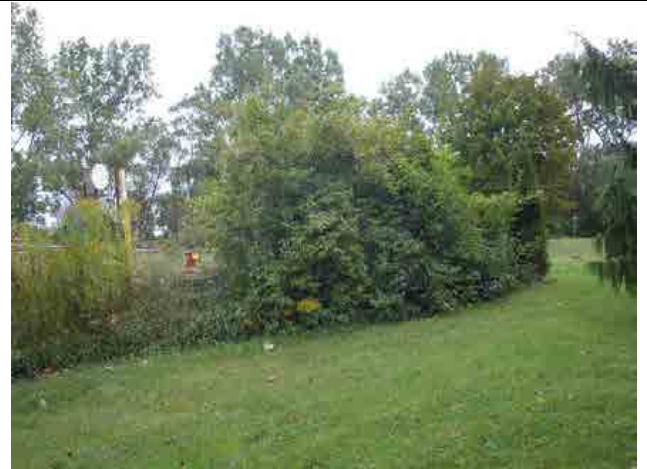
Photo #10 – Upper portions of the left downstream embankment. Seepage, cracks or loss fill through left embankment were not observed.

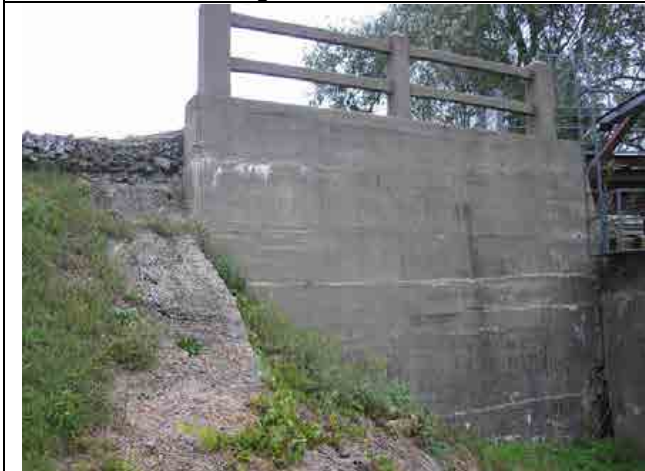
Photo #11 – Right downstream wingwall. Note the seepage at the interface between the wingwall and right most downstream pier.

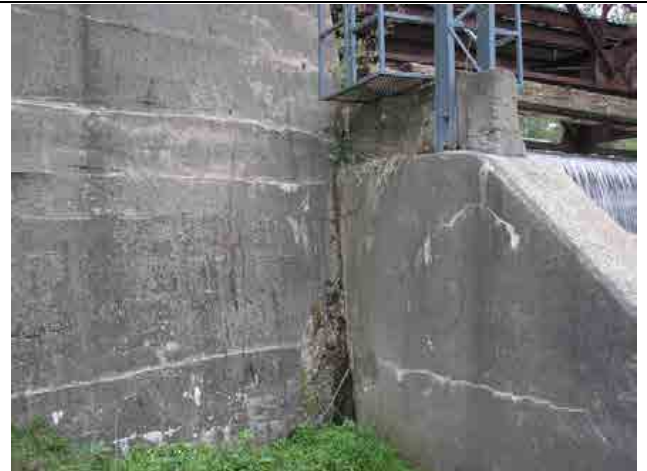
Photo #12 – Close up of the seepage through concrete at the interface between the wingwall and right most downstream pier. Note concrete deterioration in wingwalls and pier.

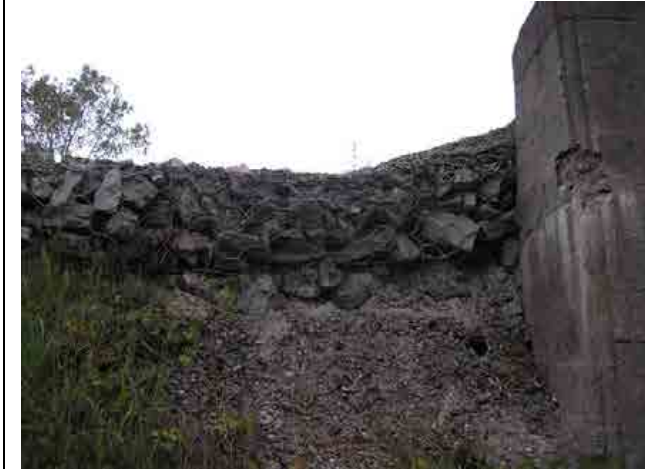
Photo #13 – Gabion mattress located on top of the right embankment at the right downstream wingwall. Downstream slope appears grouted; holes in the grout are observed.

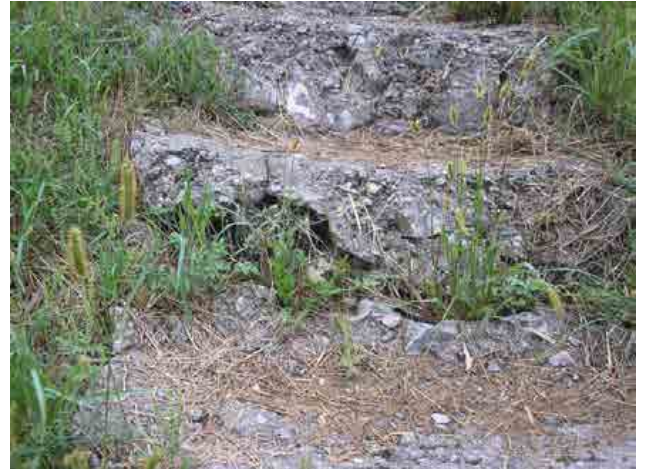
Photo #14 – Close up of the grouted portion of the right downstream slope, adjacent to the right wingwall.

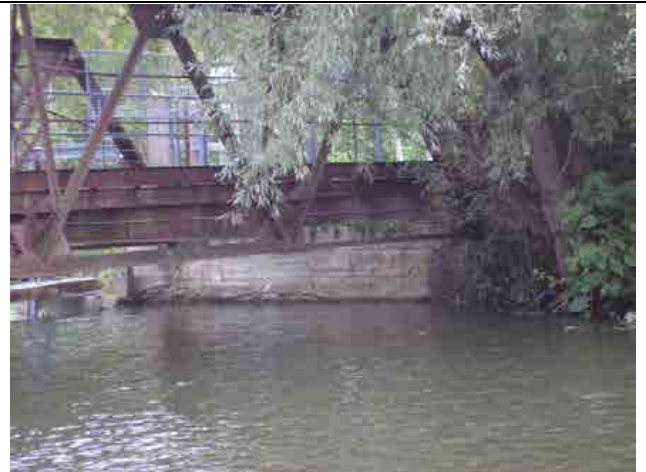
Photo #16 – Close up view of the right upstream wingwall. Concrete spalling observed at the waterline, and extends along length of wingwall.

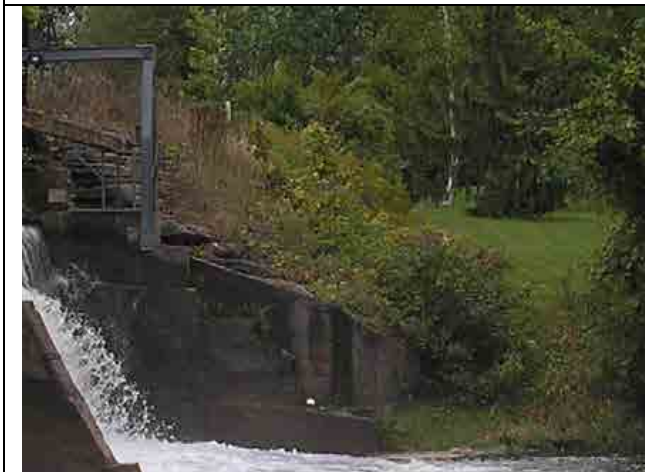
Photo #17 – General overview of the left downstream wingwall, seen from the right bank. Seepage through the wingwall at the left bank was observed.

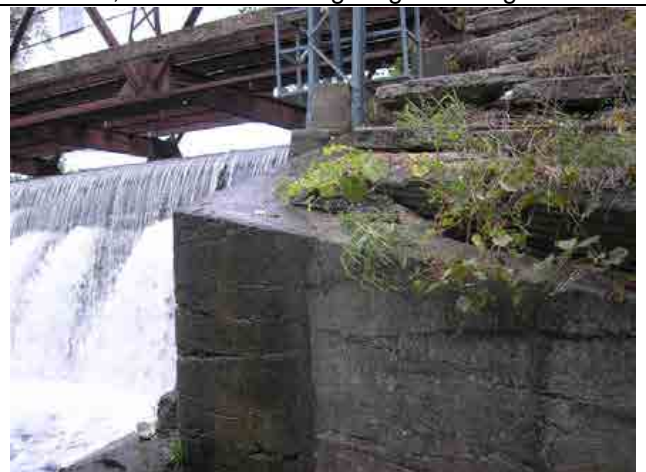
Photo #18 – Left downstream wingwall. The seepage noted was between the left most pier and the wingwall concrete.

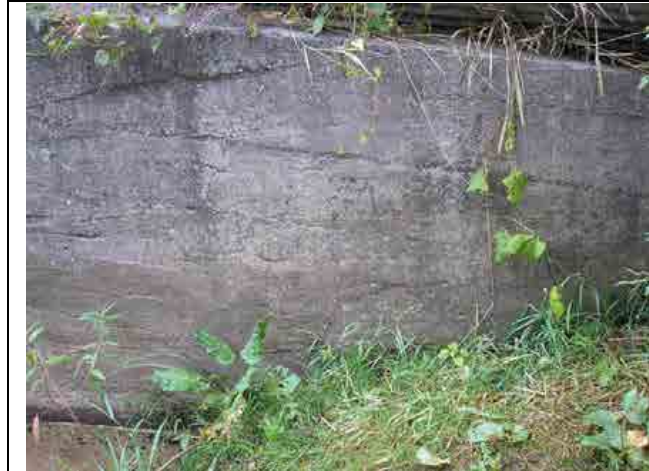
Photo #19 – Lower portion of the left downstream wingwall.

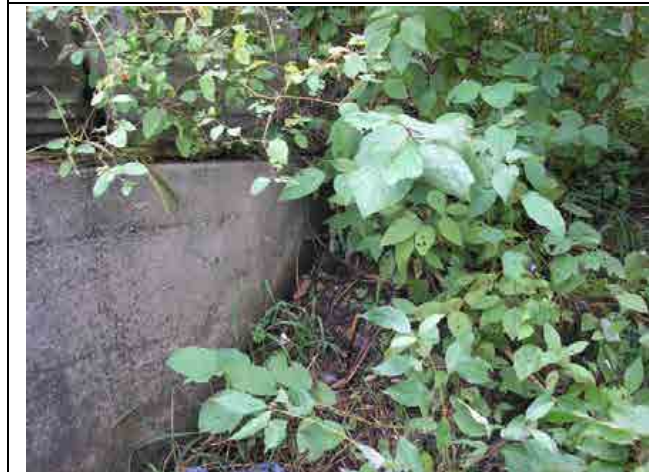
Photo #21 – Wetness was noted adjacent to the bank-wingwall interface, at the left downstream wingwall.

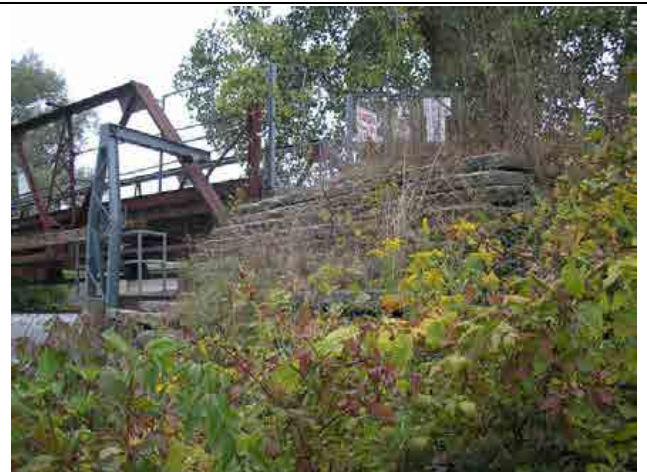
Photo #22 – Left downstream wingwall. Upper portions consist of stacked blocks, grouted together.

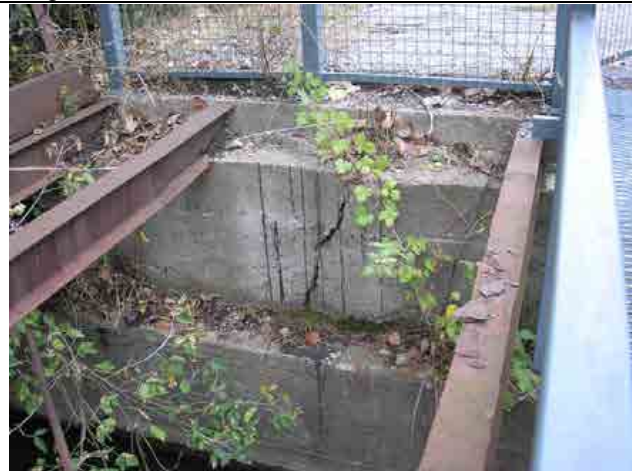
Photo #27 – A crack at the left upstream wingwall, below the old roadway surface.

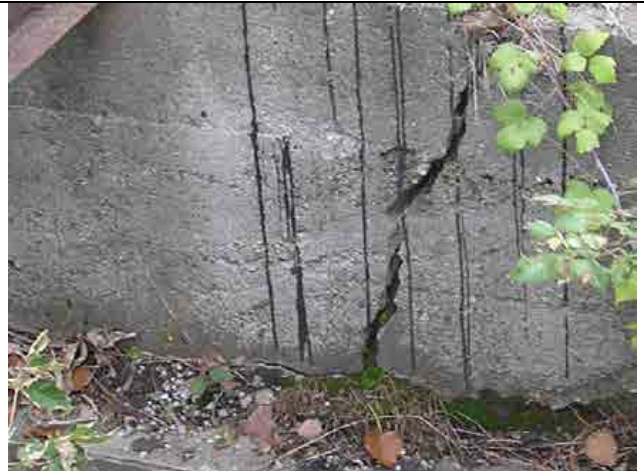
Photo #28 – Close up of the crack at the left upstream wingwall. Width of the crack is in excess of 10 mm.

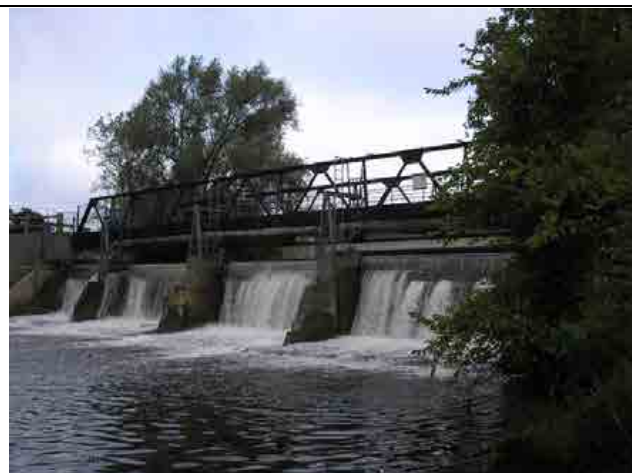
Photo #29 – Teeterville Dam as seen from the left downstream bank. The old roadway bridge is located on top of the dam, and carries maintenance traffic.

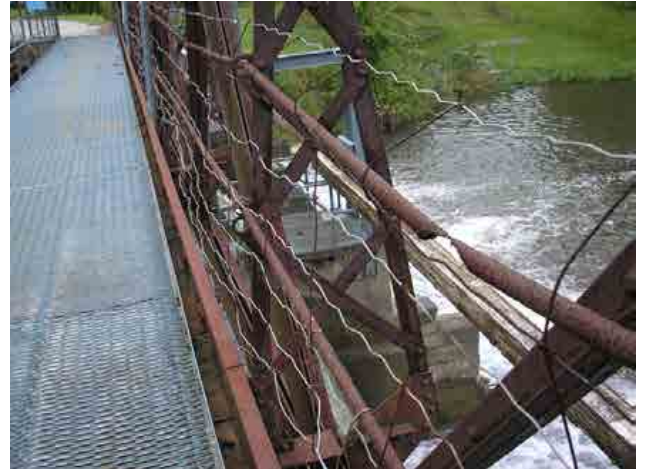
Photo #32 – Railing at the bridge is loose, and consists partially of fence wire.

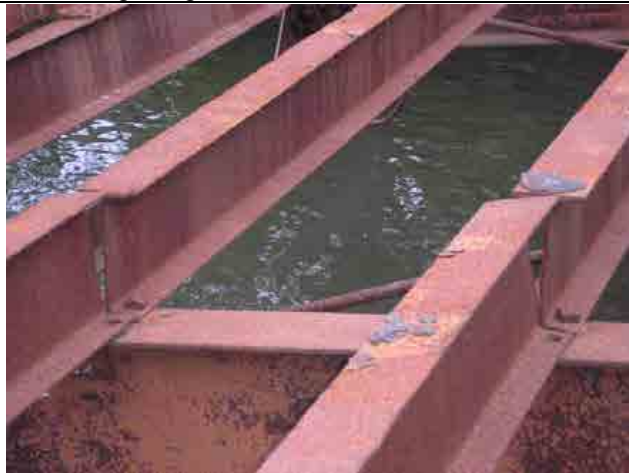
Photo #33 – Majority of the stringers spanning the girders are out of alignment.

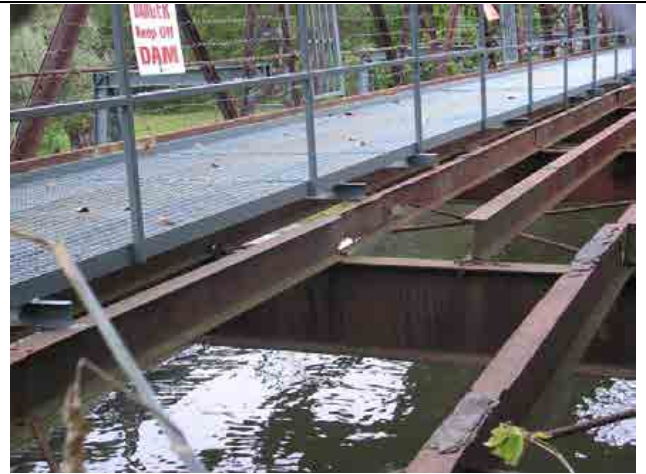
Photo #34 – Some of the stringers that support the existing bridge deck are heavily deteriorated, and do not carry load.

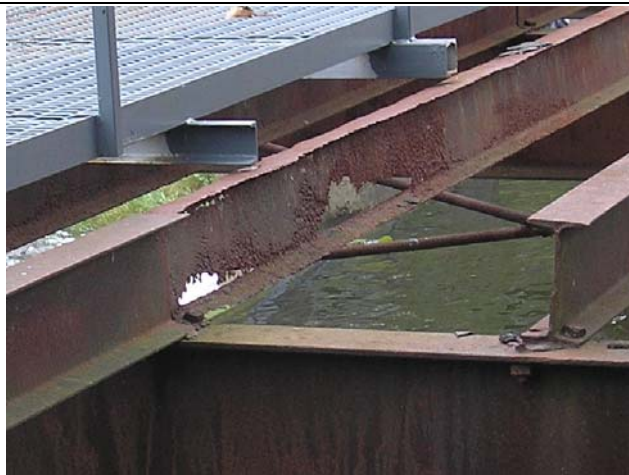
Photo #35 – Close up view of the stringers below the bridge deck. Web of the beam is entirely corroded.

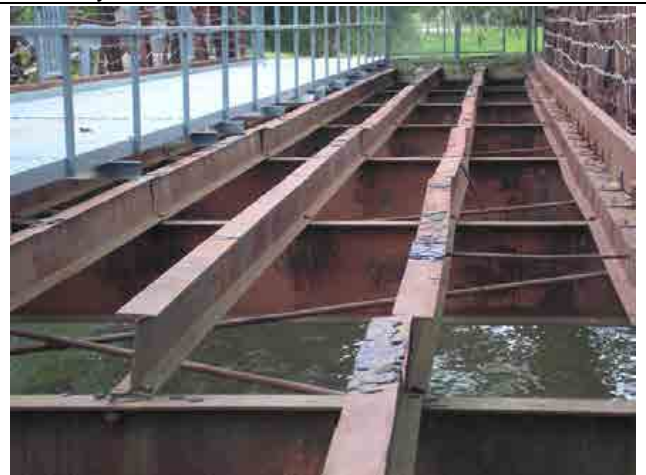
Photo #36 – General view of the stringers adjacent to the deck.

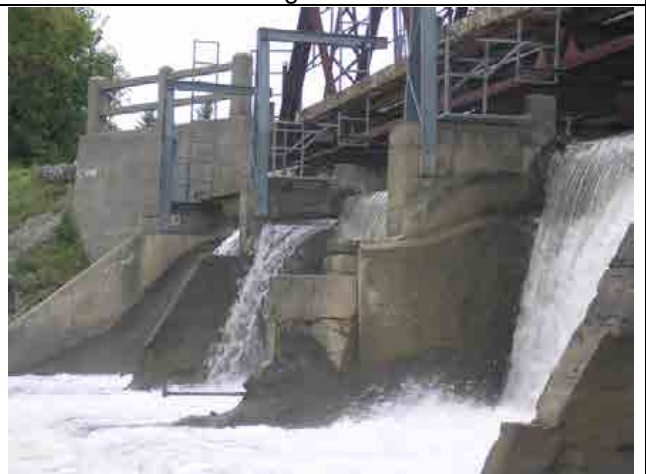
Photo #40 – Teeterville Dam piers. Note the heavy concrete deterioration at the base of the piers.

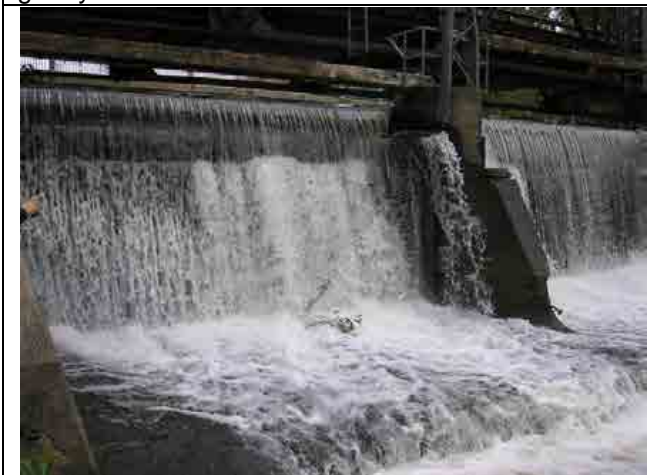
Photo #41 – Right most bay; concrete at the piers heavily deteriorated.

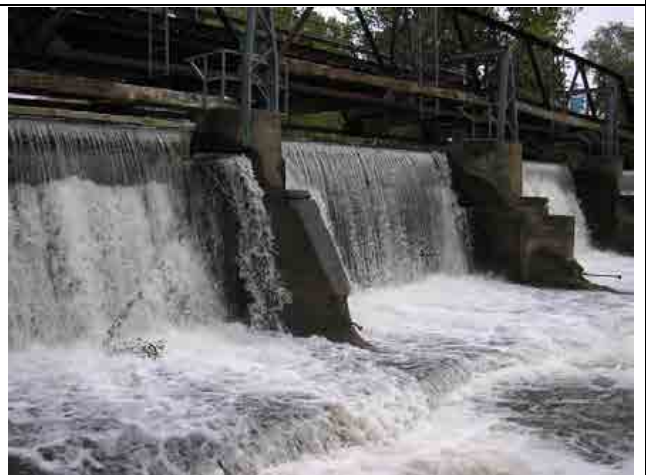
Photo #42 – Concrete is also heavily deteriorated at the inner bays of the dam. Note the elevation difference between the sill of the dam and the bottom of channel.

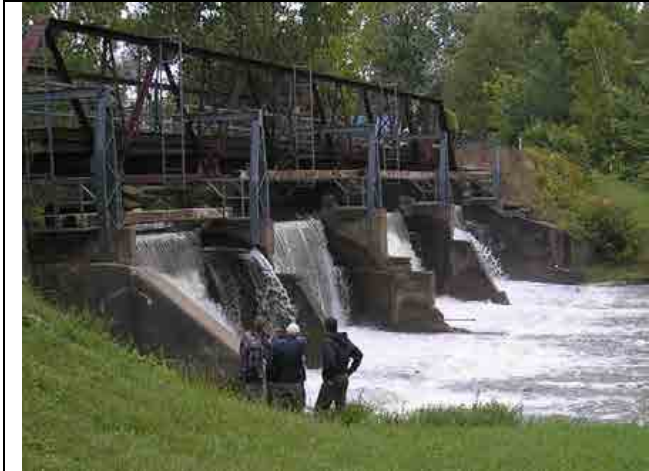
Photo #43 – Downstream channel, as seen from the right bank.

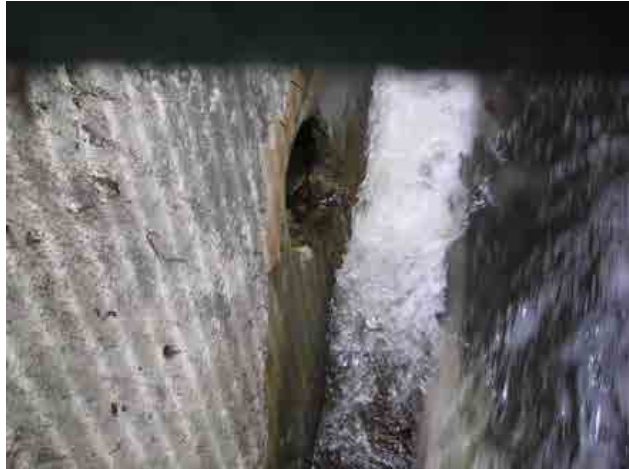
Photo #7 – Lehman Dam toe drain (inside the outlet structure) was observed to be functioning, draining left portion of the embankment.

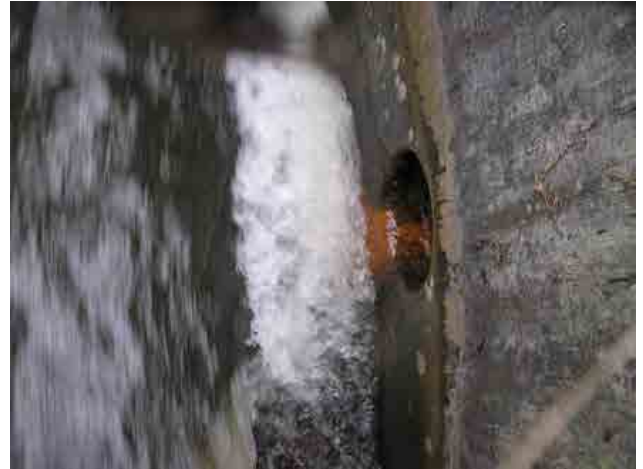
Photo #8 – Lehman Dam toe drain (inside the outlet structure) was observed to be functioning, draining right portion of the embankment.

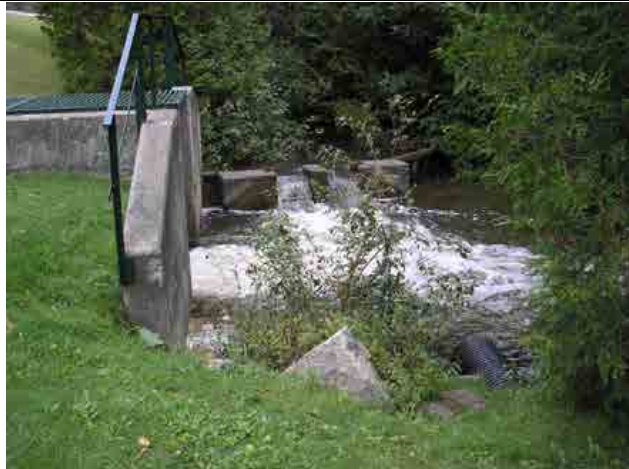
Photo #9 – Downstream outlet channel and fish ladder outlet. A perforated pipe observed for collecting upland storm water.

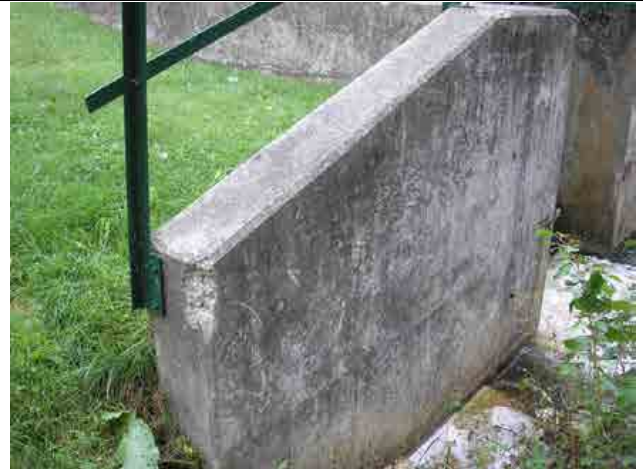
Photo #10 – Right wingwall of the outlet structure. Minor spalling of concrete on the downstream side. Concrete is generally in good condition.

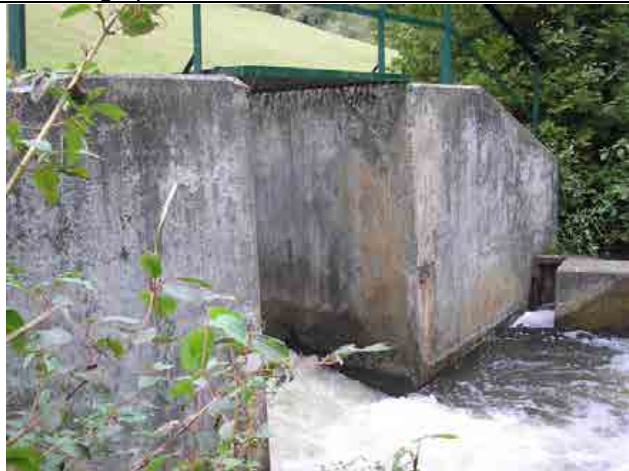
Photo #11 – Left wingwall of the outlet structure, (at the interface with the fish ladder outlet). Concrete observed to be in good condition.

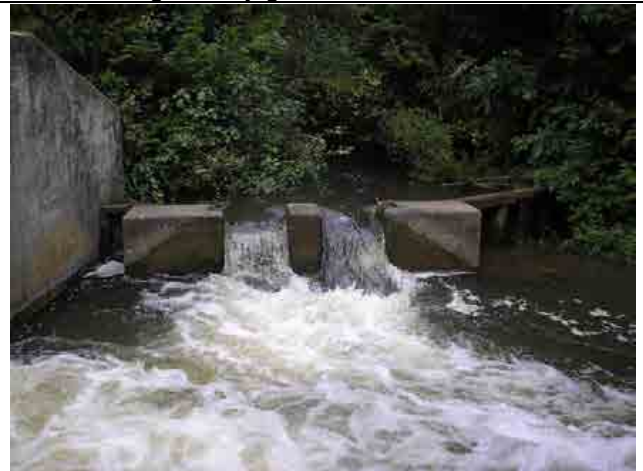
Photo #12 – Outlet of the fish ladder channel, Concrete blocks and sheet pile wall in good condition.

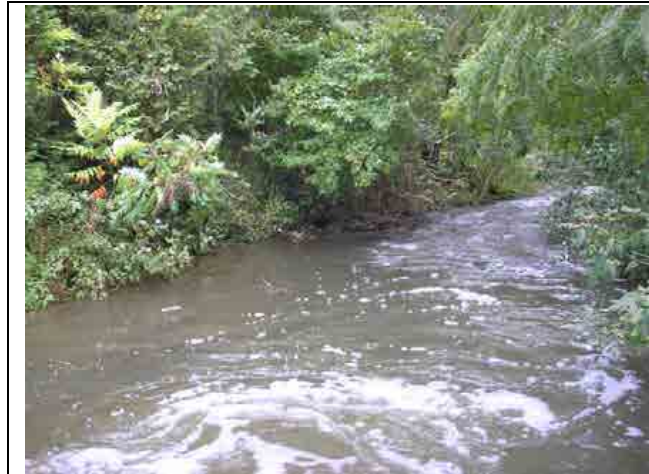
Photo #13 – Lehman Dam downstream channel. Banks heavily vegetated.

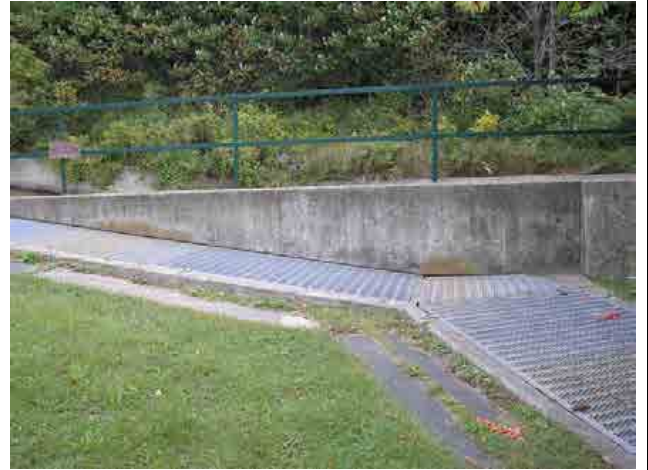
Photo #16 – Lower portion of the Lehman Dam fish ladder. The adjacent right downstream wingwall concrete is in good condition.

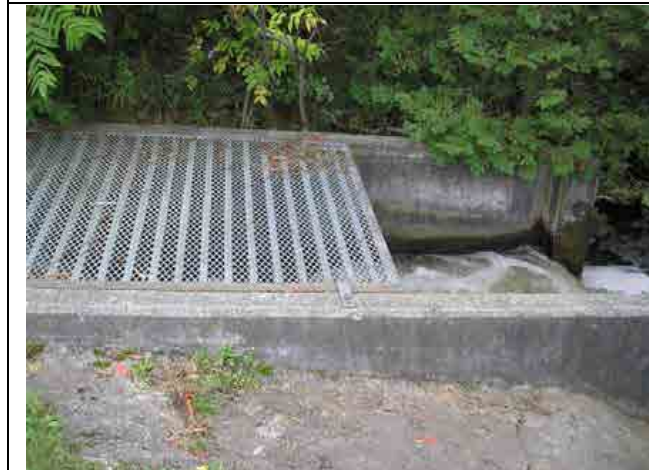
Photo #17 – Outlet of the fish ladder. Right bank is grouted with concrete. Opening in grate required for upstream fish migration. Opening poses safety hazard for staff.

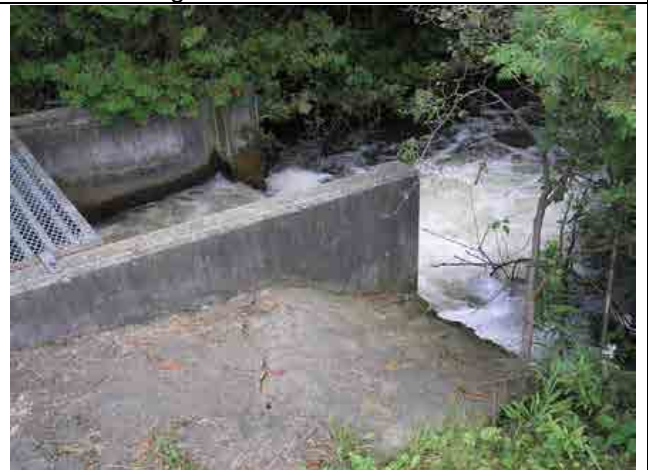
Photo #18 – Outlet of fish ladder, looking downstream. The channel immediately downstream of the outlet appears lower than bottom of outlet.

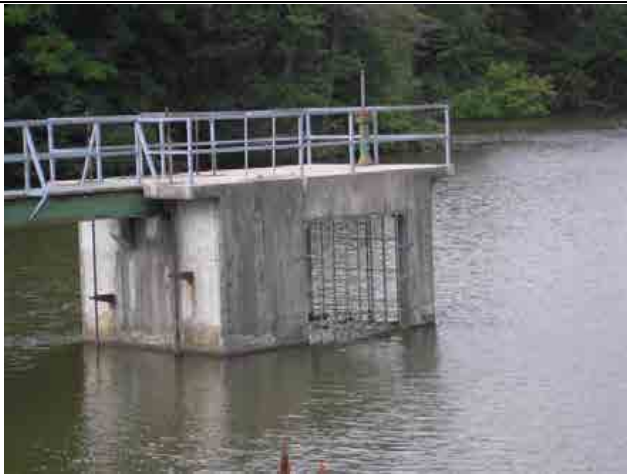
Photo #27 – Lehman Dam intake tower. Concrete is in generally good condition. Overflow gates are located on three sides of the structure.

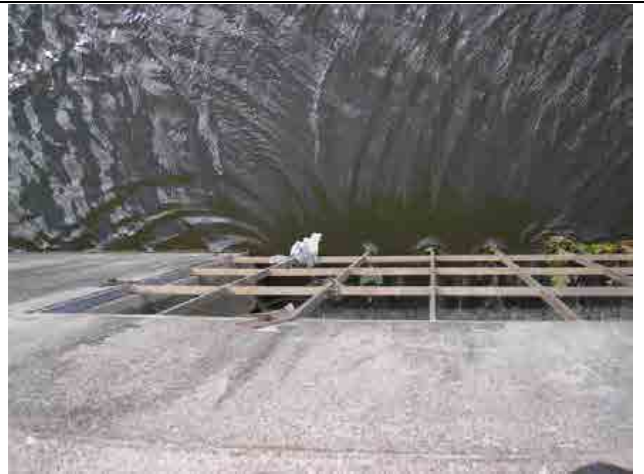
Photo #28 – Typical view at the intake grate. Small amount of trash observed adjacent to grate.

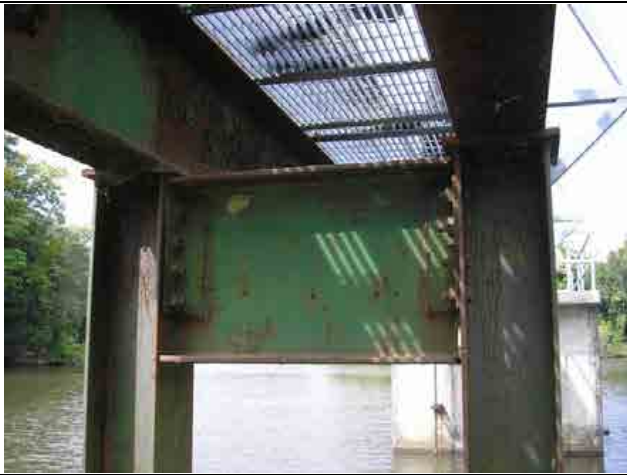
Photo #29 – Pile bent supporting the access walkway to the intake structure. Steel appears in good condition.

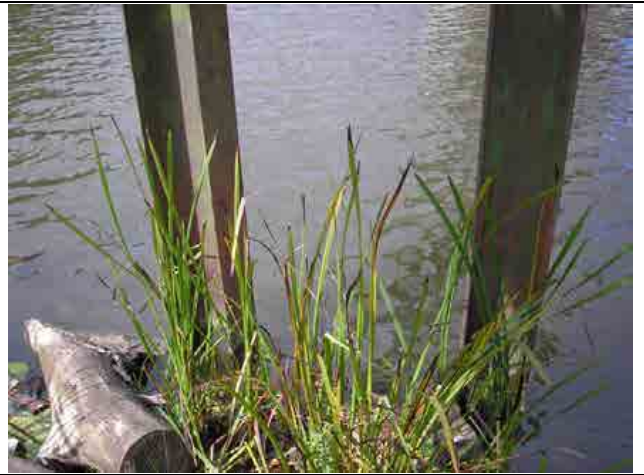
Photo #30 – Bottom of the pile bent, at the waterline.

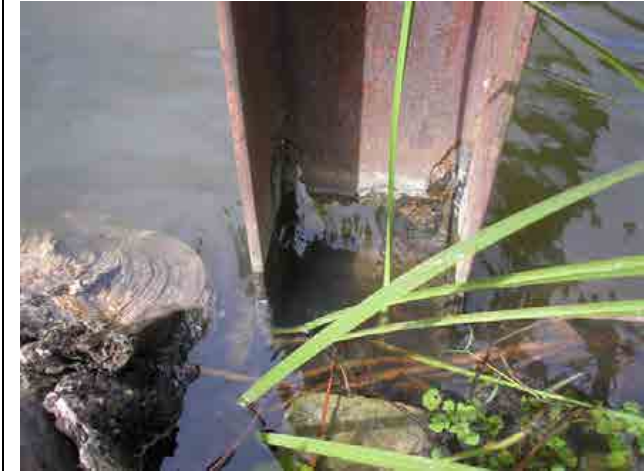
Photo #31 – Right bent. Corrosion through the web observed at waterline.

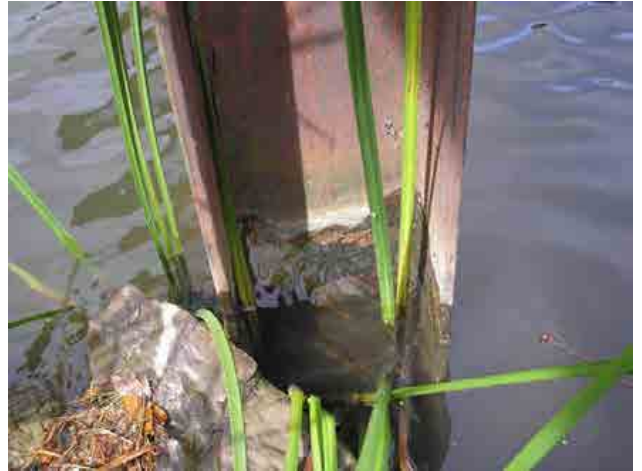
Photo #32 – Left bent. Corrosion through the web observed at waterline.

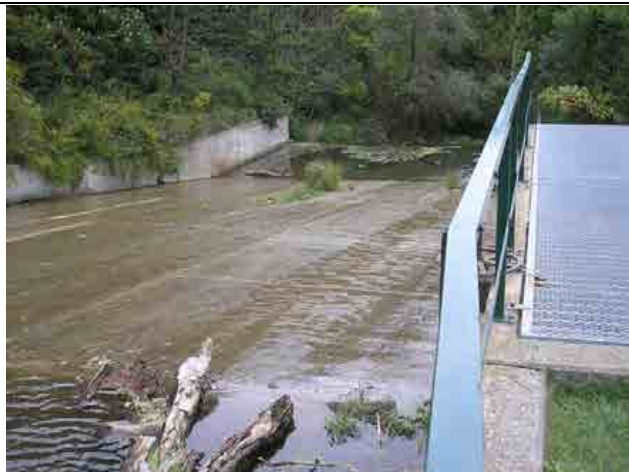
Photo #33 – Lehman Dam main spillway, standing on top of wingwall and looking downstream.

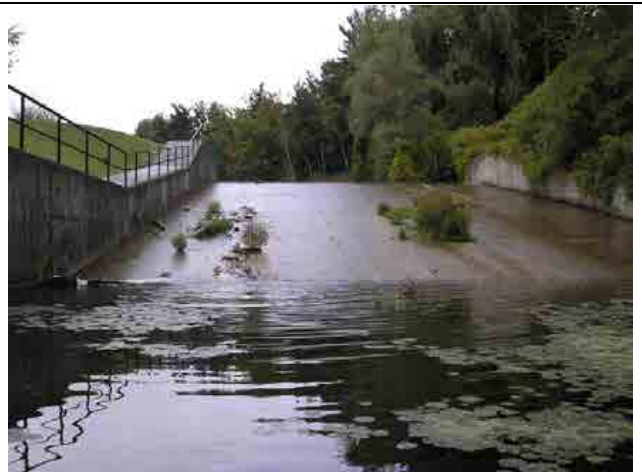
Photo #34 – Main spillway, standing in stilling basin and looking upstream. Minor vegetation growing through the concrete spillway observed.

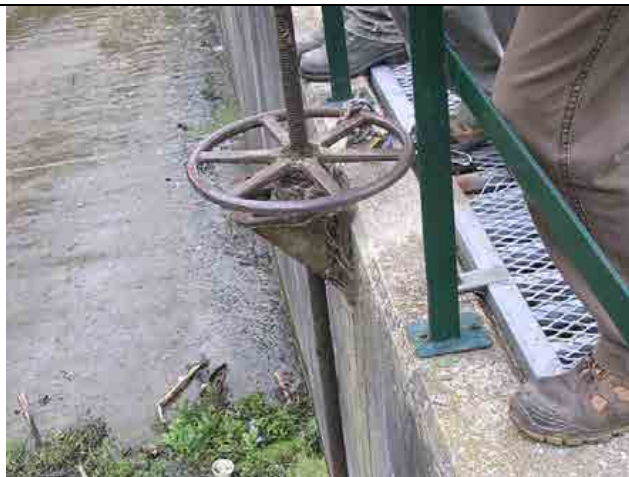
Photo #35 – Fish ladder intake gate in the right upstream wingwall. LPRCA staff informs gate is functional.

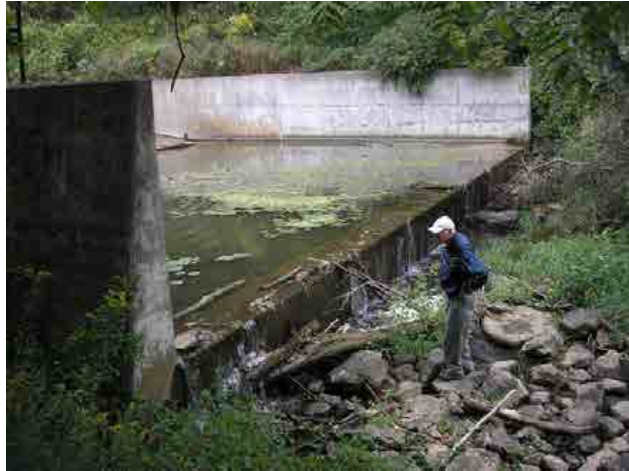
Photo #37 – Stilling basin and downstream channel. Note the missing riprap stone downstream.

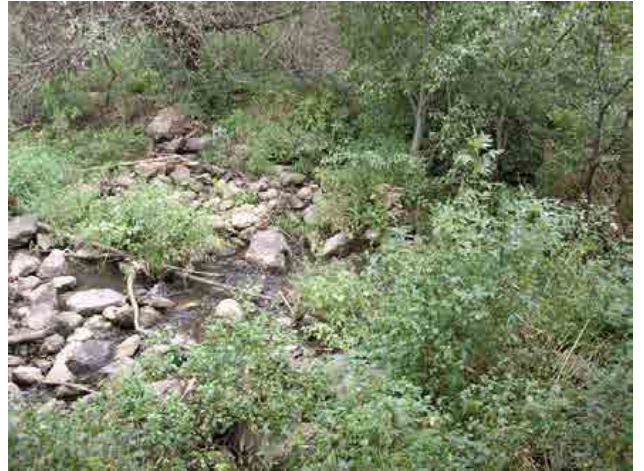
Photo #38 – Channel downstream of the spillway is heavily vegetated with brush. Loose riprap evident.

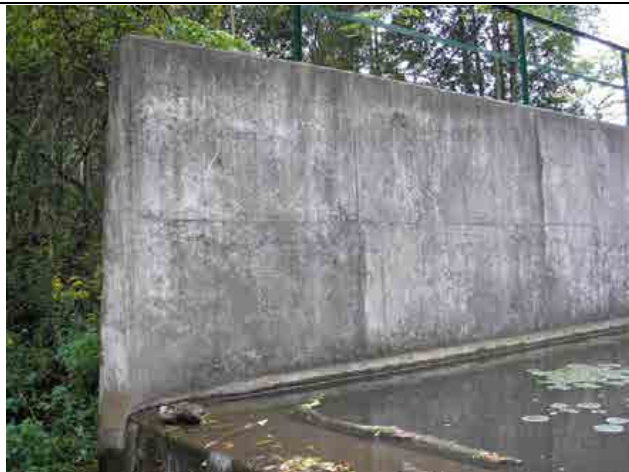
Photo #39 – Right downstream wingwall, at the stilling basin. Concrete appears in good condition.

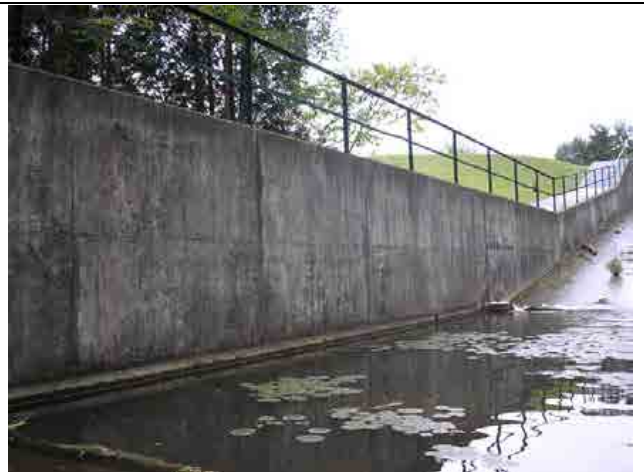
Photo #40 – Right downstream wingwall, as seen from the stilling basin. The wingwall also functions as the fish ladder channel.

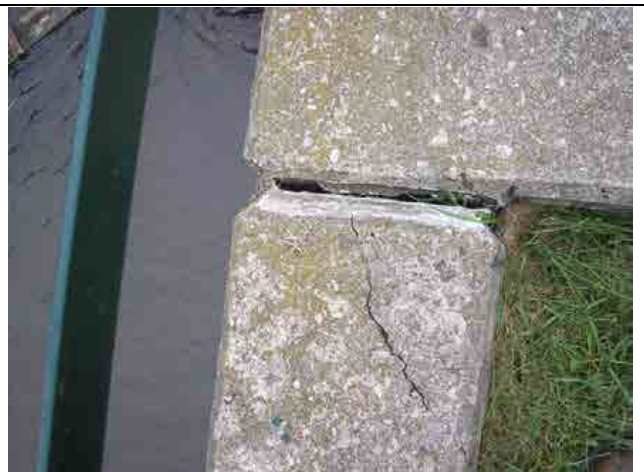
Photo #42 – Crack and joint movement at the right downstream wingwall and fish ladder channel structure.
