Cliff Evanitski
General Manager
Long Point Region Conservation Authority
4 Elm Street
Tillsonburg, Ontario
N4G 0C4

Dear Mr. Evanitski,

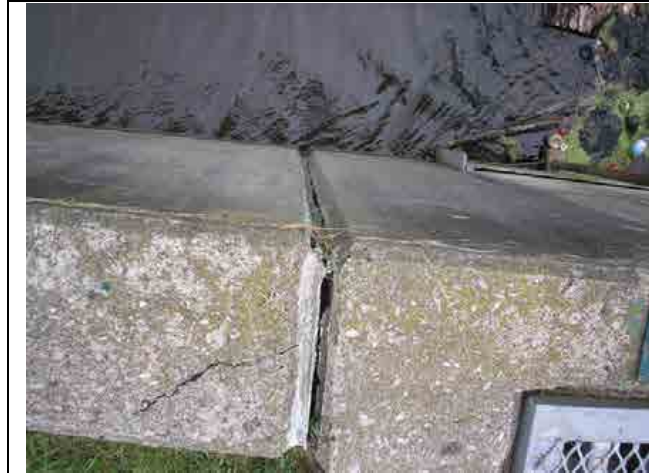
Photo #43 – Top view of the joint movement at the right downstream wingwall and fish ladder.

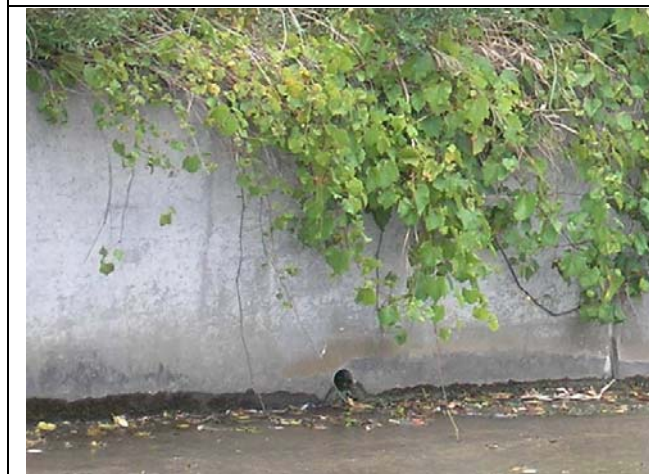
Photo #47 – Drain holes at the left downstream wingwall observed as functioning.

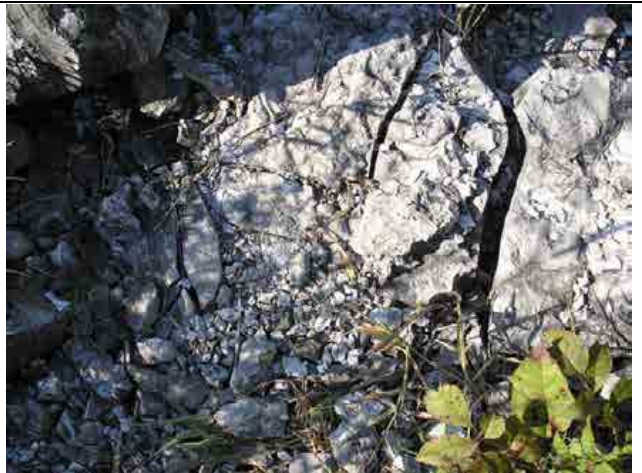
Photo #6 – Close up view of the deterioration of the riprap along the slope of right upstream embankment. Riprap varies from 10 to 1000 mm.

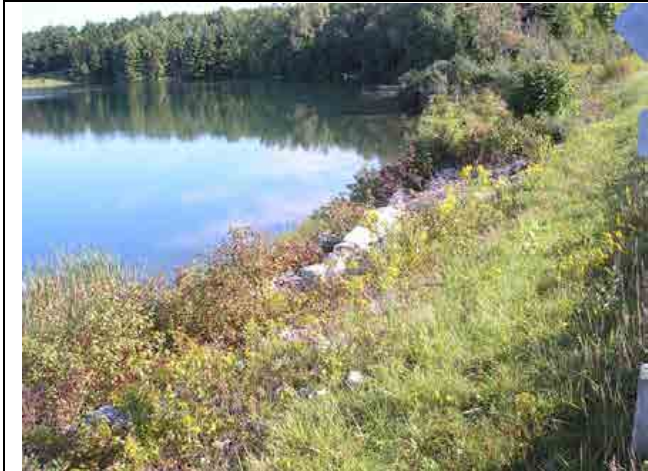
Photo #7 – Left upstream embankment, looking towards the left bank. Slope below waterline appears mild.

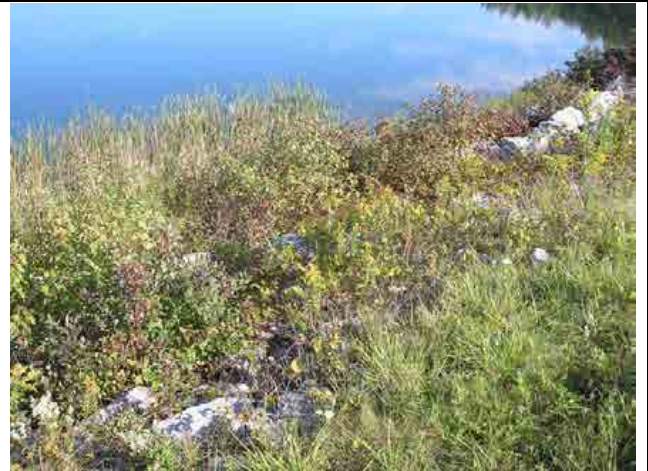
Photo #8 – Change in slope observed above the waterline approximately half way between the lift control chamber and the bridge.

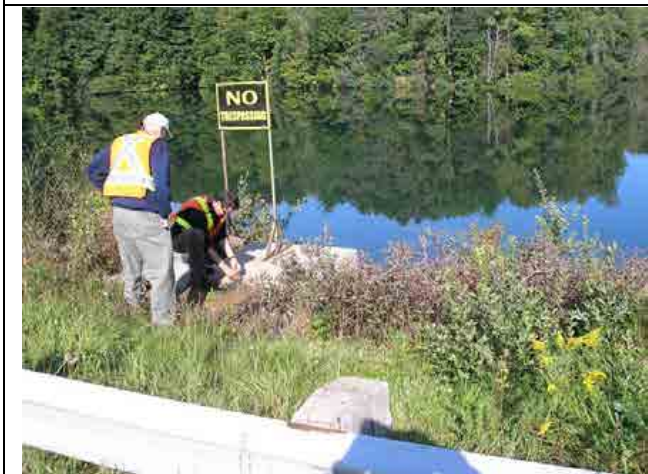
Photo #9 – Lift control chamber, located on top of left upstream embankment.

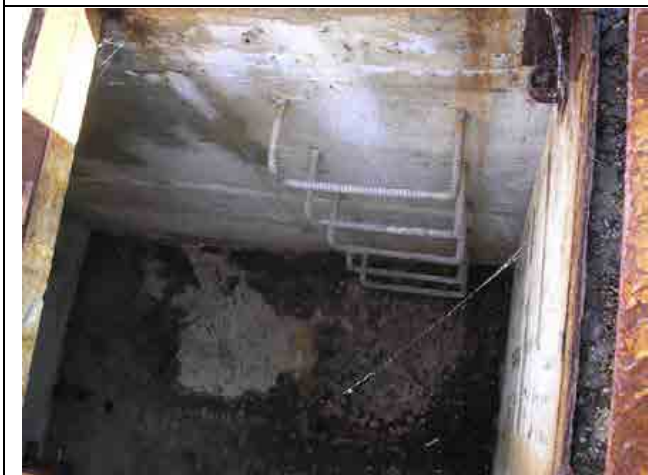
Photo #11 – Access to the lift chamber from above. Minor concrete deterioration at the top.

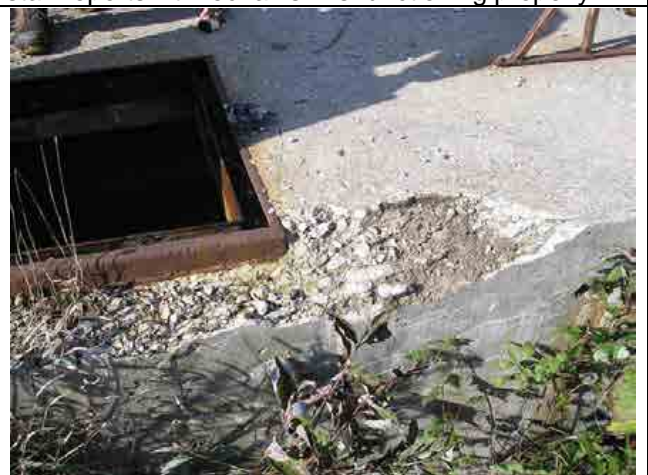
Photo #12 – Concrete spalling on the outside of the lift chamber. Damage likely exacerbated from application of salt during winter on adjacent road.

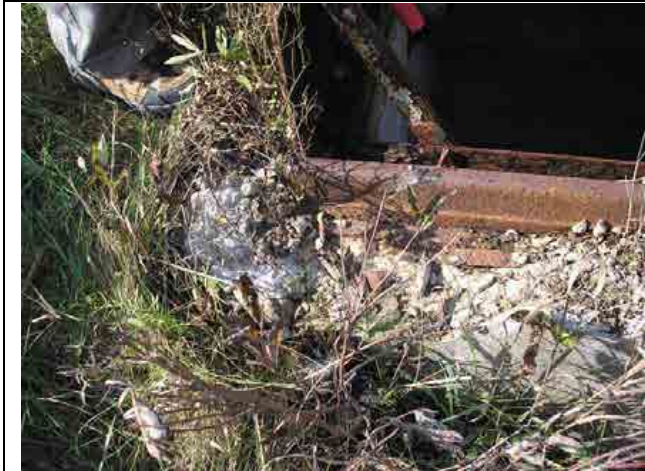
Photo #13 – Close up view of the concrete spalling outside of the lift chamber.

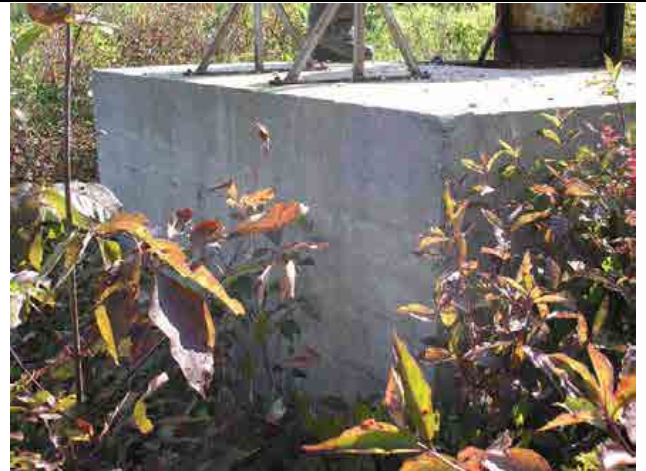
Photo #14 – Lift chamber, as seen from the left downstream slope.

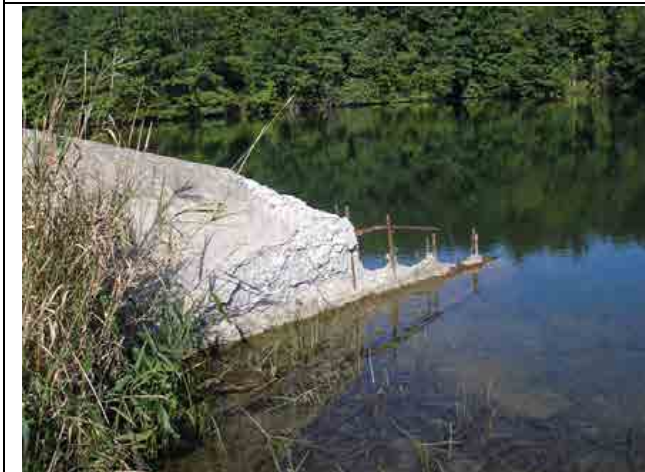
Photo #15 – Left upstream wingwall. Note missing concrete and exposed reinforcing bars.

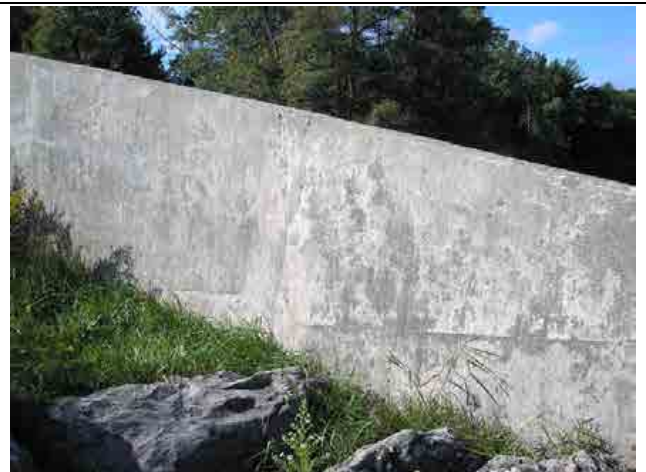
Photo #16 – Left upstream wingwall, along the upstream slope. Concrete is in generally good condition.

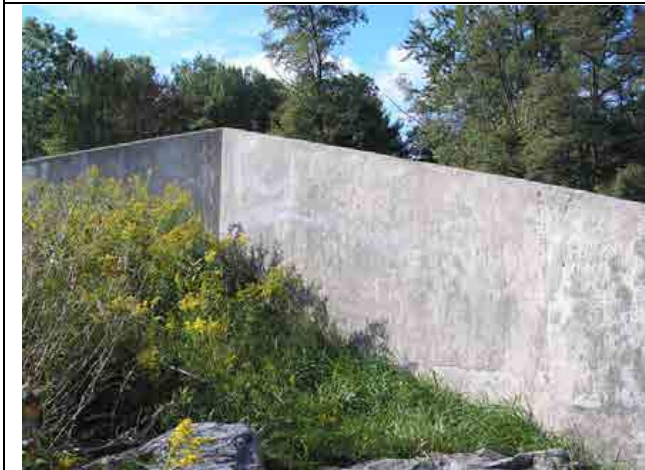
Photo #17 – Left upstream wingwall, at top of slope.

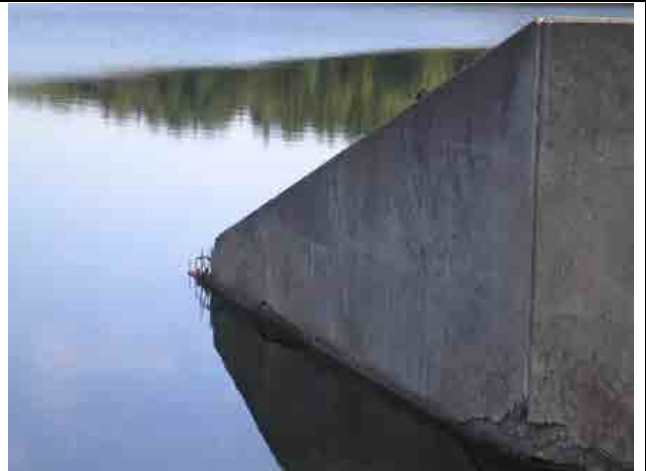
Photo #20 – Left upstream wingwall, as seen from the right upstream bank. Note concrete spalling at the waterline.

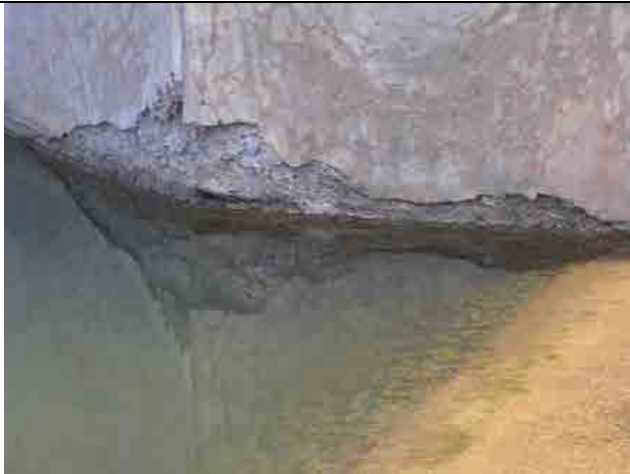
Photo #21 – Close up of the concrete spalling at the waterline.

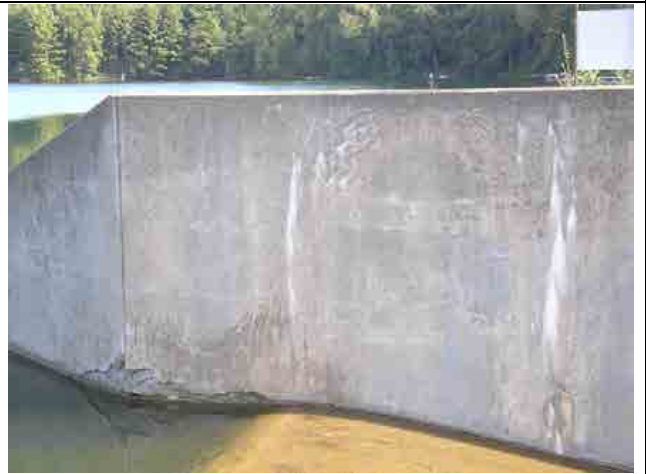
Photo #22 – Left upstream wingwall adjacent to the spillway.

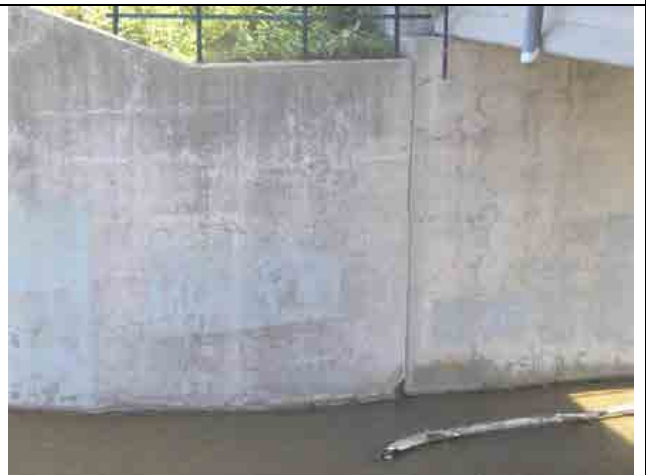
Photo #24 – Left upstream wingwall, at and underneath the roadway bridge. Concrete appears in good condition.

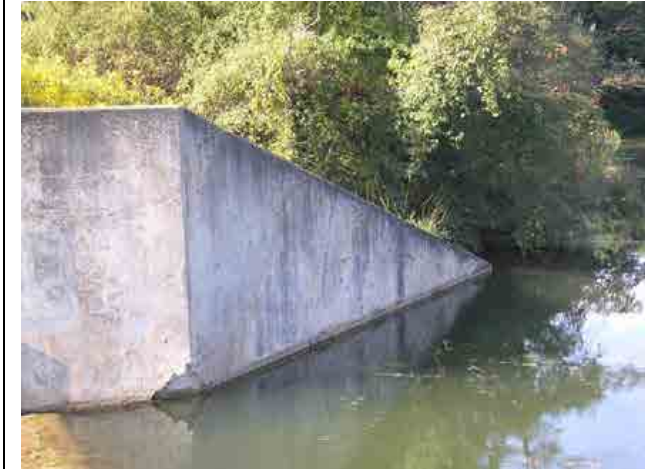
Photo #25 – Right upstream wingwall. Concrete is in generally good condition, although spalling is visible at waterline where wall changes alignment.

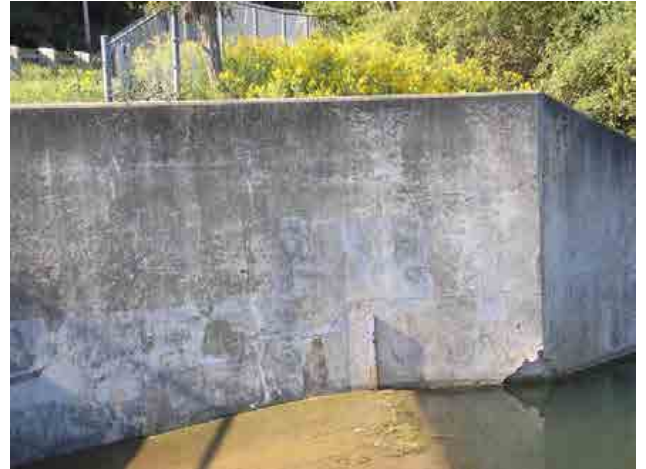
Photo #26 – Right upstream wingwall, upper portions. Top of spillway is at the old water level gauge.

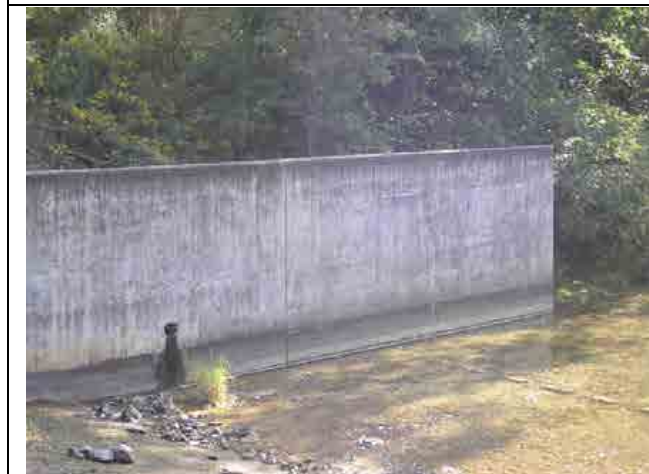
Photo #33 – Left downstream wingwall, panel 8. Corrugated steel toe drain noted as functional.

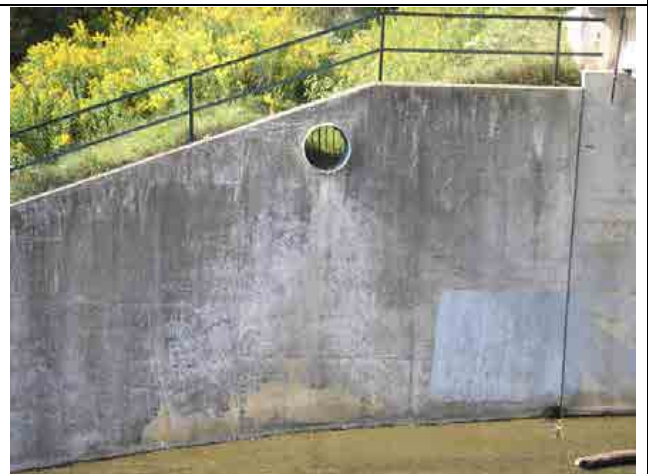
Photo #34 – Right downstream wingwall, panel 1. Panels are numbered from 1 (at bridge) to 8 (at spillway). No joint filler material between panels.

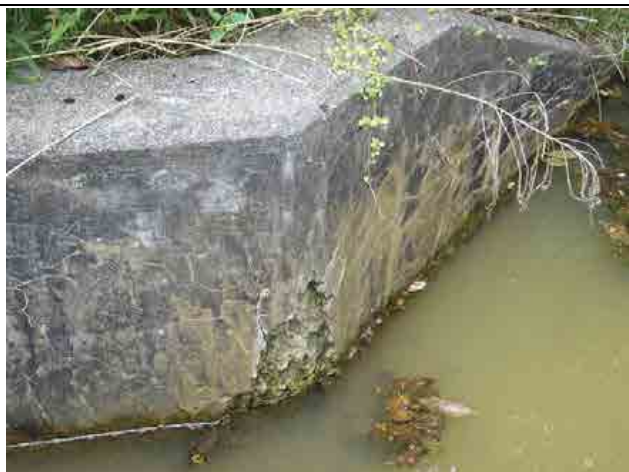
Photo #47 – Low flow outlet structure, left downstream wingwall. Note concrete deterioration.

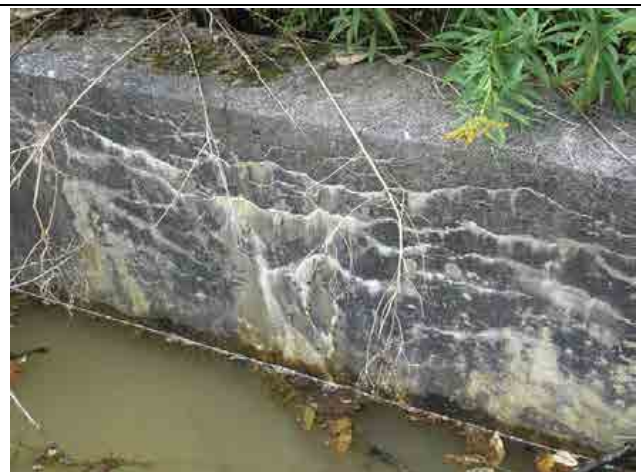
Photo #48 – Low flow outlet structure, left downstream wingwall. Note alkali-silica reaction.

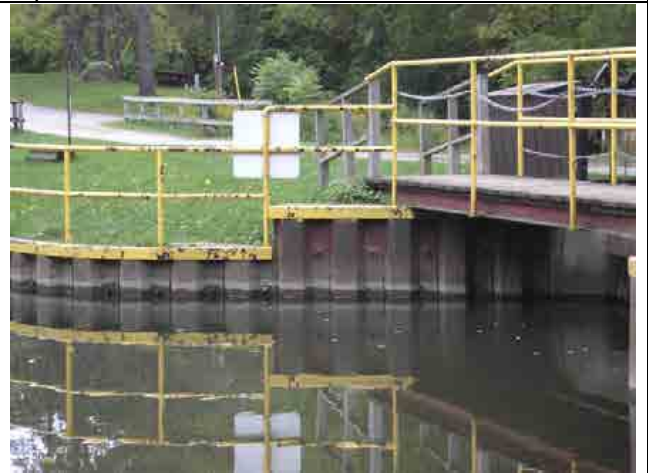
Photo #6 – Close up of the left upstream wingwall that consists of sheet piling. Piling is in good condition.

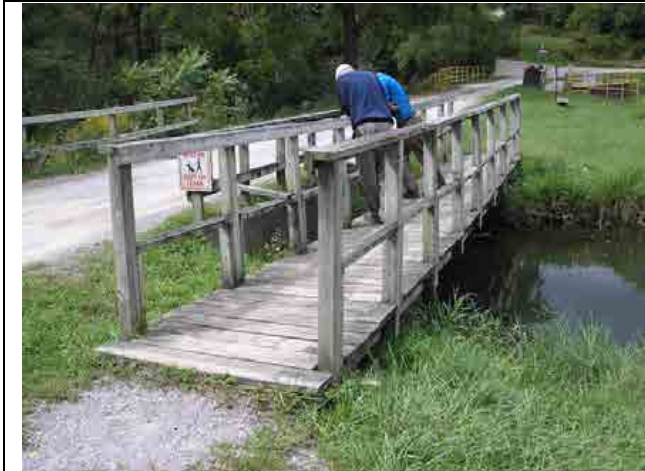
Photo #7 – Upstream embankment and millrace intake. Slopes of upstream embankment are fairly mild. Note pedestrian access over millrace intake.

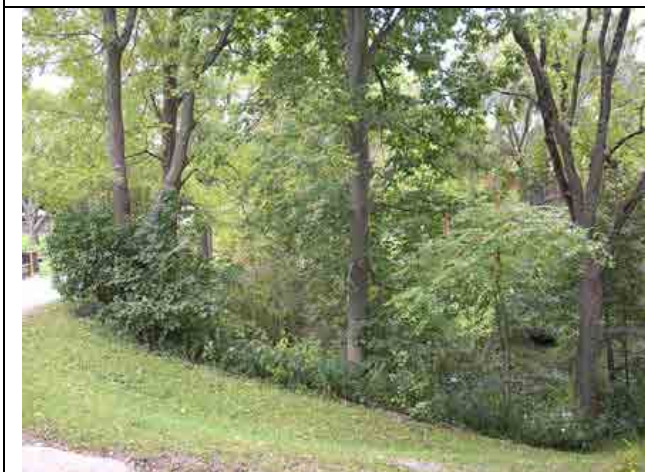
Photo #11 – Backus Mill Dam, right downstream embankment. Slope is approximately 1.5H:1V and is covered with heavy brush and mature trees. Seepage at toe of slope was not observed.

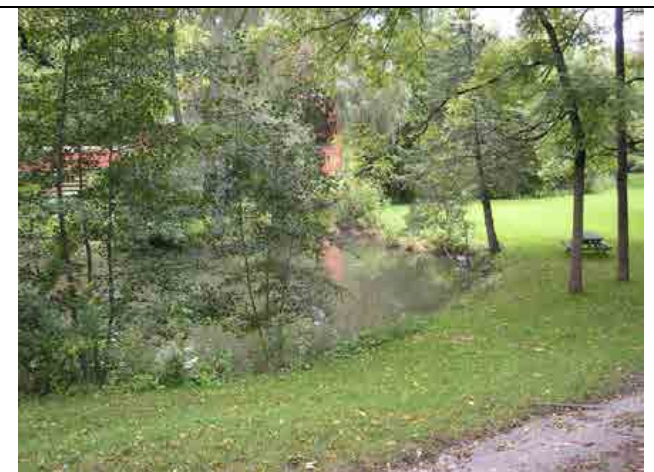
Photo #12 – Channel and right downstream bank.

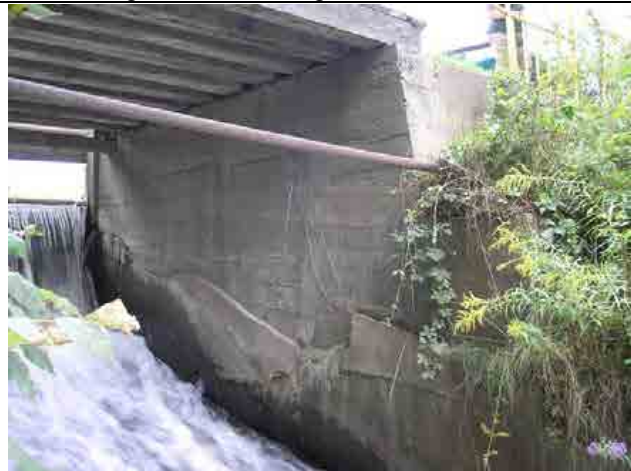
Photo #21 – Left downstream wingwall, underneath the bridge. Evidence of past concrete repairs is evident.

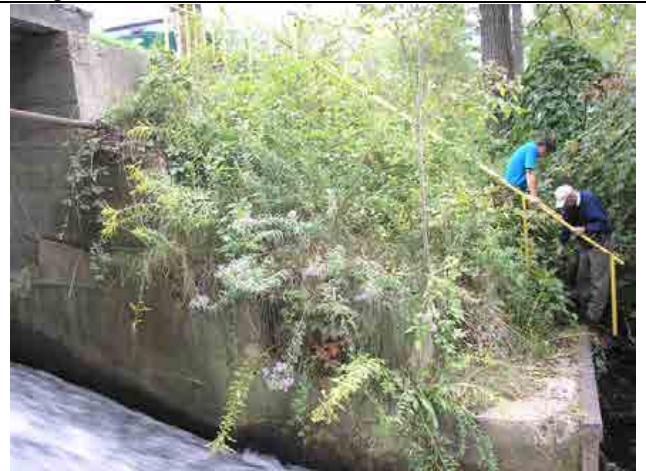
Photo #22 – Left downstream wingwall. Slope above consists of grouted concrete blocks, with brush vegetation growing between the blocks.

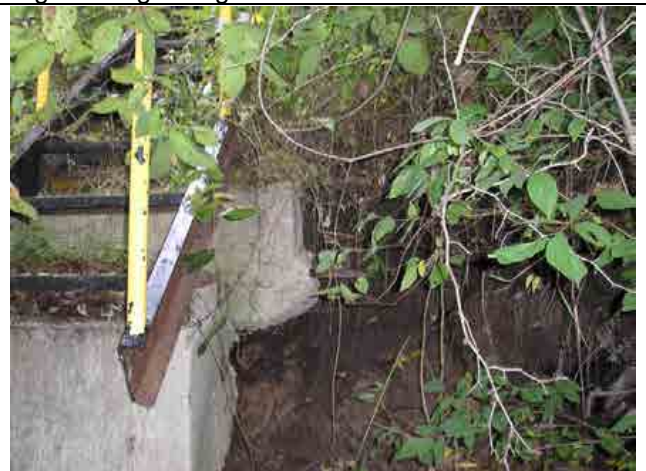
Photo #24 – Left downstream embankment left of the access stairs consists of slope that is over steepened. Localised loss of embankment fill was observed.

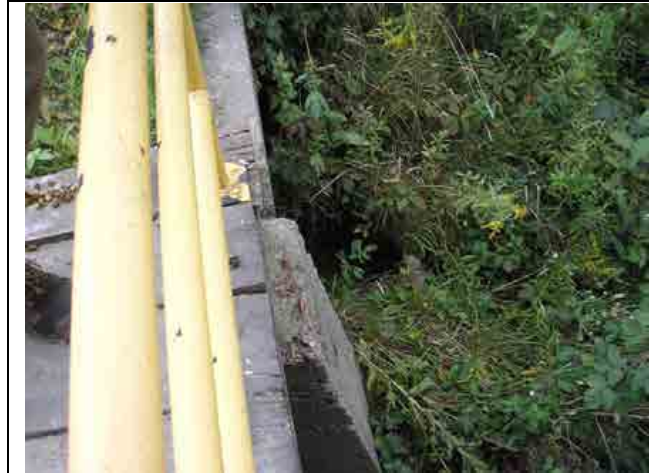
Photo #25 – Void in the left downstream embankment noted, adjacent to the left downstream wingwall.

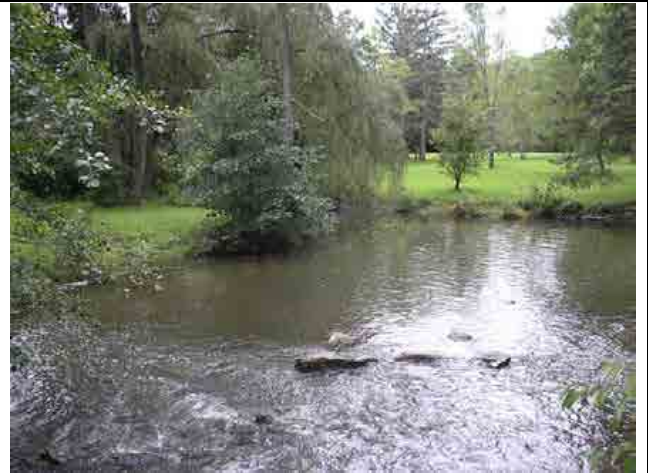
Photo #26 – Channel downstream of main spillway, some bank protection present.

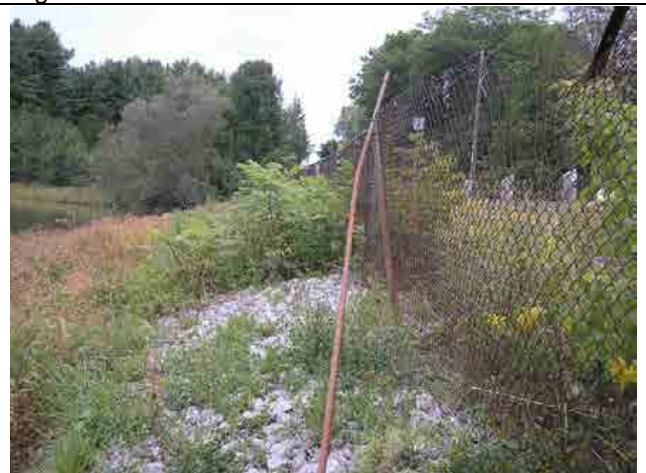
Photo #6 – Left upstream embankment, standing at left wingwall looking towards left. Gabion mattress adjacent to left upstream wingwall. Damaged fence.

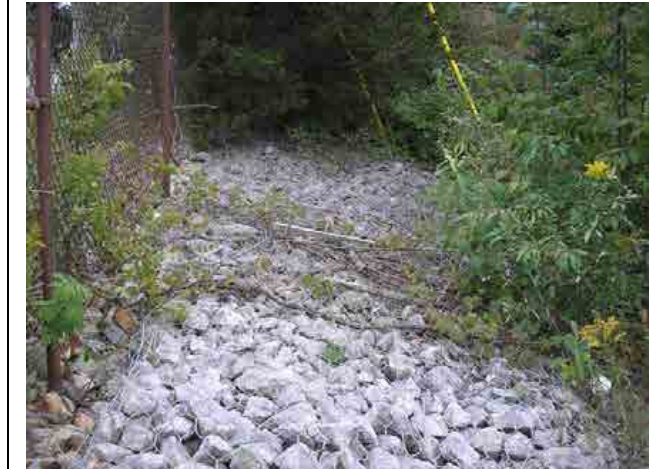
Photo #7 – Right upstream embankment, standing on right wingwall looking right. Note gabion mattress.

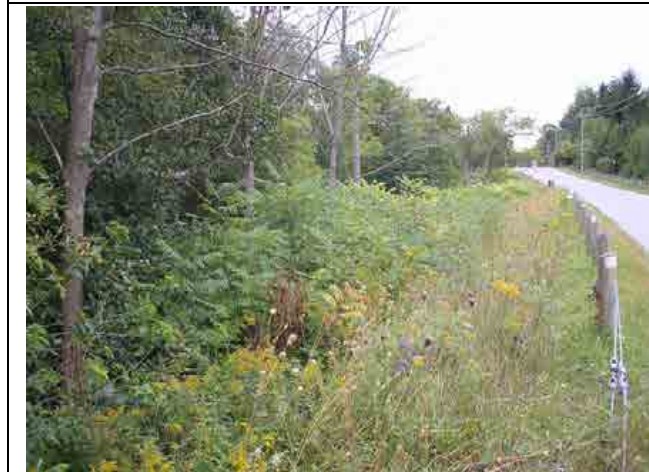
Photo #9 – Left downstream embankment. Brush and trees growing along lower slopes. Seepage through embankment not observed.

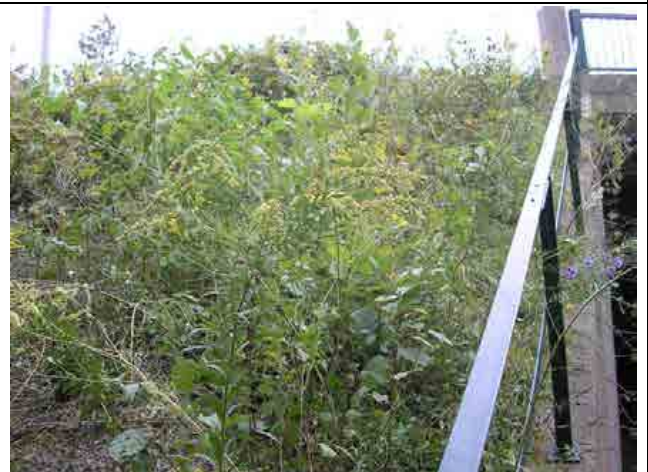
Photo #10 – Right downstream embankment, looking towards road. Portion of the embankment adjacent to right downstream wingwall is surfaced with asphalt.

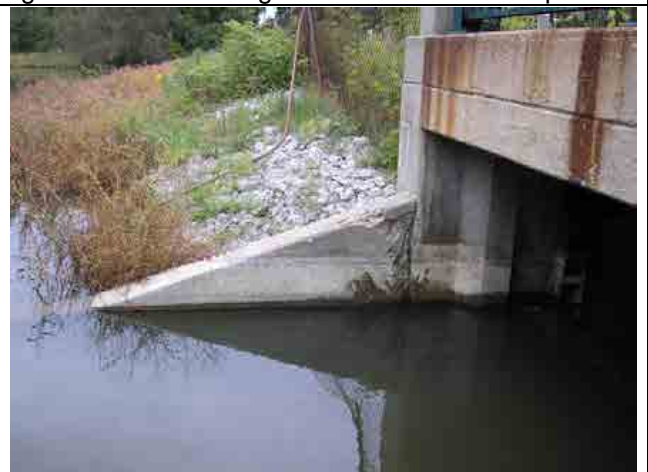
Photo #12 – Concrete deterioration at the left upstream wingwall.

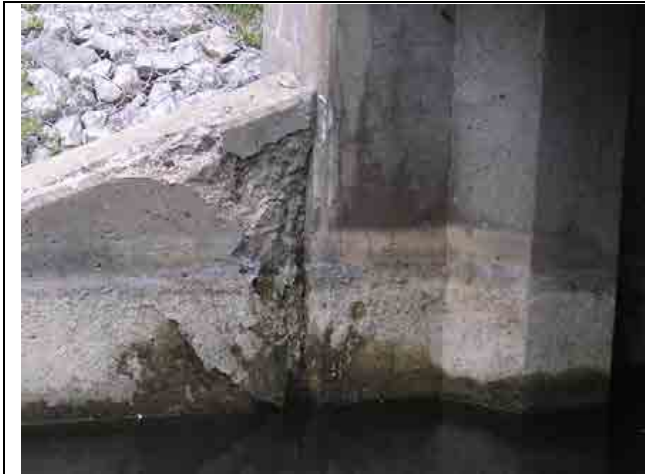
Photo #13 – Close up of the deterioration at the left upstream wingwall.

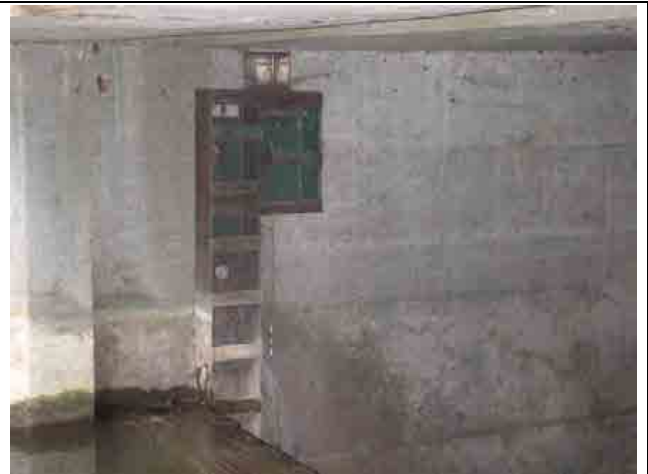
Photo #14 – Shear pin mechanism (disabled) at the left gain, looking from right wingwall.

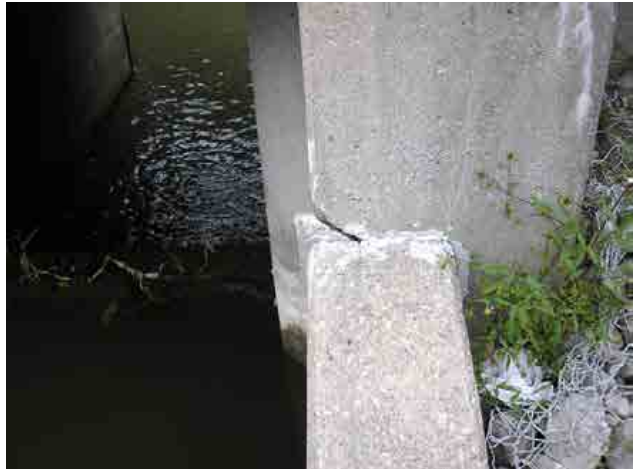
Photo #20 – Right upstream wingwall, looking downstream. Wingwall movement responsible for deterioration of right abutment concrete.

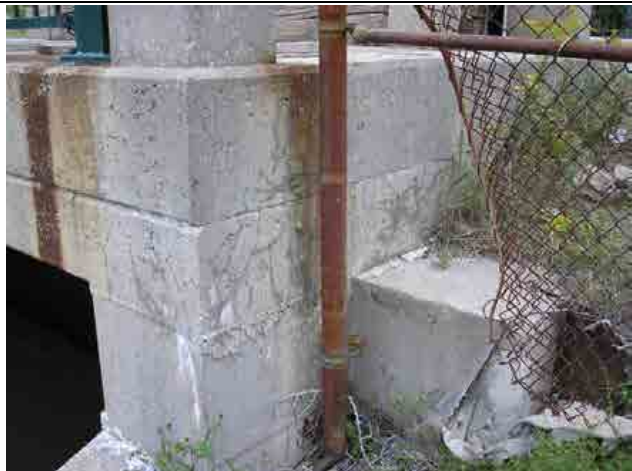
Photo #21 – Alkali silicate reaction above the right upstream wingwall. Sheet pile evident, in line with stop logs. Opening in fence. Alkali silicate reaction.

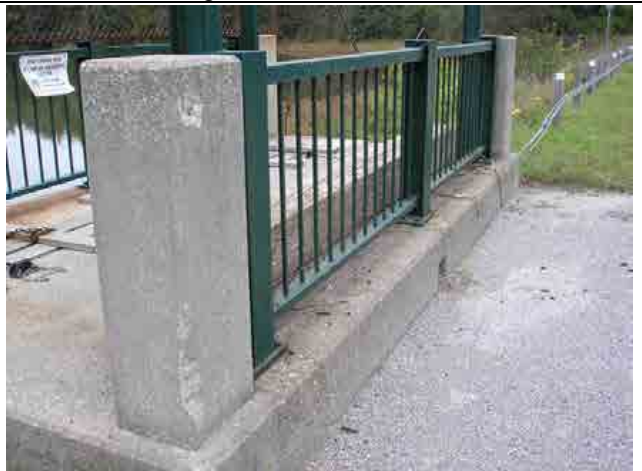
Photo #22 – Minor deterioration (spalling) of concrete adjacent to the railing on the upstream side of the bridge.

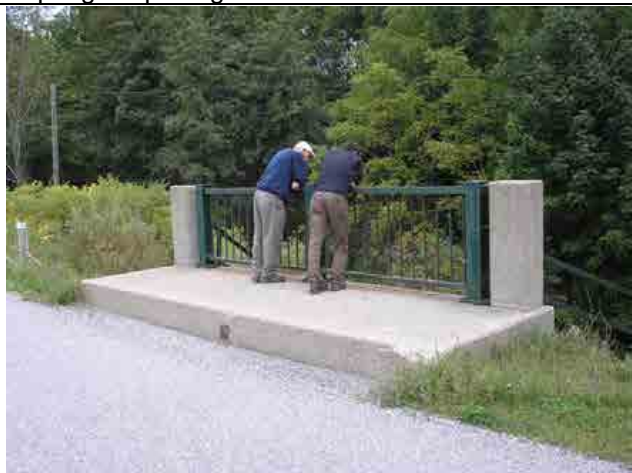
Photo #23 – Railing at the downstream side of the bridge.

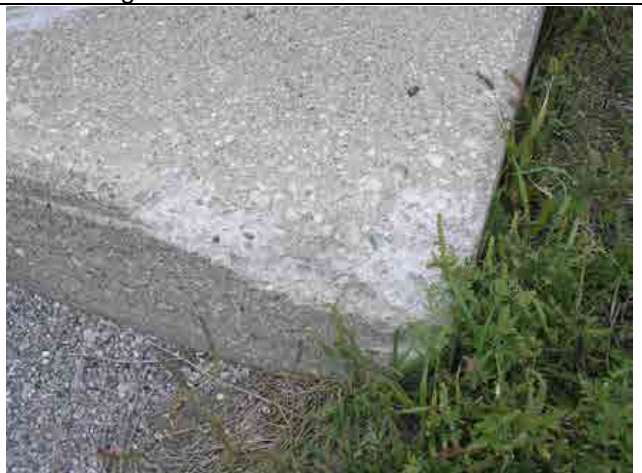
Photo #24 – Close up view of minor concrete spalling on the downstream pad.

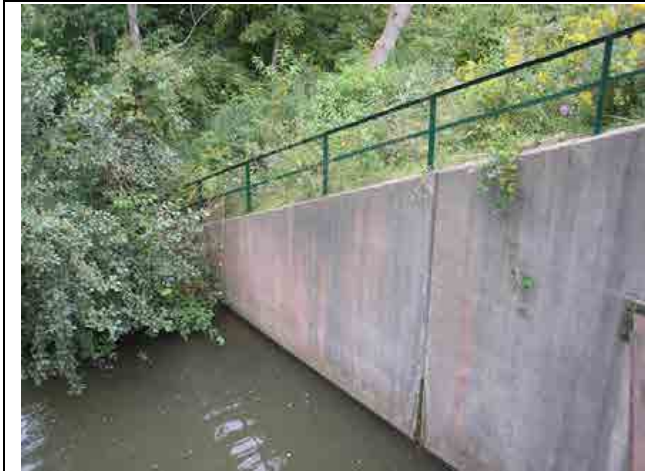
Photo #25 – Right upstream wingwall at Hay Creek Dam.

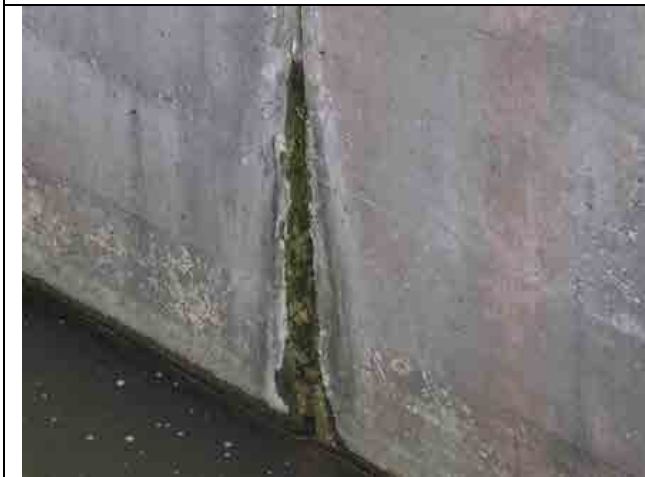
Photo #27 – Joint at right downstream wingwall. Wetness and moisture at the joint indicates backfill material is no longer free draining and water is building up behind the wall.

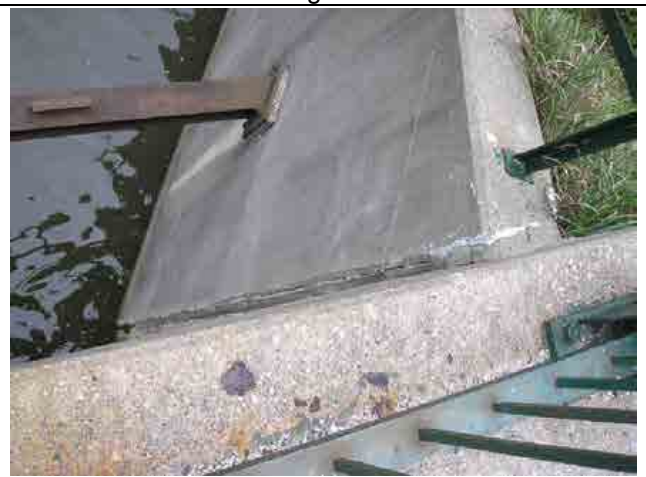
Photo #28 – Top view of the joint at the interface of the bridge abutment and right downstream wingwall. Most of the lateral movement is at the top.

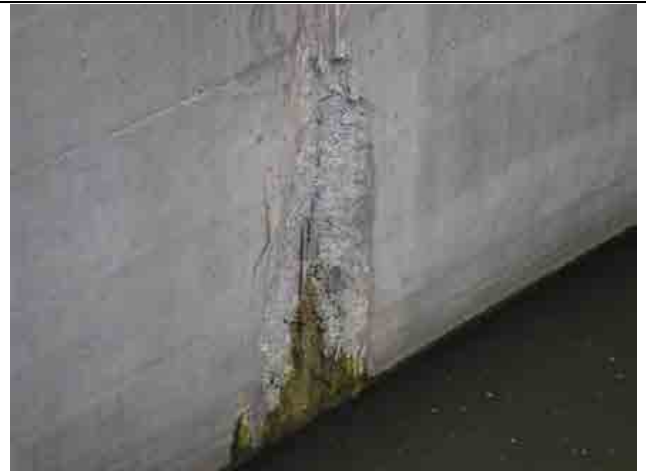
Photo #34 – Close up of the concrete spalling through joint in the left downstream wingwall. Moisture indicates water build up behind wall.

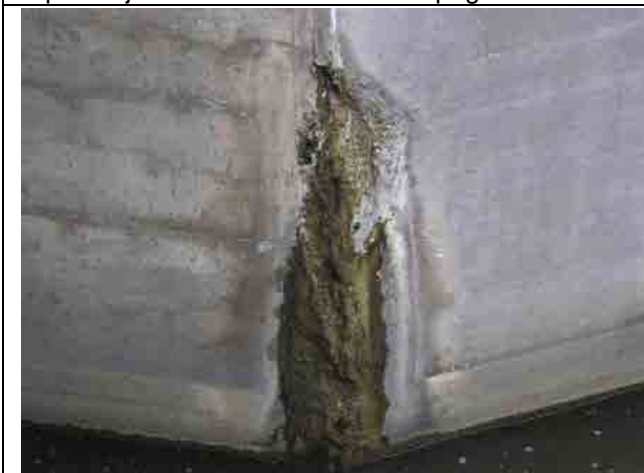
Photo #35 – Close up of the joint between bridge abutment and left downstream wingwall. Moisture along wall indicates water build up behind wingwall.

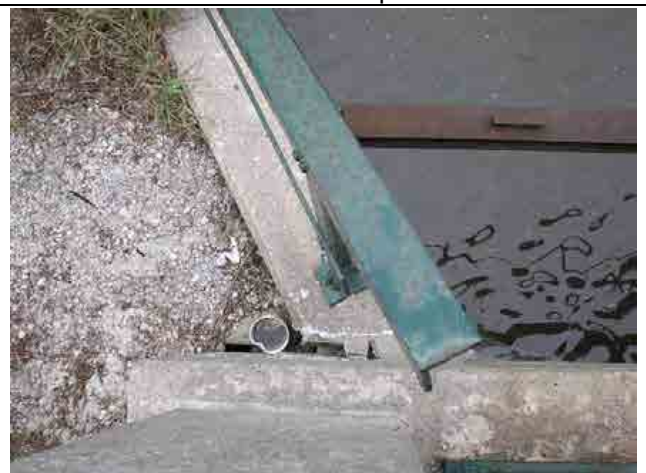
Photo #36 – Top view of the joint between bridge abutment and left downstream wingwall. Note joint movement.
