PROJECT PLAN
TEETERVILLE DAM CLASS ENVIRONMENTAL ASSESSMENT
TEETERVILLE, ONTARIO

Prepared for: **LONG POINT REGION CONSERVATION AUTHORITY**

Prepared by: **MONTROSE ENVIRONMENTAL SOLUTIONS CANADA INC.**

Version 2.0
February 2026
Guelph, Ontario

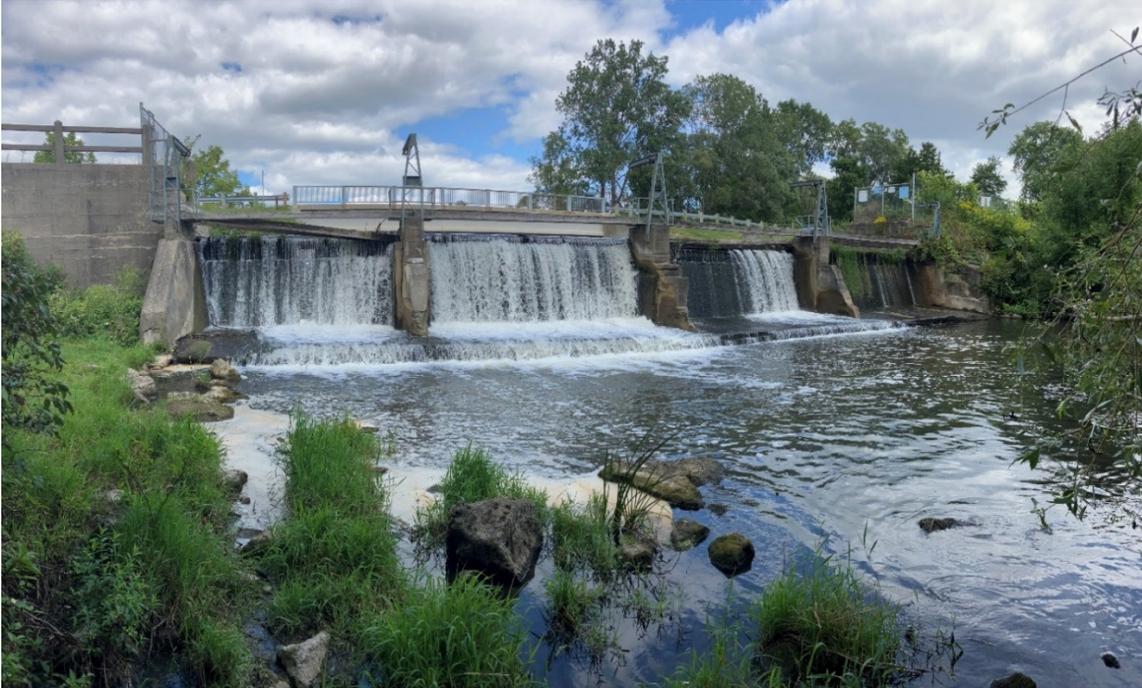
Figure 2 Teeterville Dam – Downstream Face

Oriented in a general northwest-southeast direction, the earthen berm portion of the dam measures approximately 160 m, while the concrete spillway portion of the structure is approximately 31.5 m long. The dam consists of an upstream wall and downstream base slab supported by three piers and two abutments and there are concrete wingwalls beyond each end of the structure related to the bridge. The overall height of the dam from the top of the concrete base slab to the top of stop logs is approximately 3 m. The earthen berm height to the north and south of the concrete control structure is approximately 4 m high, with side slopes of approximately 2H:1V. Further details regarding the physical dam structure can be found in the DSR (2016). Reservoir levels are maintained by timber stop log controls in a four-bay spillway configuration structure at the south end of the reservoir. There are no flow controls below the level of the concrete sill that hold the stop logs, and the reservoir cannot be fully drained by gravity. A site photolog is provided in Appendix A.

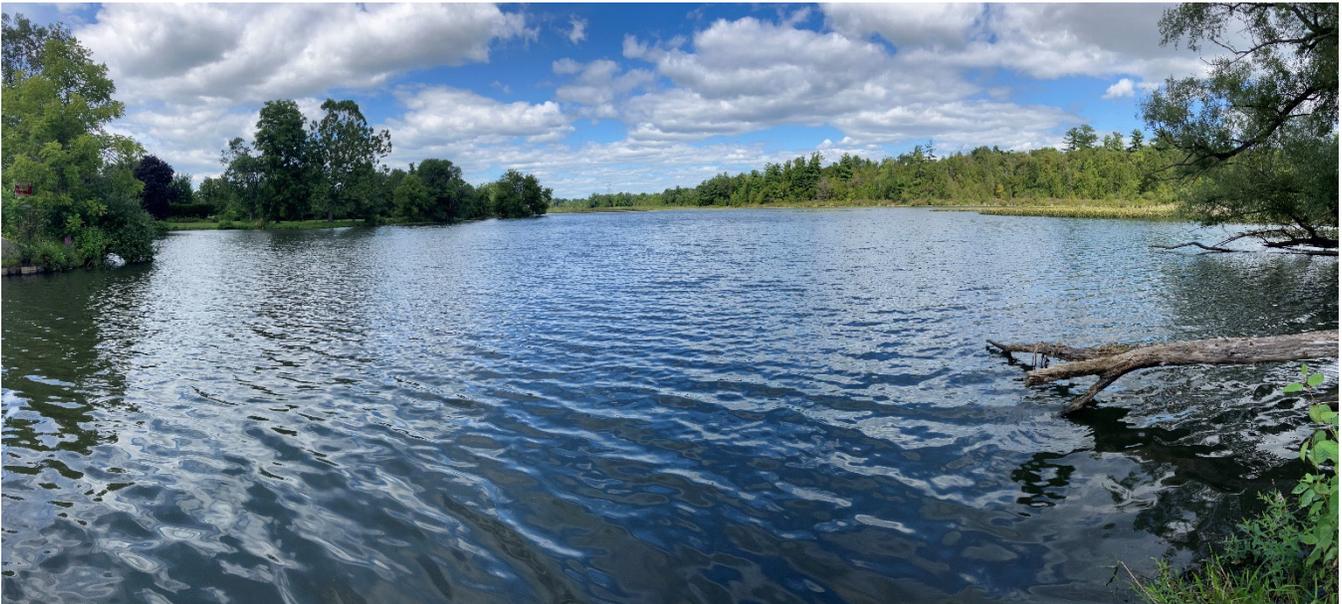
Figure 3 Teeterville Reservoir – Looking Upstream from County Road 25

The 12.5 ha (+/-) reservoir created by the dam measures approximately 600 m long by 210 m wide, on average. The reservoir and associated marshy perimeter areas have created valuable wetland and near shore habitats for various sensitive species worthy of consideration, and the study area encompasses a large section of the BC11 Provincially Significant Wetland Complex. The area surrounding the dam and reservoir is mainly treed, with some residential, institutional, natural reserve and agricultural properties in the immediate vicinity as previously described.

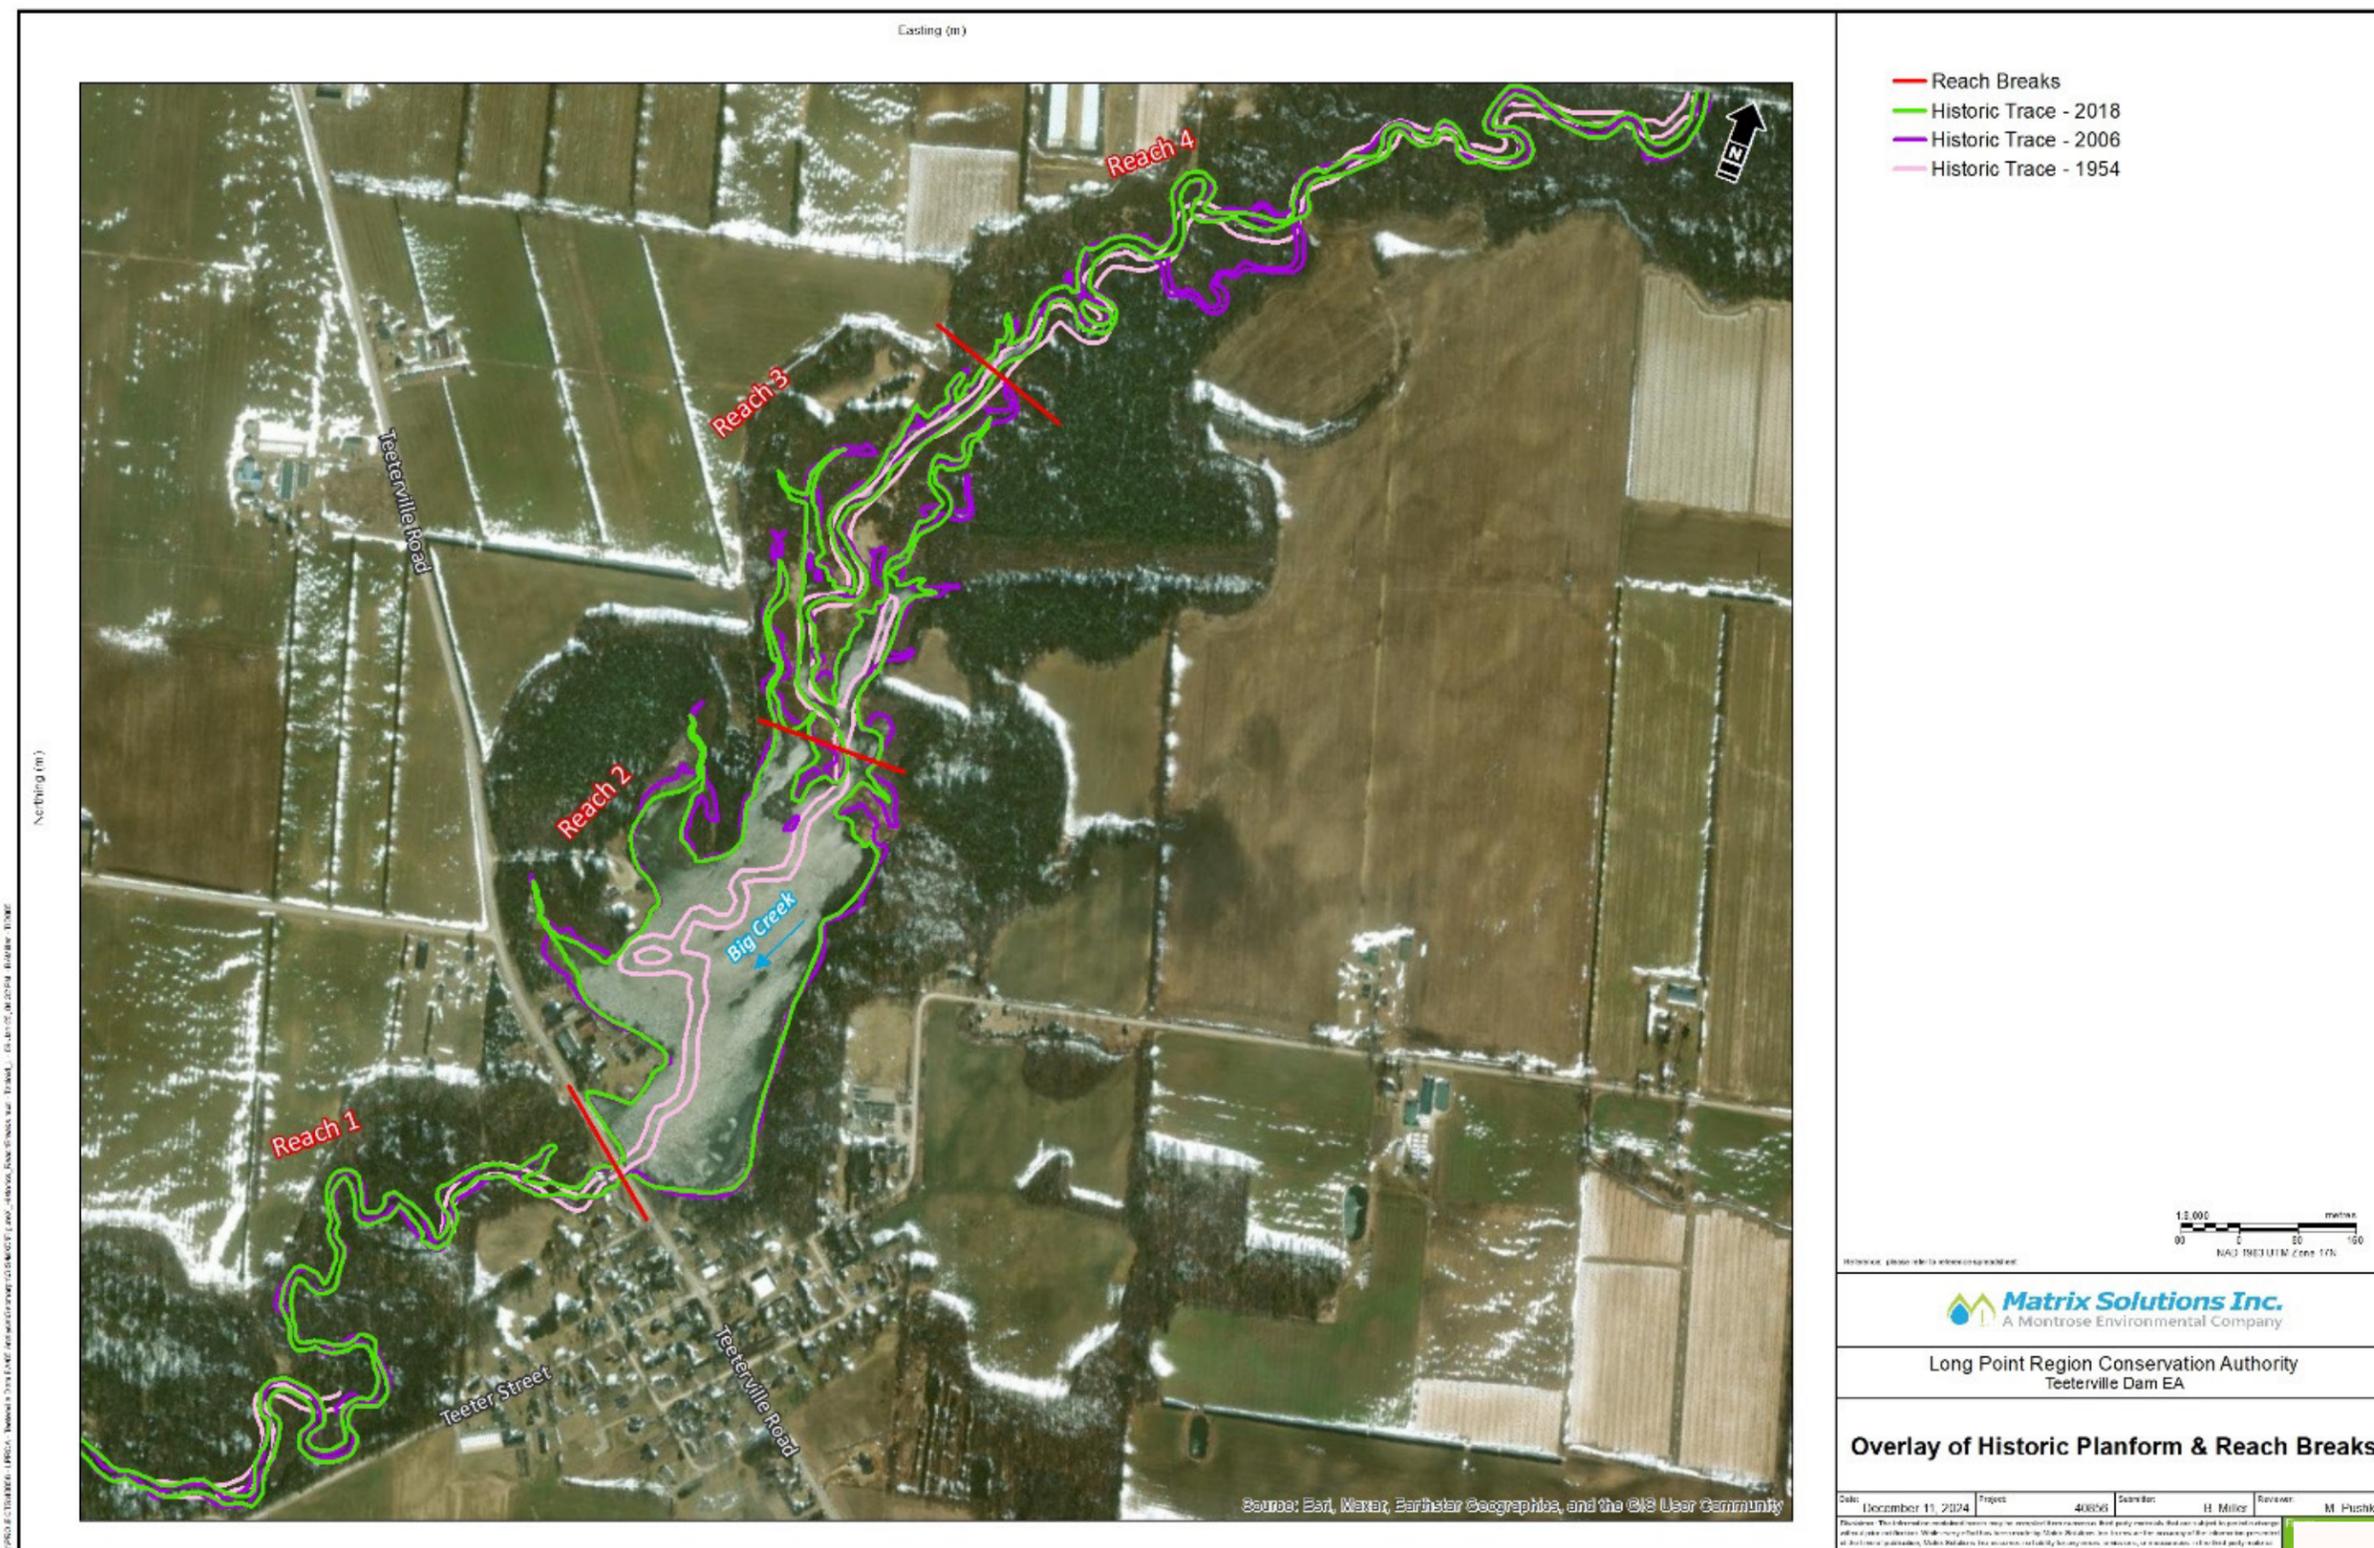
Figure 6 Overlay of Historical Planforms and Reach Breaks

Year	Key Observations
1954	<ul style="list-style-type: none"> • Area surrounding the Big Creek study area is predominantly agricultural with a sparsely wooded riparian corridor ranging between 140 m and 600 m wide. • The planform shows a regular meander sequence with a wavelength frequency of approximately 150 m and a uniform amplitude of 30 m upstream (north) of Teeterville Dam. • Downstream of the dam site (note: road crossing and old-configuration dam), the channel remains meandering, but with decreased wavelength (200 to 300 m, 35 to 50 m amplitude). • Minor creek encroachment has occurred around Teeterville but consists predominantly of small clearings or agricultural fields outside of the floodplain.
1964	<ul style="list-style-type: none"> • Construction of the modified Teeterville Dam was completed at the time of the air photograph, with water levels appearing close to current levels. • There appears to be some additional residential development on properties on the southeastern and southwestern edges of the reservoir, where the existing Royal Canadian Legion (Branch 526) and elementary school are located now (November 2024) along with some minor housing development within Teeterville; much of the broader surrounding landscape remains agricultural or under forest cover. • Vegetation in the riparian corridor remains as was the case in 1954. • The channel planform upstream of the backwatered conditions caused by the reservoir remains similar in configuration to 1954 conditions and through the reach downstream of the dam.

2006	<ul style="list-style-type: none"> • No major changes to the surrounding land uses around Teeterville, the reservoir, or the channel within the study area. • The channel downstream of the reservoir has increased in sinuosity, with the channel now occupying the full width of the available valley floor and abandoning part of the occupied channel from 1954. • Migration has continued upstream of the reservoir, with most bends increasing in radius, and an increase in length in previously straight sections of channel. • Some development of depositional islands and vegetation clusters in the upper portions of the reservoir and along the shallower edges.
2018	<ul style="list-style-type: none"> • No significant changes to the surrounding land uses near the creek or reservoir. • The channel upstream and downstream of the reservoir remains relatively stable, with only minor natural adjustment to the channel planform. • The reservoir has continued infilling, with edge of water traces showing reductions in open water area and an increase in more established vegetated bars and islands, with some tributary channels becoming undefined. • Transition area between the reservoir water limits and the upstream creek has become multi-threaded, with many flow paths around sedimentary bars.

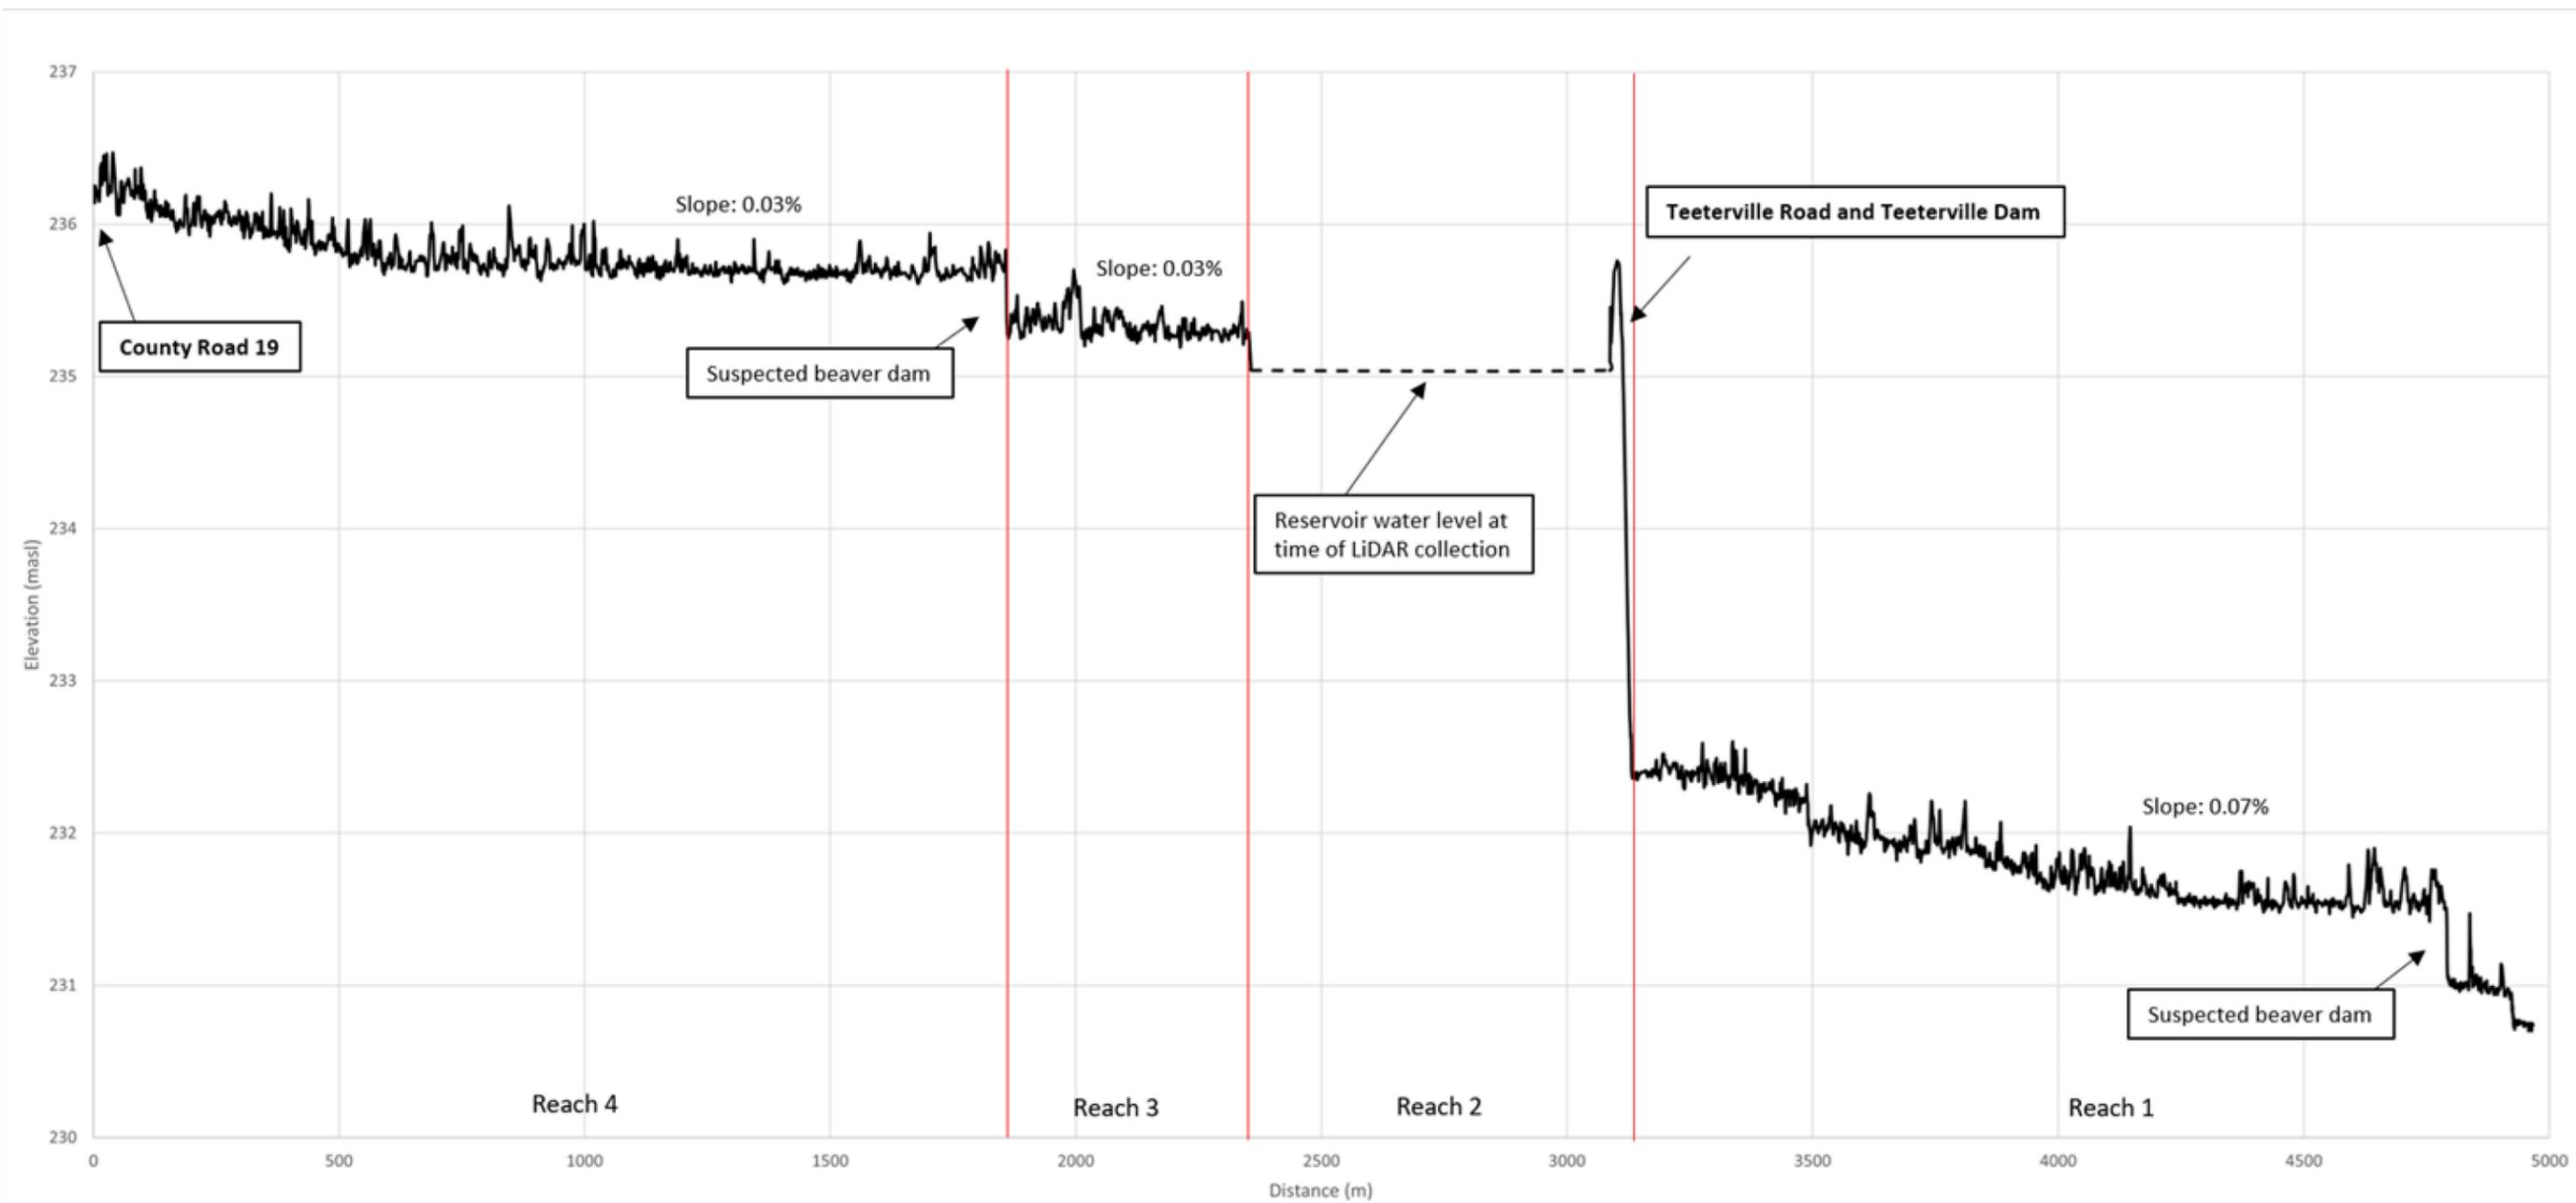
Figure 7 Creek Profile Assessed at Teeterville Dam (derived from LiDAR)

Representing Reach 2, the length of the inundated reservoir area, from the dam to the upstream extent of backwater influence, is approximately 600 m. This length will vary depending on water level and may include some of the upstream creek (Reach 3) during periods of elevated backwater.

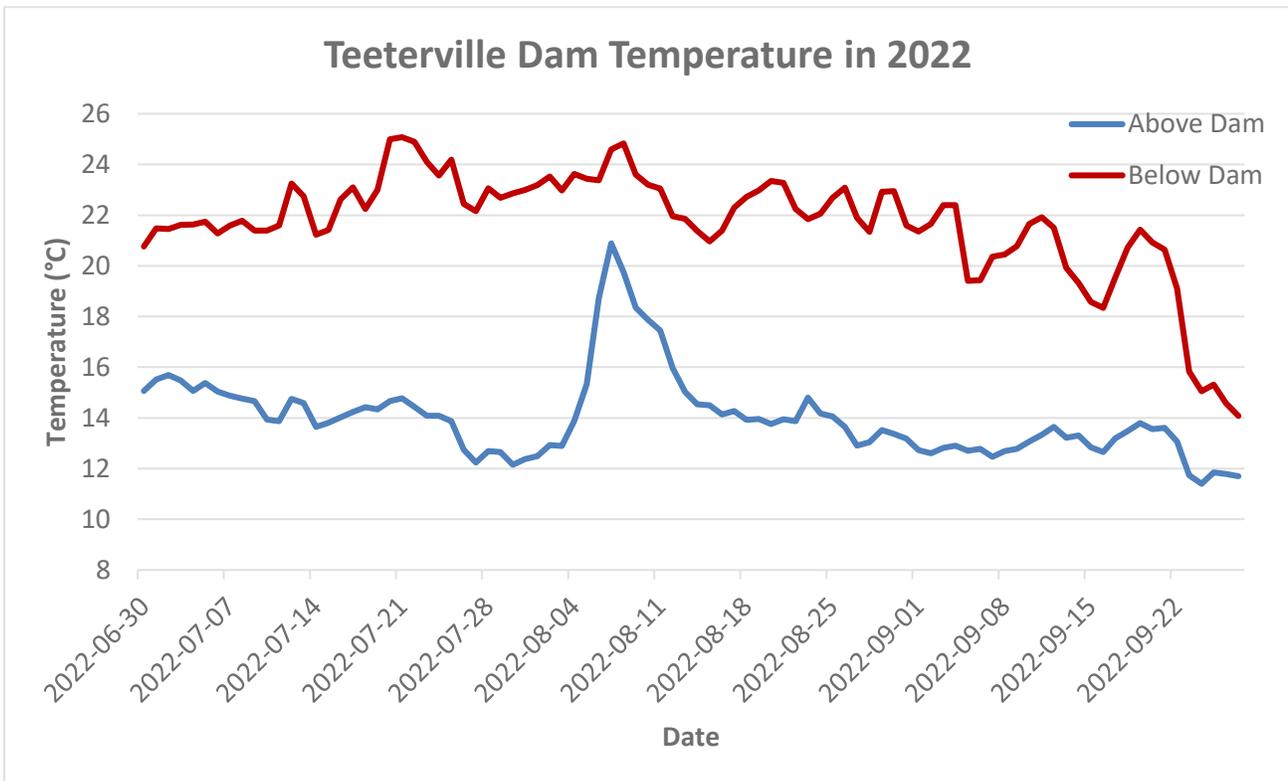
Figure 8 Temperature Data Above and Below Teeterville Reservoir – 2022 Summer Season

Year	Average Above Dam Temperature (°C)	Average Below Dam Temperature (°C)
2015	16.5	20.2
2016	17.5	23.1
2017	17.1	19.6
2018	18.7	21.3
2019	17.6	20.6
2020	16.1	21.4
2021	17.9	20.6
2022	14.0	21.7
2023	16.4	19.6

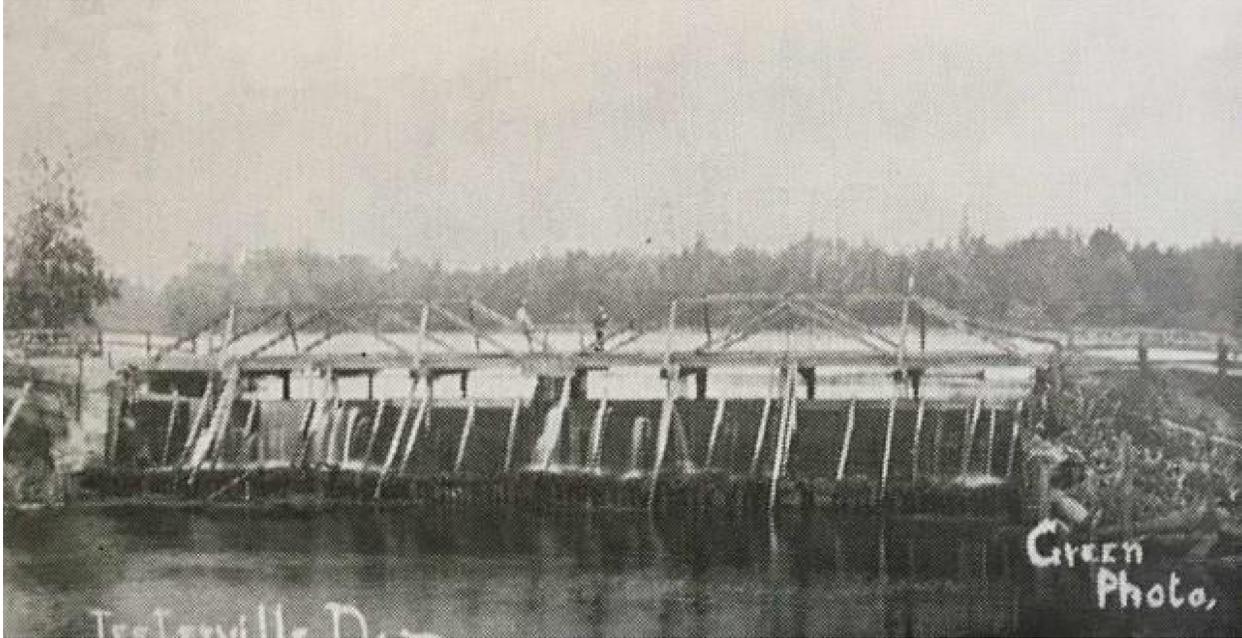
Figure 13 Teeterville Dam and Bridge (c. 1880-1915)

In June 1892, the dam was again lost to flooding. It is likely that the dam was replaced with a two-basin spillway with a two-span wooden truss bridge above (Figure 13). In 1915, when this iteration of the dam was destroyed in a flood, it was replaced by an earthen berm dam with a concrete spillway in the location of the contemporary dam. In the Fall of 1917, concrete abutments were constructed in preparation for the single-span Warren pony truss bridge that was constructed in the Spring of 1918 by the Sarnia Bridge Company (Figure 14).

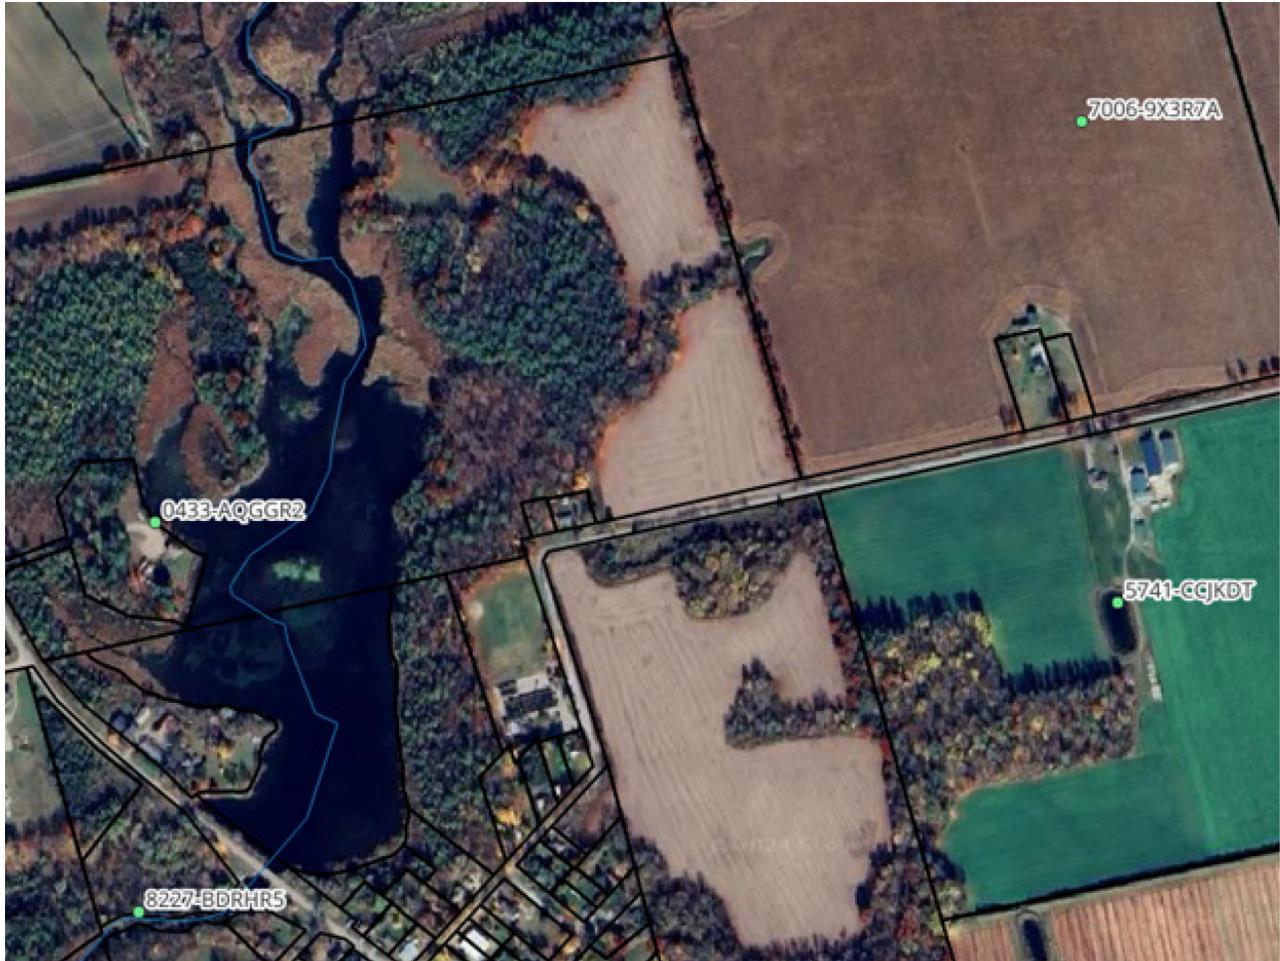
Figure 15 Active MECP Permits-to-Take-Water Near to the Study Area

Two other active surface water PTTWs exist in the vicinity (8227-BDRHR5 and 7006-9X3R7A), with both identified as drawing from Big Creek itself.

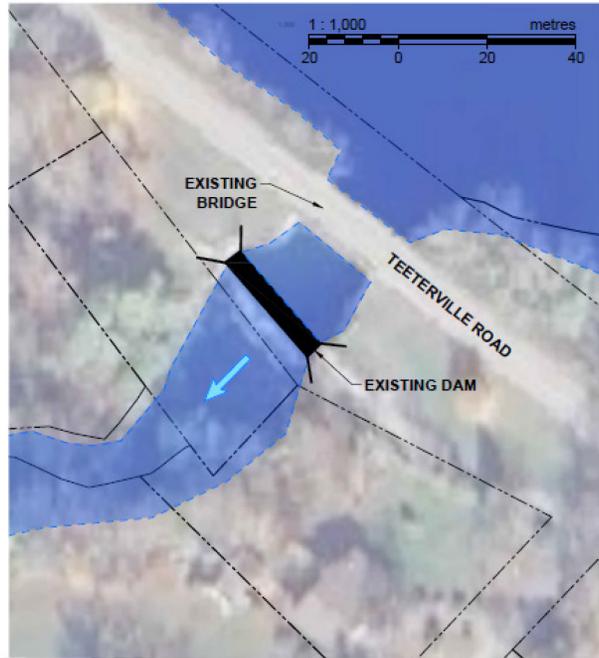
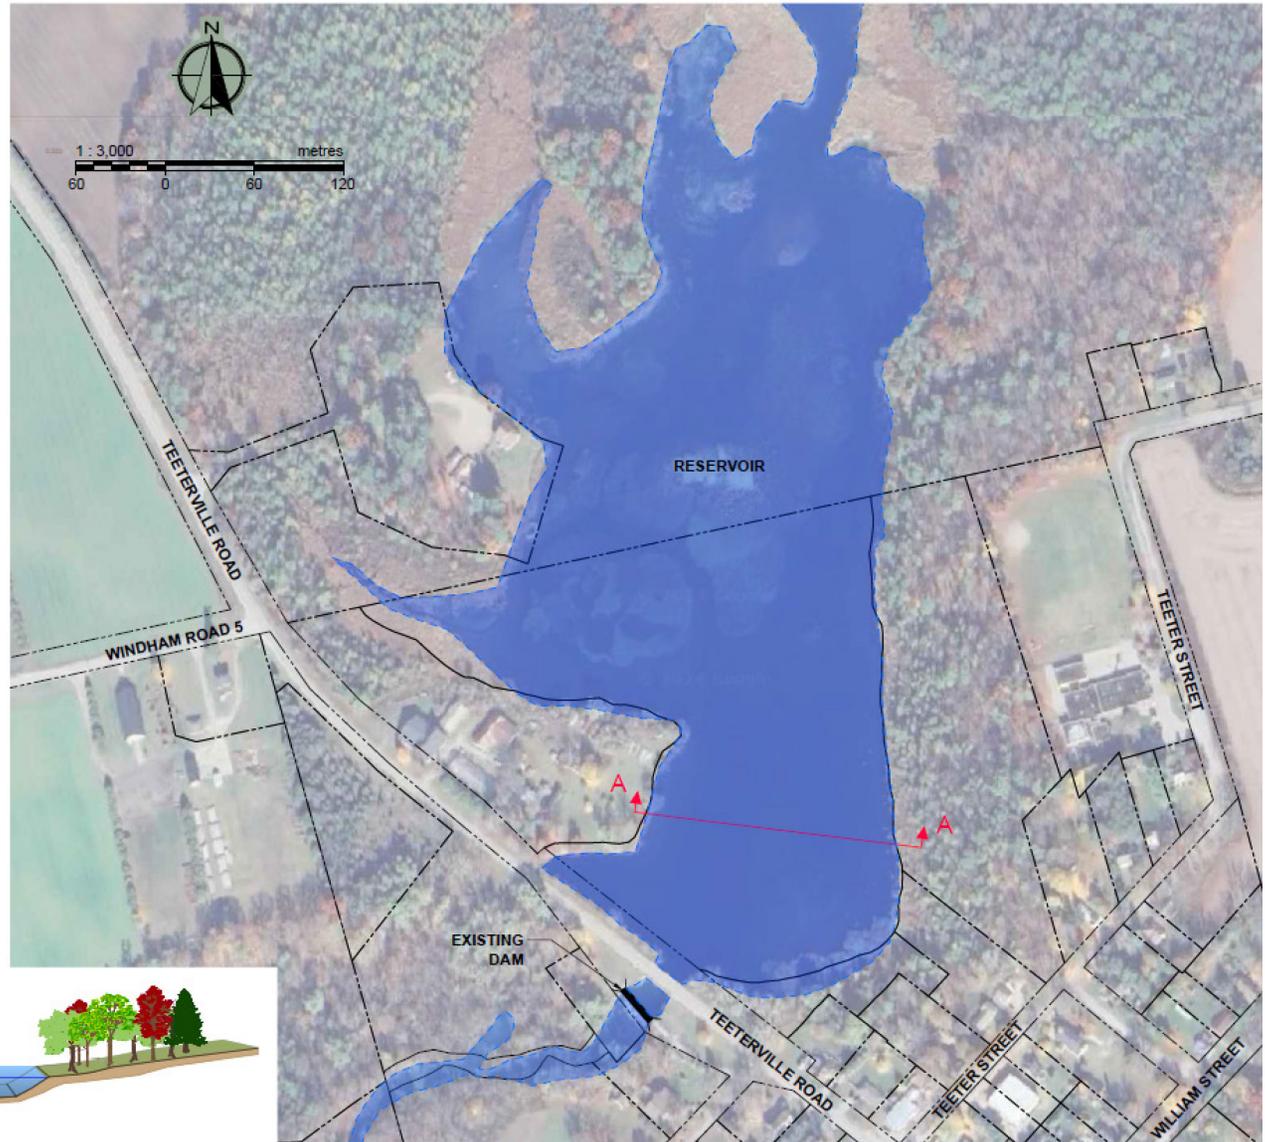
Figure 16 Alternative 1 – Do Nothing

Maintaining current operational protocols, regular monitoring would continue to be completed with routine minor works and periodic major works, undertaken as necessary to provide ongoing stabilization of the dam. With the retention of a shallower pond depth, additional efforts and costs will also be incurred in maintaining reliable functionality of the County's emergency fire water supply source (i.e., sediment-free). Formal dam assessments including HPCs and dam safety reviews (DSRs) would continue to be required. The risk of dam failure would persist with associated environmental consequences (e.g., minor flooding, watercourse erosion, and unmanaged sediment movement). The liability to the LPRCA in the event of a dam failure would not be reduced, and may increase, potentially adding to insurance costs.

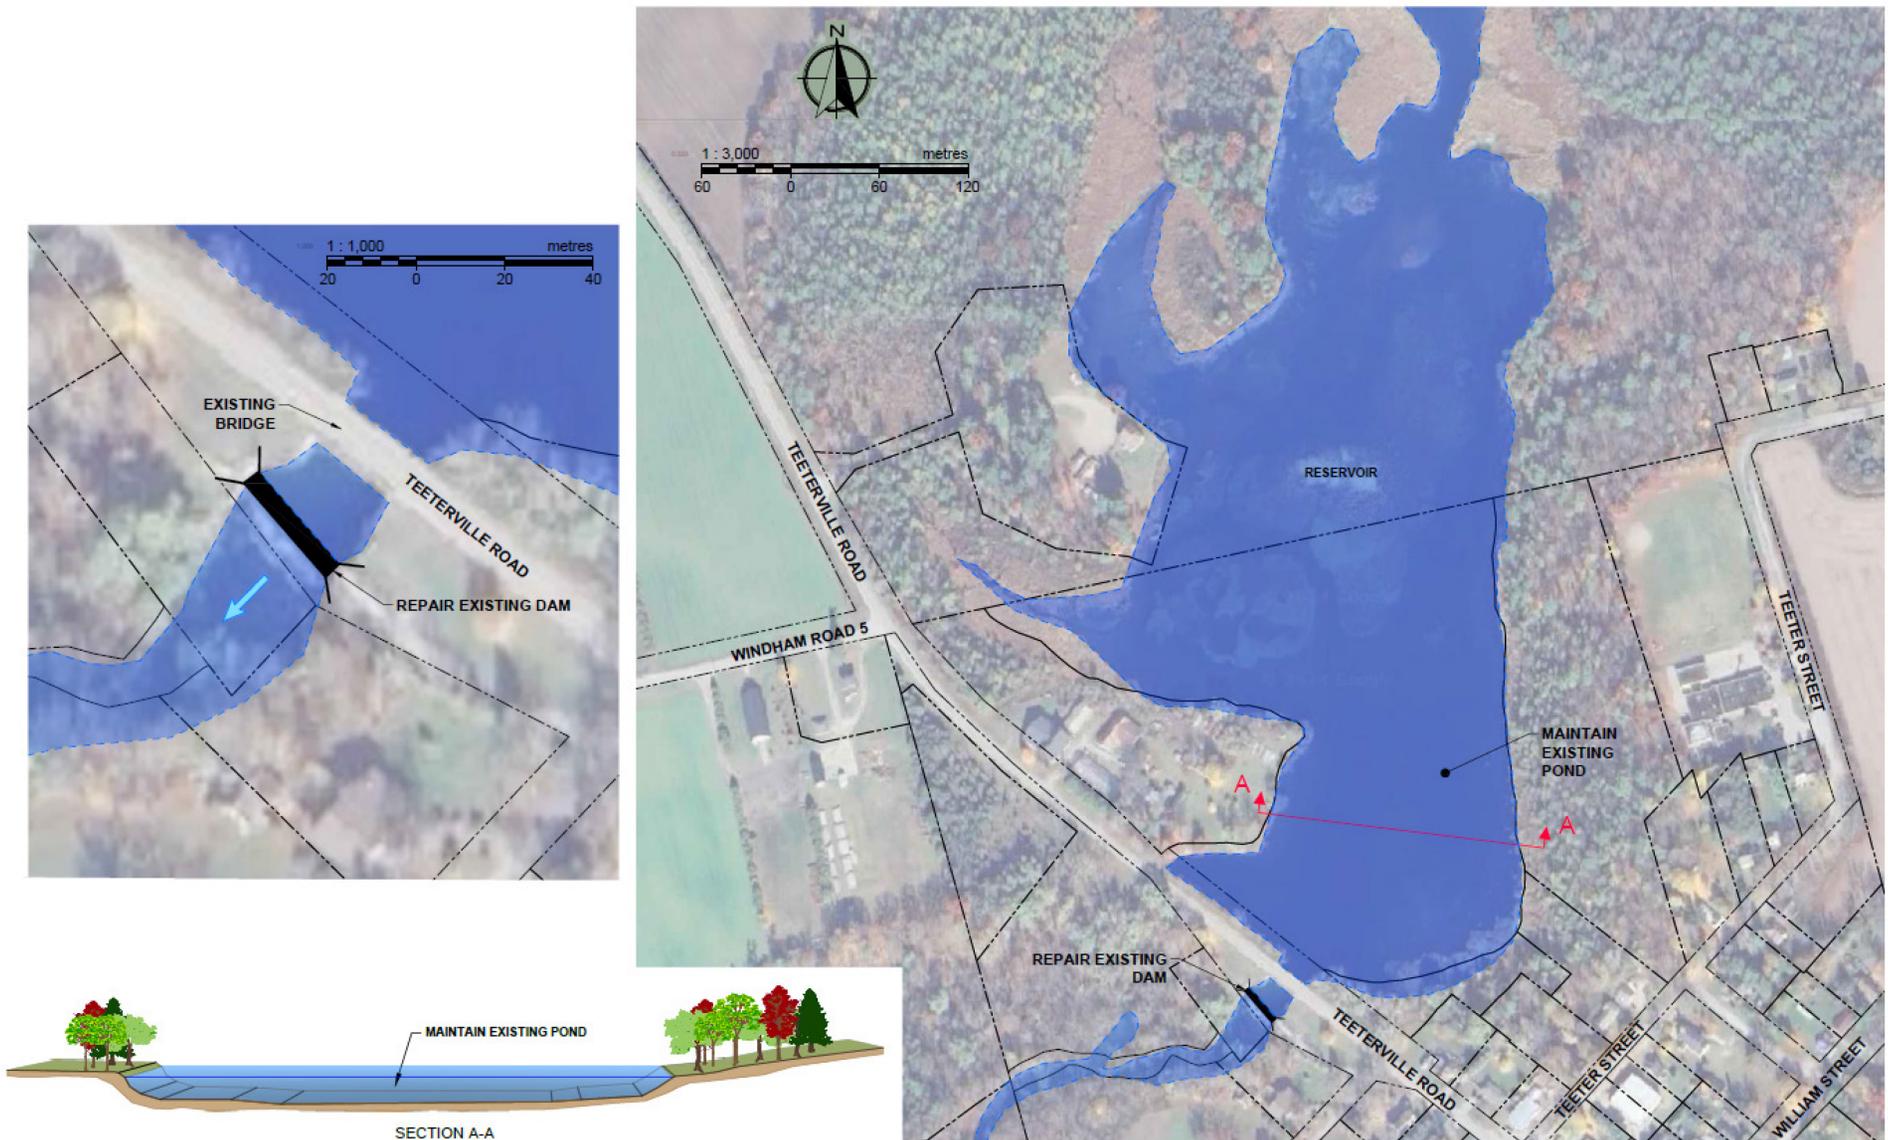
Figure 17 Alternative 2 – Repair Dam

Implementation of the repair dam alternative can partially address climate change adaptation or mitigation considerations, associated with the predicted increases in the frequency and magnitude of extreme flood events, as the risk of failure associated with such condition is reduced. However, the predicted climate change impact of increasing air temperatures would not be addressed with the retention of a dam structure / shallow reservoir and known thermal water quality impacts. Further, as noted earlier for the do nothing alternative, shallow reservoirs are considered greenhouse gas emitters as methane produced in the anoxic bottom sediments bubbles free and is released to the atmosphere, a characteristic that would remain. A potential positive climate change adaptation benefit to the reservoir's retention is as an emergency source of irrigation supply in times of drought.

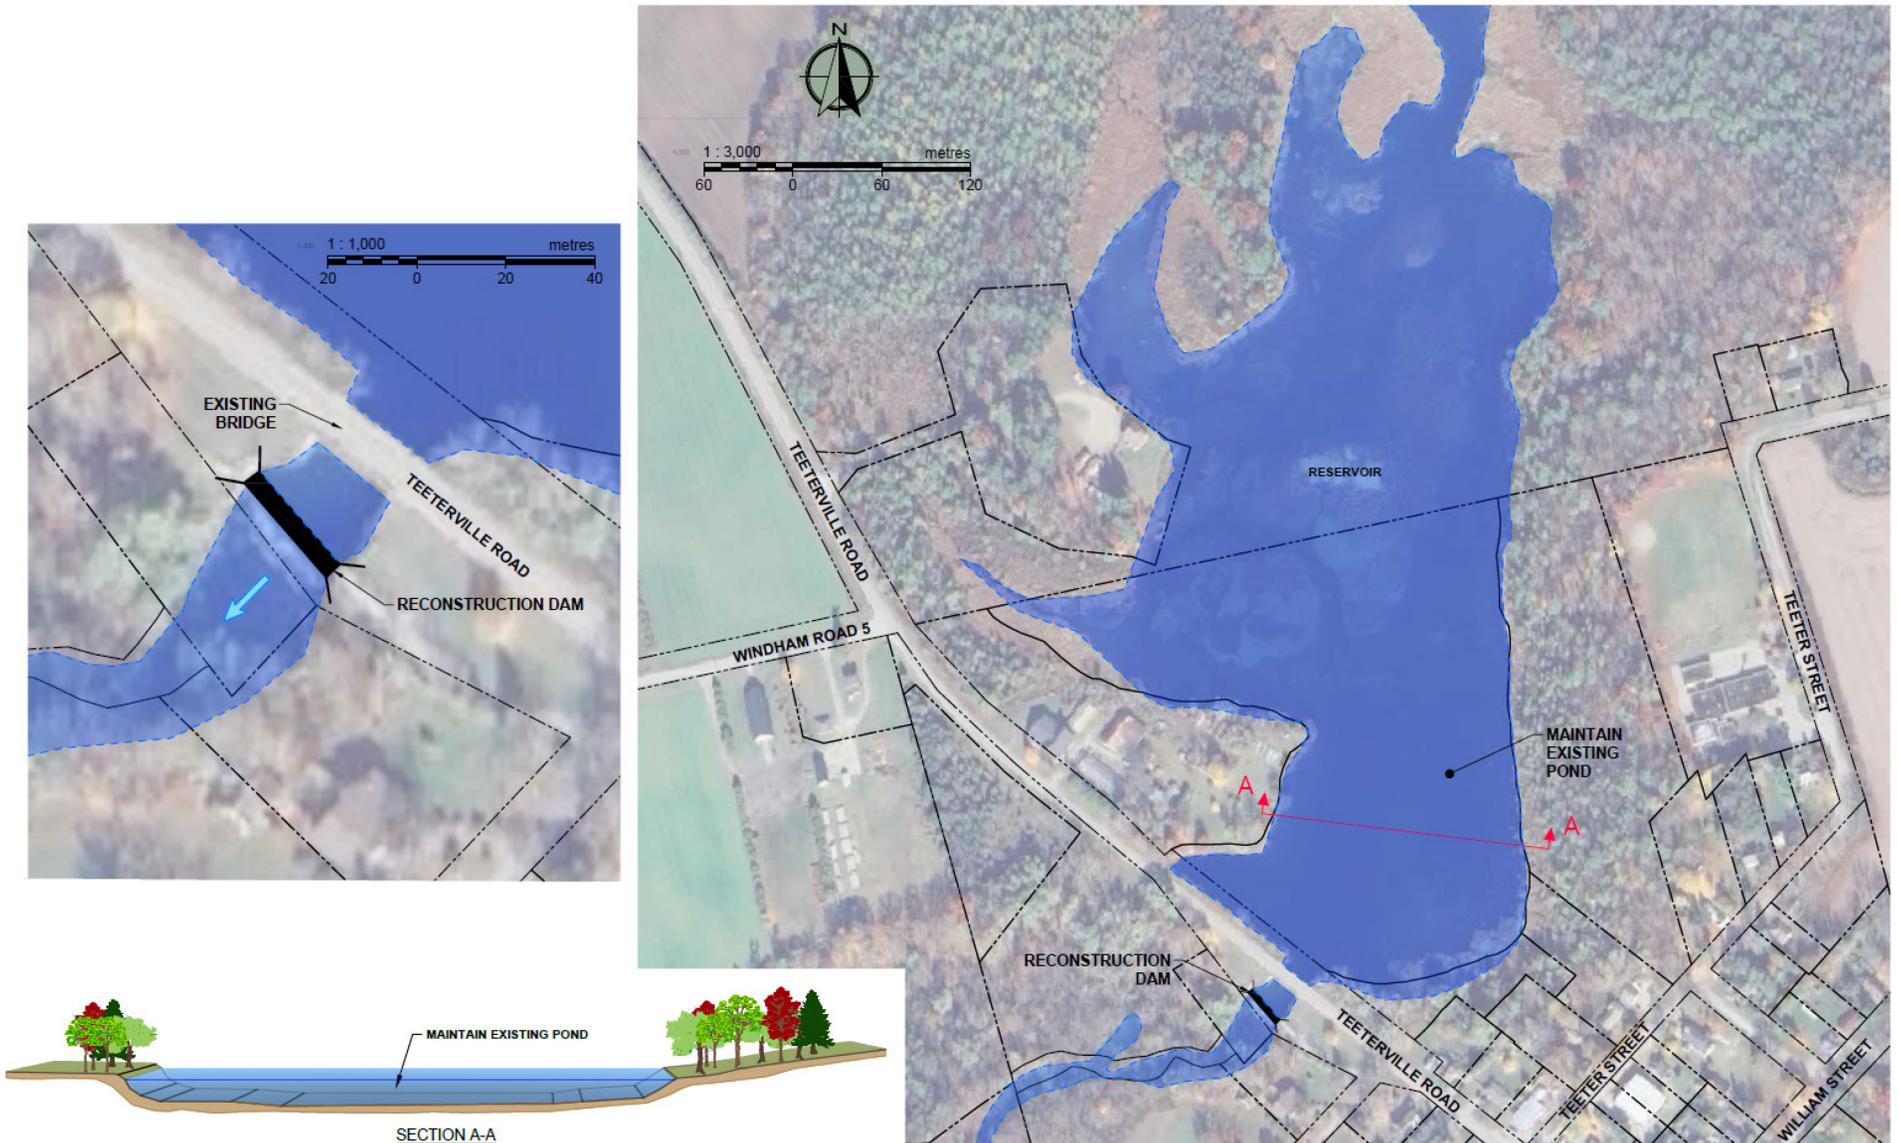
Figure 18 Alternative 3 – Replace Dam

Implementation of the replace dam alternative can partially address climate change adaptation or mitigation considerations, associated with the predicted increases in the frequency and magnitude of extreme flood events, as the risk of failure associated with such condition is reduced. However, the predicted climate change impact of increasing air temperatures would not be addressed with the retention of a dam structure / shallow reservoir and known thermal water quality impacts. Further, as noted earlier for the do nothing alternative, shallow reservoirs are considered greenhouse gas emitters as methane produced in the anoxic bottom sediments bubbles free and is released to the atmosphere, a characteristic that would remain. A potential positive climate change adaptation benefit to the reservoir's retention is as an emergency source of irrigation supply in times of drought.

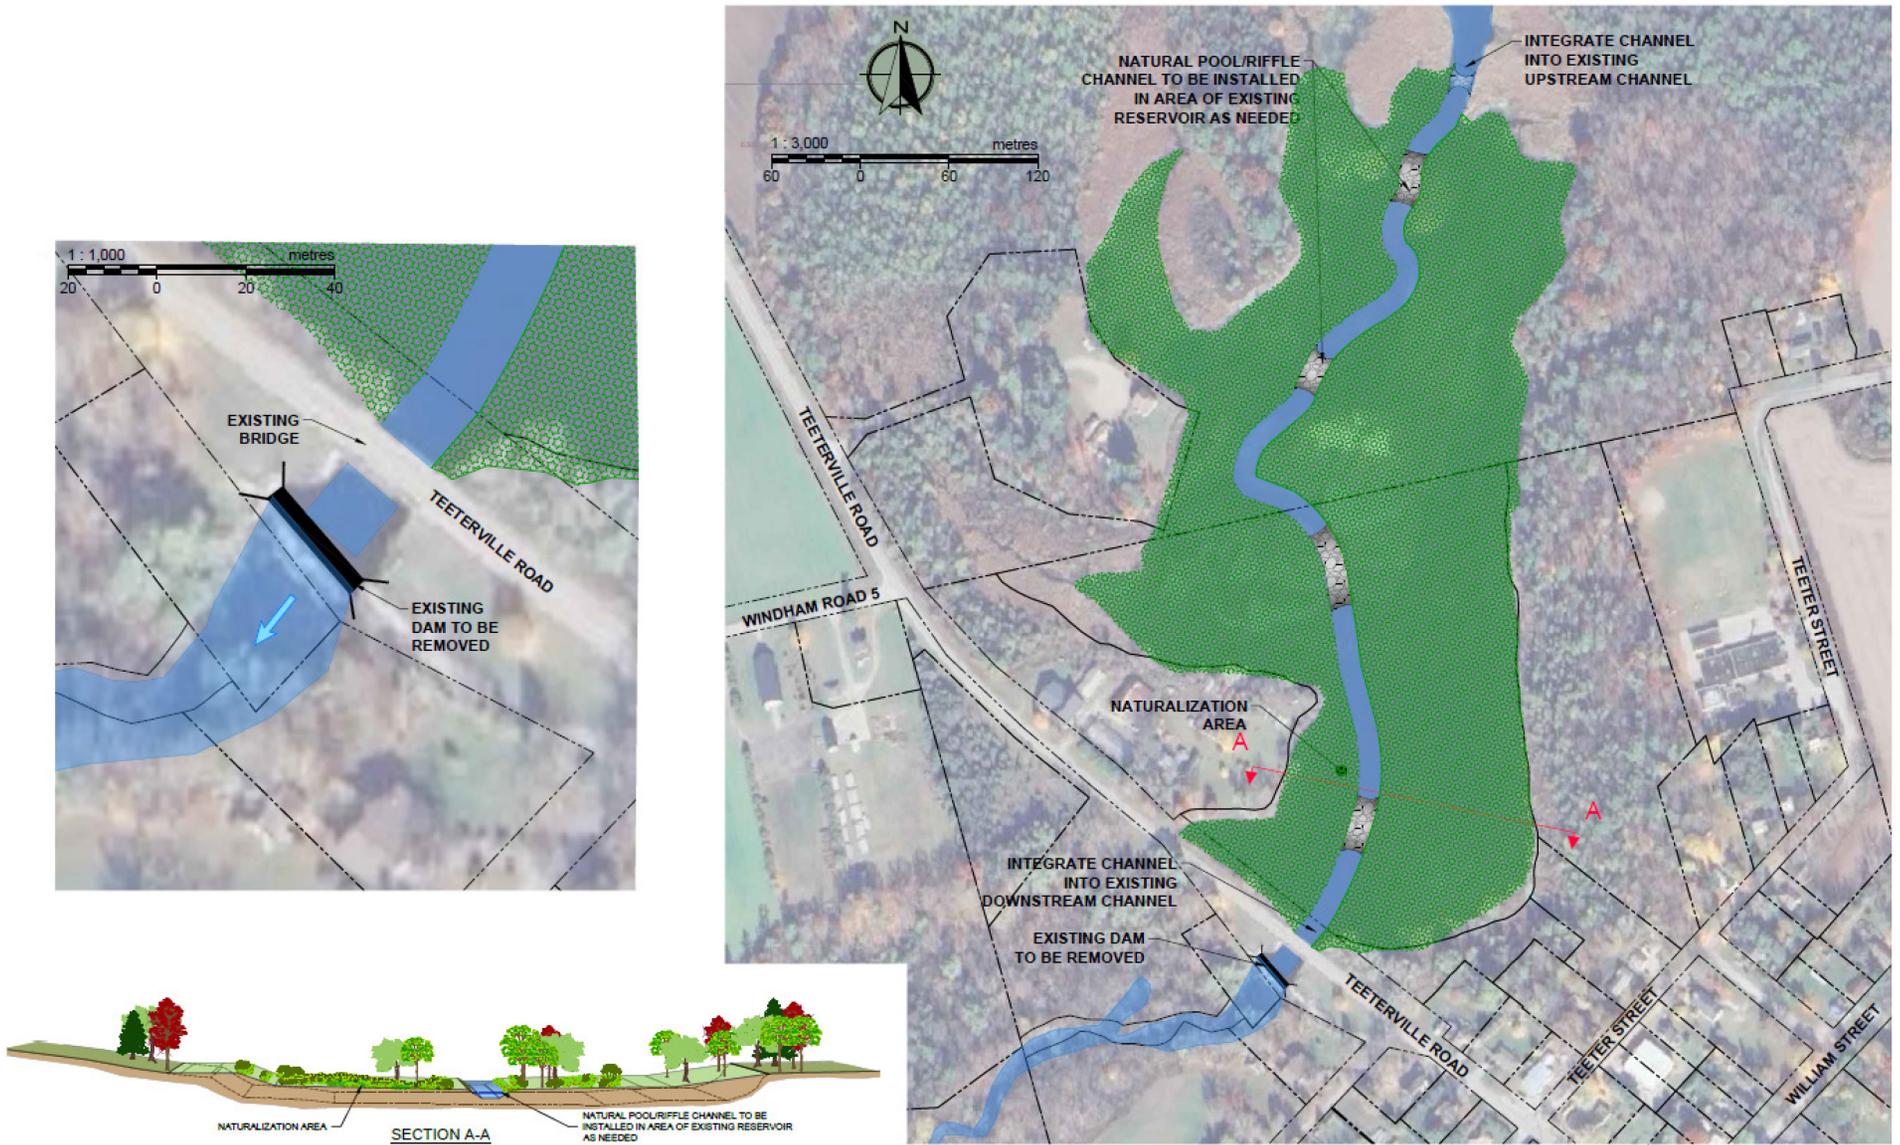
Figure 19 Alternative 4 – Remove Dam and Reinststate Watercourse

Though decommissioning of the structure itself is expected to be more straightforward and less expensive than dam repair or replacement over both capital and operational timeframes, a significant cost associated with this alternative's implementation is the loss of the County's emergency fire water supply source with the reservoir's removal and the requirement for mitigation through replacement. This would require finding and purchasing or leasing land (approx. 0.3 to 0.4 ha [0.75 to 1.0 ac.]) nearby and constructing a new purpose-built supply pond. Beyond property acquisition, related capital costs associated with this element are assumed to include site preparation, pond excavation, impermeable liner, installation of supply well and dry hydrant infrastructure, and associated civil works (heavy duty driveway, signage, fencing [if necessary], etc.). The total capital cost estimate for this alternative is \$1.7 M, whereas the long-term operational costs are significantly reduced to \$200k. A more fulsome discussion of the cost estimation considerations is included in Appendix H.
