PROJECT PLAN
TEETERVILLE DAM CLASS ENVIRONMENTAL ASSESSMENT
TEETERVILLE, ONTARIO

Prepared for: **LONG POINT REGION CONSERVATION AUTHORITY**

Prepared by: **MONTROSE ENVIRONMENTAL SOLUTIONS CANADA INC.**

Version 2.0
February 2026
Guelph, Ontario

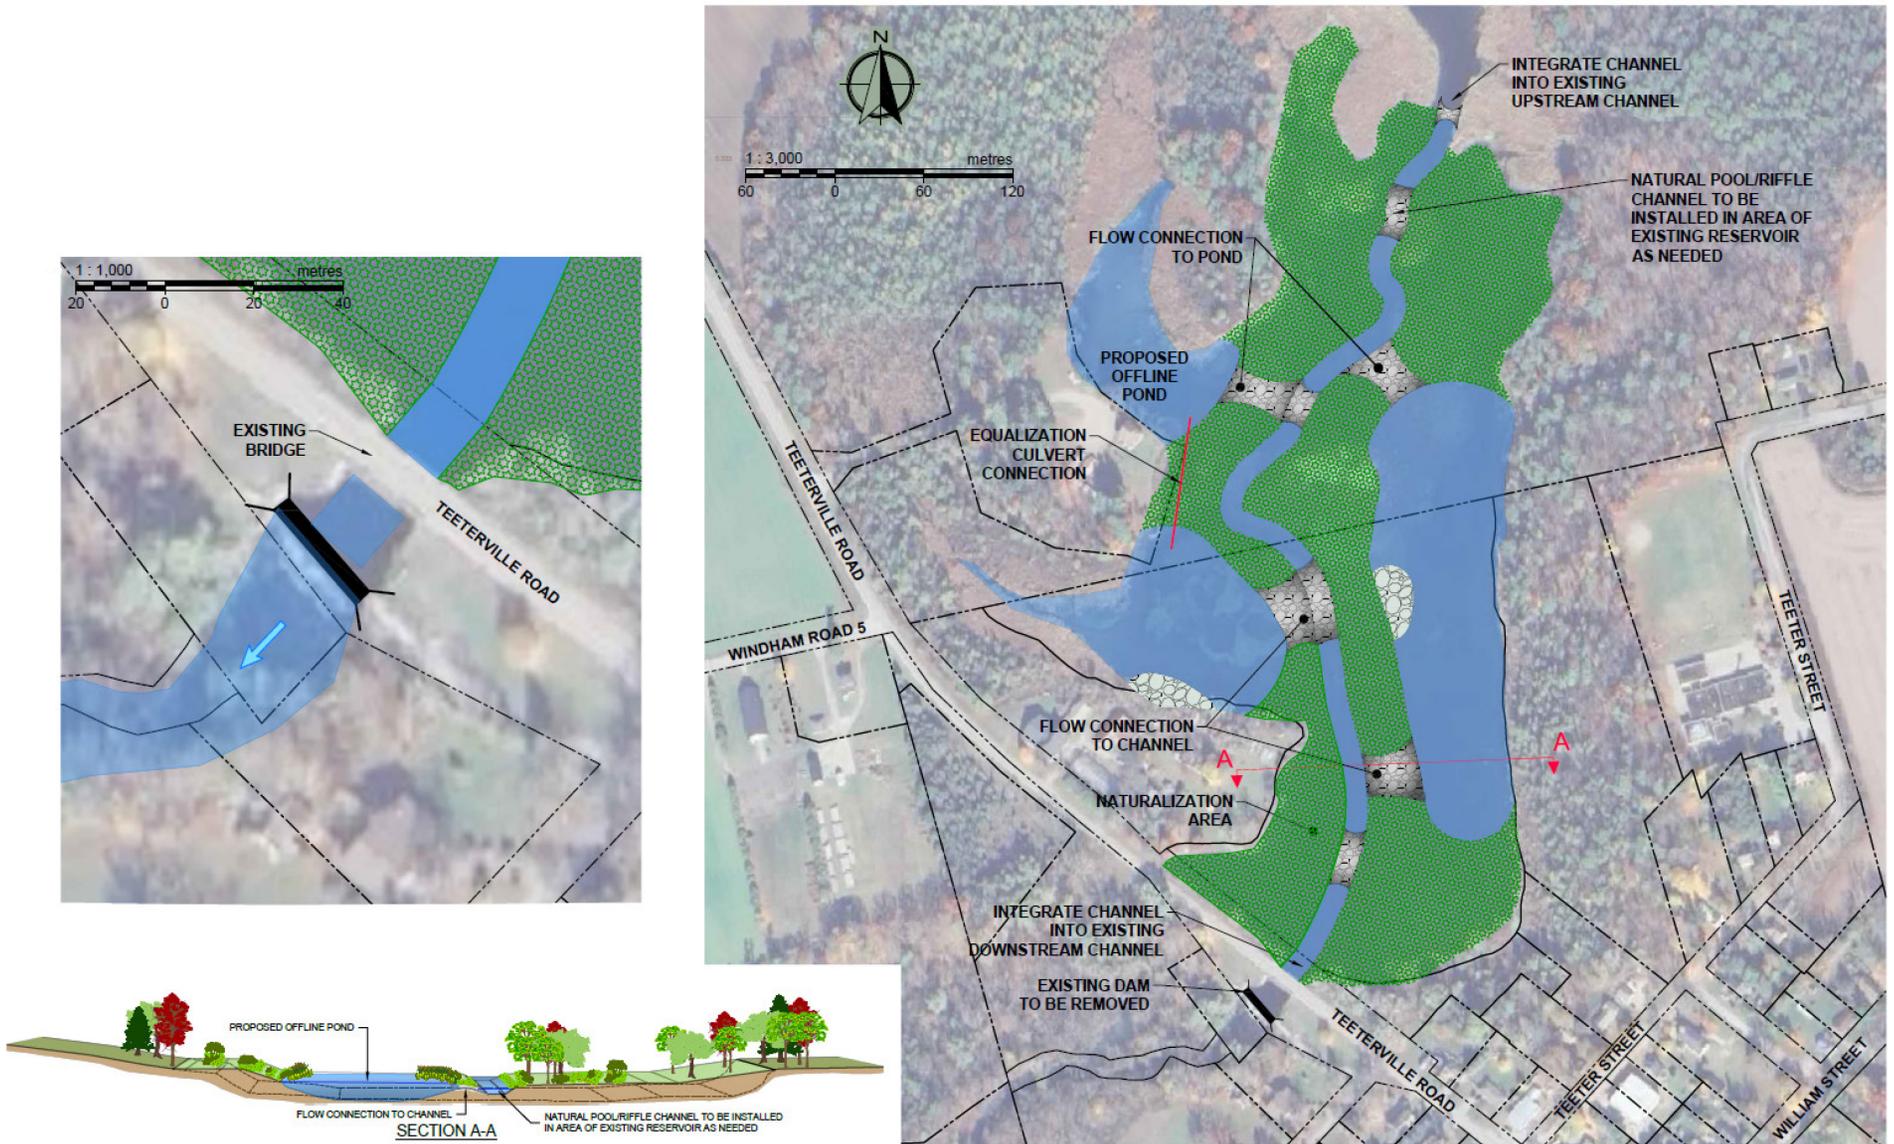
Figure 20 Alternative 5 – Remove Dam, Reinstatement Watercourse, Create Offline Ponds / Wetlands

construct a wet pond(s) or wetland(s) can be retained onsite and used to create riparian habitat diversity in terrestrial wetland landscape features. The ability to retain and use dredged material on the property would eliminate a significant cost often inherent in sediment management, i.e., sampling, testing, transport, and offsite disposal. However, costs associated with designing, tendering, and contracting such works remain and are not insignificant potentially representing half of the capital cost of this alternative's implementation. There may be alternative approaches identified through implementation planning that could lessen the associated impacts, such as accessing municipal staff/equipment or community group resources to complete some or all of the works. Further, the inclusion of such dedicated habitat could provide access to other funding sources that support such efforts (e.g., Ducks Unlimited) that might otherwise be unavailable. Regardless, for the purposes of alternative comparison, it is reasonable to assume that the implementation of Alternative 5 would represent more effort and a higher cost than that of Alternative 4. The total capital cost estimate for this alternative is \$3.6 M, whereas the long-term operational costs (\$400k) are lower than those of a "retain dam" alternative but higher than the strictly creek reinstatement alternative (#4). A more fulsome discussion of the cost estimation considerations is included in Appendix H.

Alternative 5 addresses most of the same climate change adaptation/mitigation considerations listed for Alternative 4 related to the ability to effectively manage more extreme flow events and reduced thermal impacts. However, it could be considered slightly less effective in this regard given that the introduction of shallow, standing water features on the landscape will have the potential to simultaneously add to greenhouse gas emissions from anoxic sediment conditions and reduce greenhouse gas sink benefits of increased vegetation.
