Long Point Region Conservation Authority

Teeterville Dam Safety Review and Condition Assessment

AECOM

March 2016

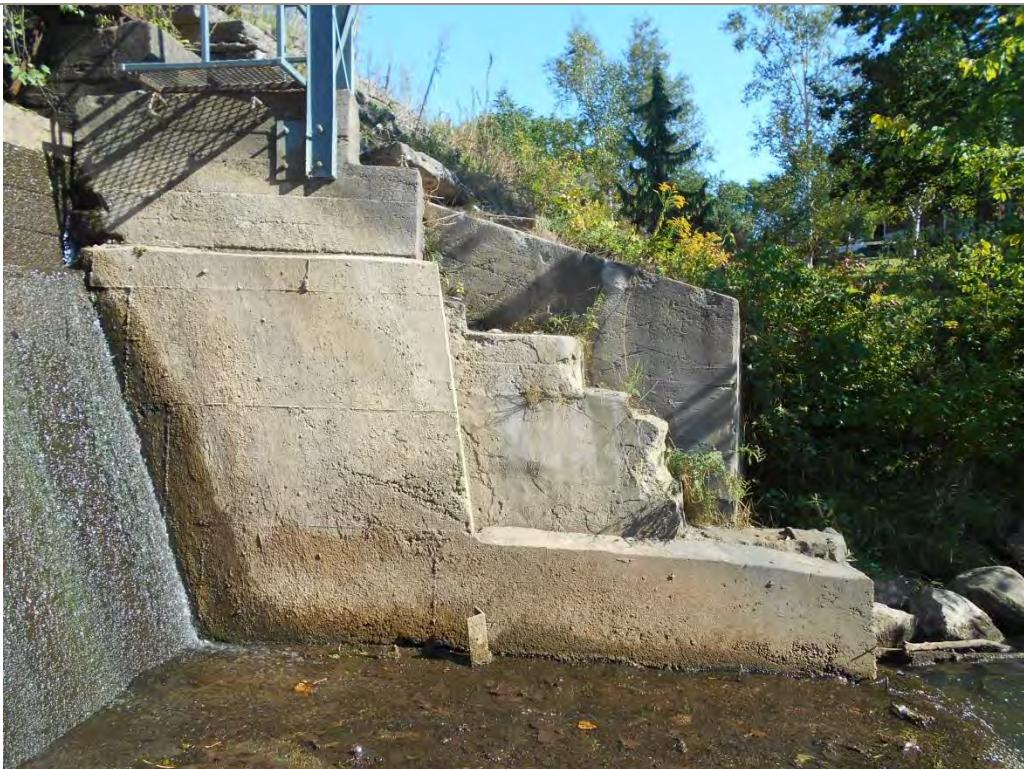
Photo 2: Dam looking East

Photo 3: East Dam Abutment

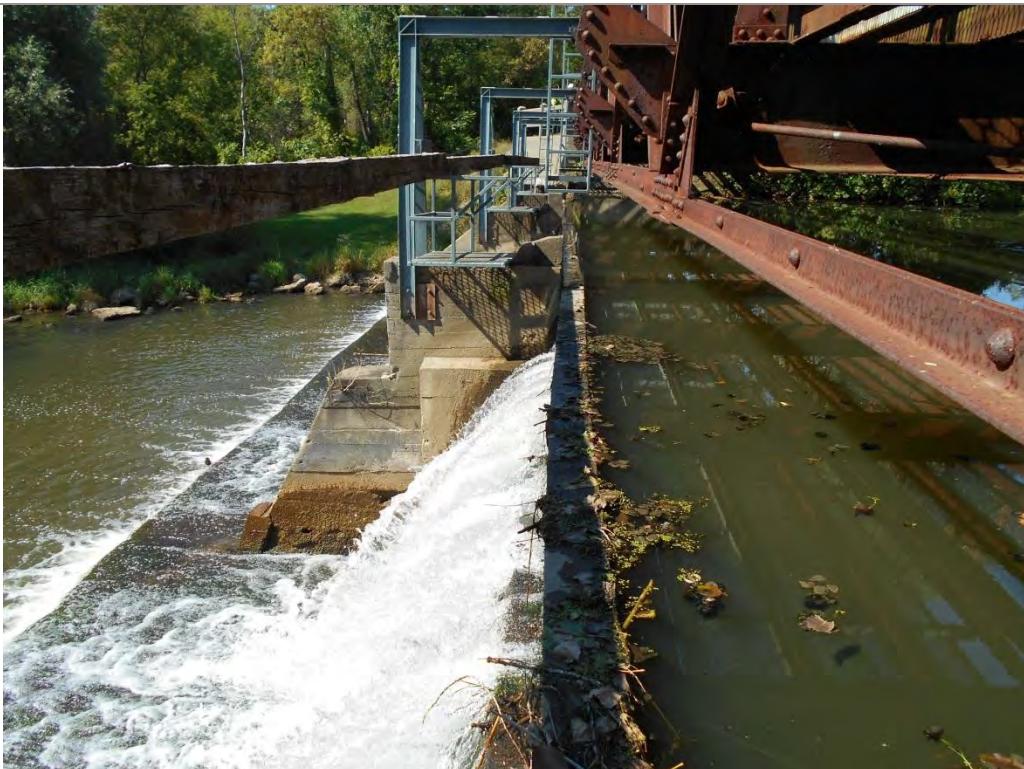
Photo 6: Dam Stoplogs

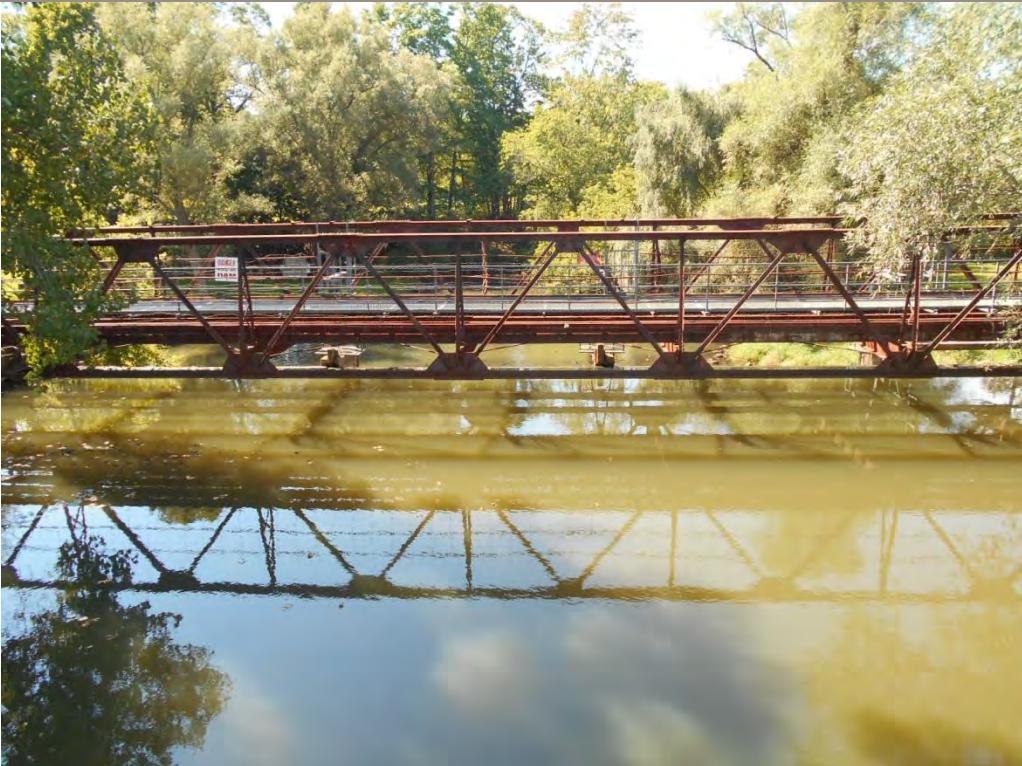
The northwest downstream slope shows evidence of erosion from run-off at the crest of the slope. A loss of material was also observed at the downstream wingwall on the northwest side as a result of run-off (Photo 7). Seepage between the concrete wingwall and pier was also observed at this location.

Photo 7: Bridge Elevation from Upstream

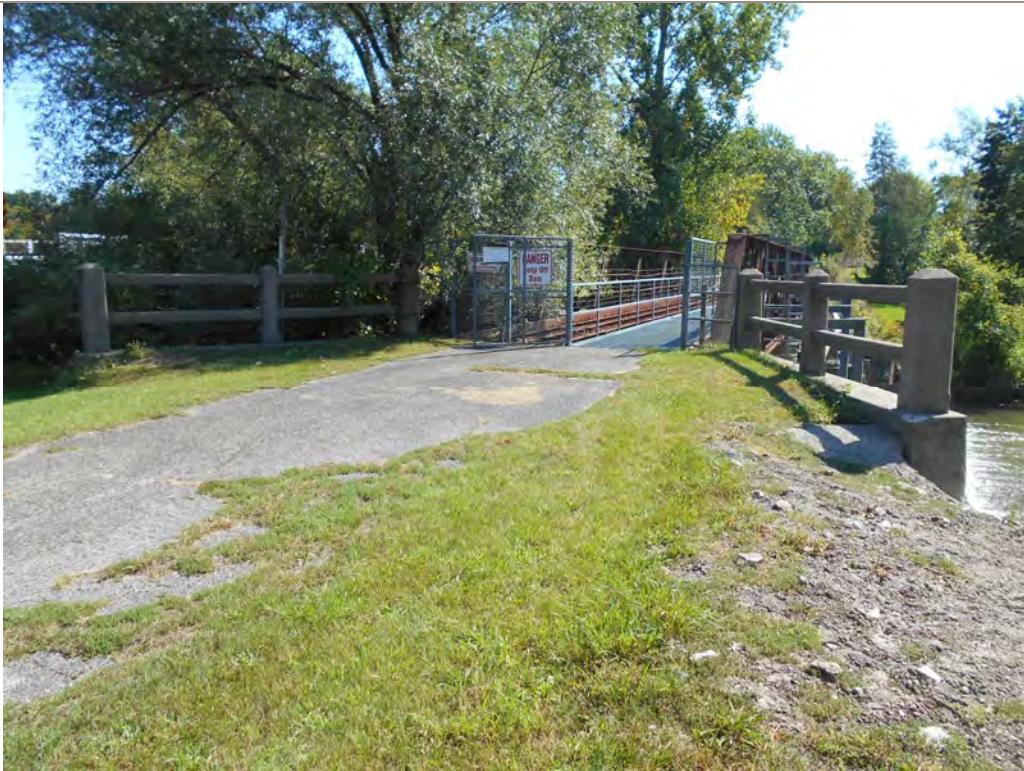
Photo 15: West Approach

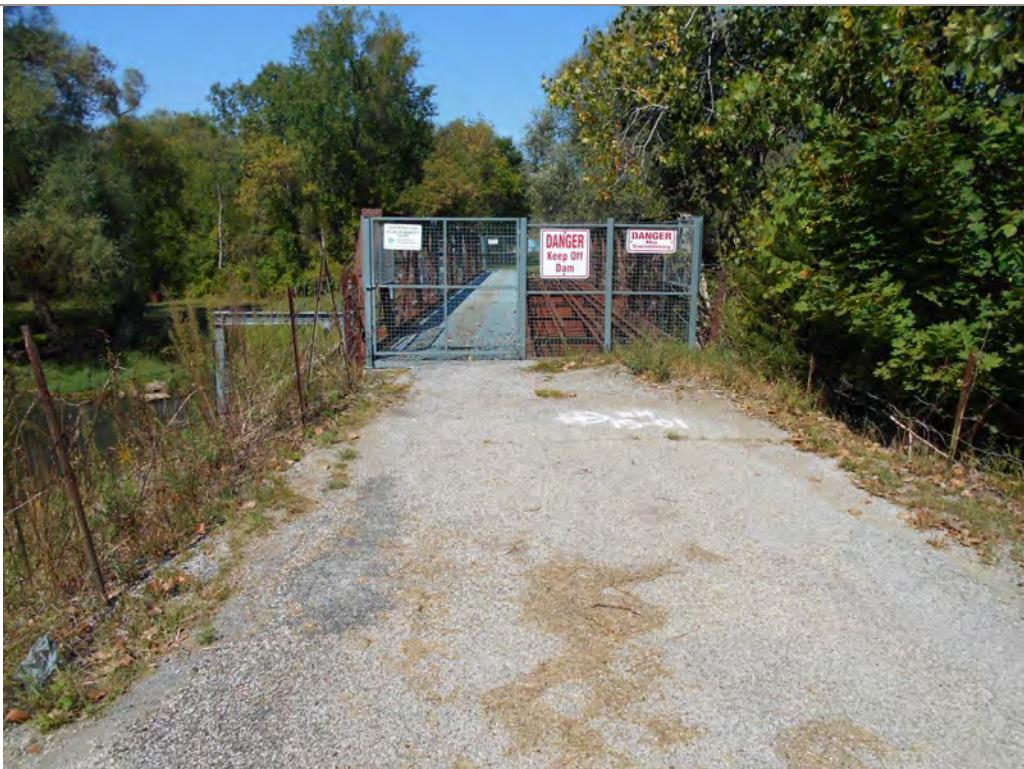
Photo 16: East Approach

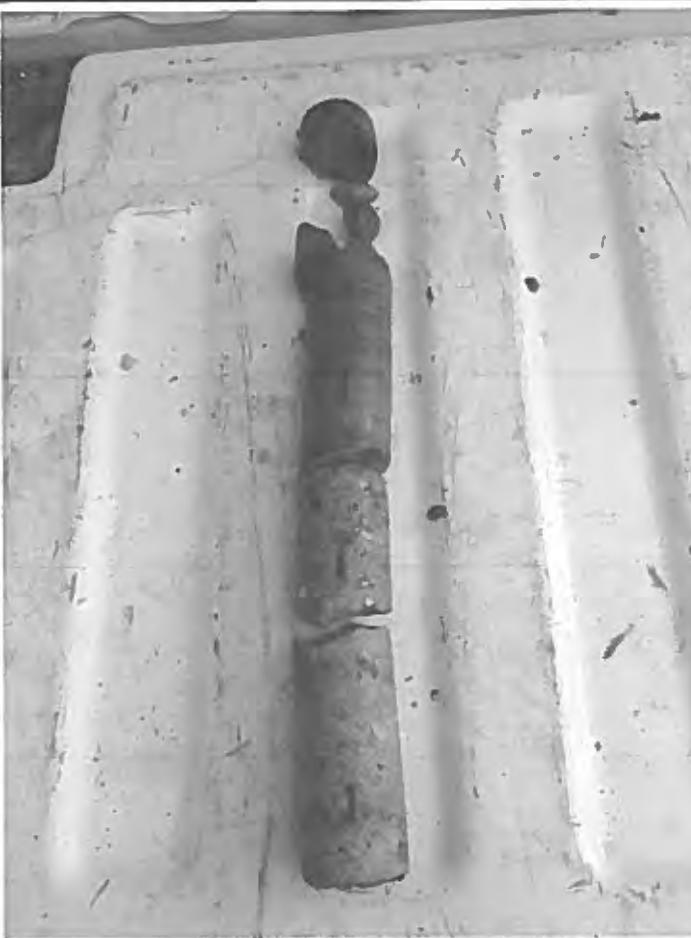
PHOTO # 5

Core Sample 1

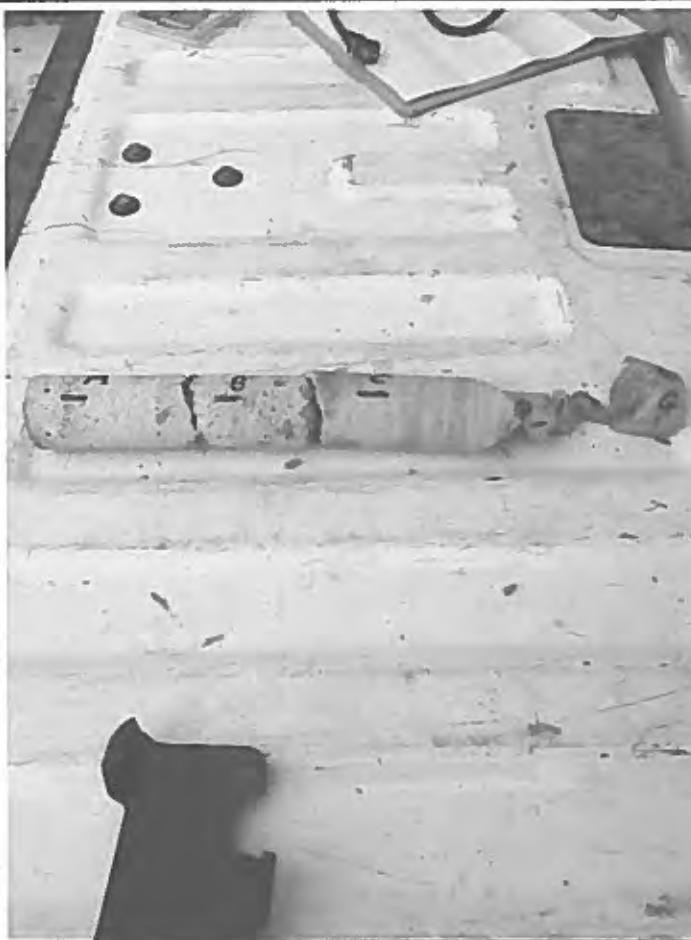
PHOTO # 6

Core Sample 1

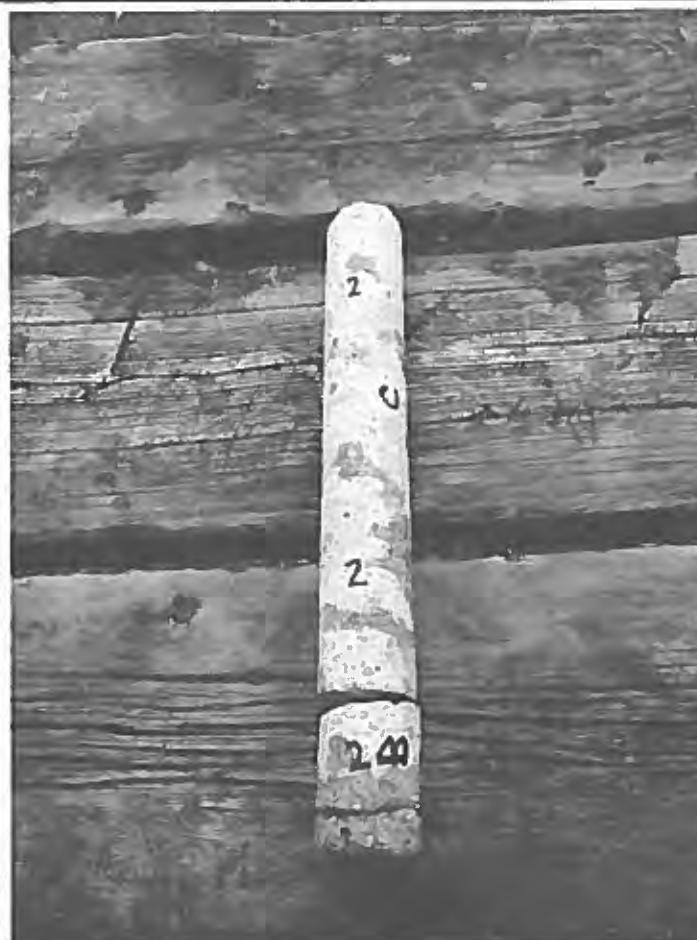
PHOTO # 7

Core sample 2

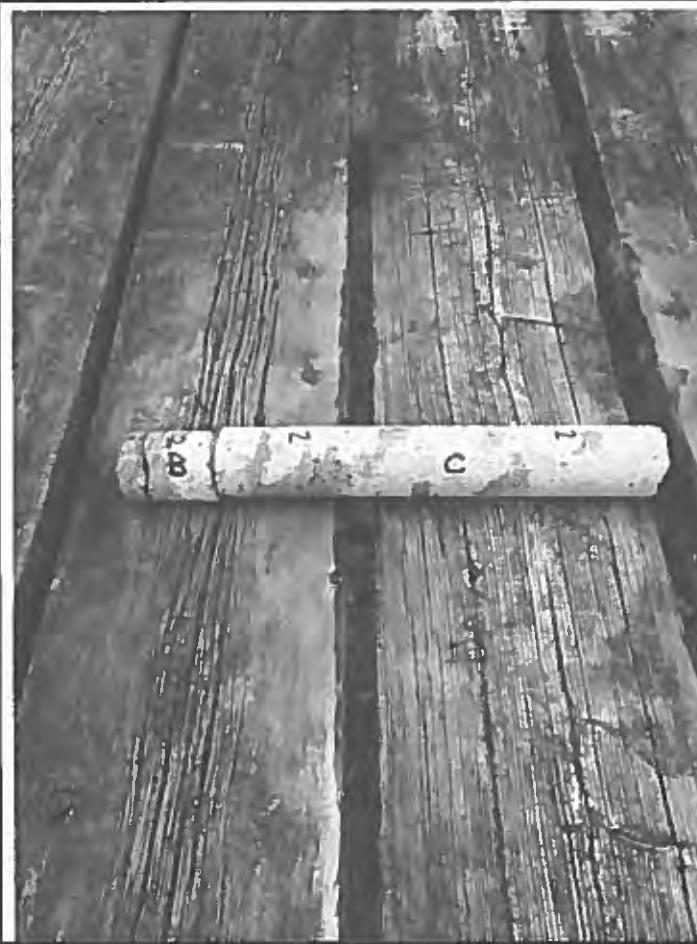
PHOTO # 8

Core sample 2

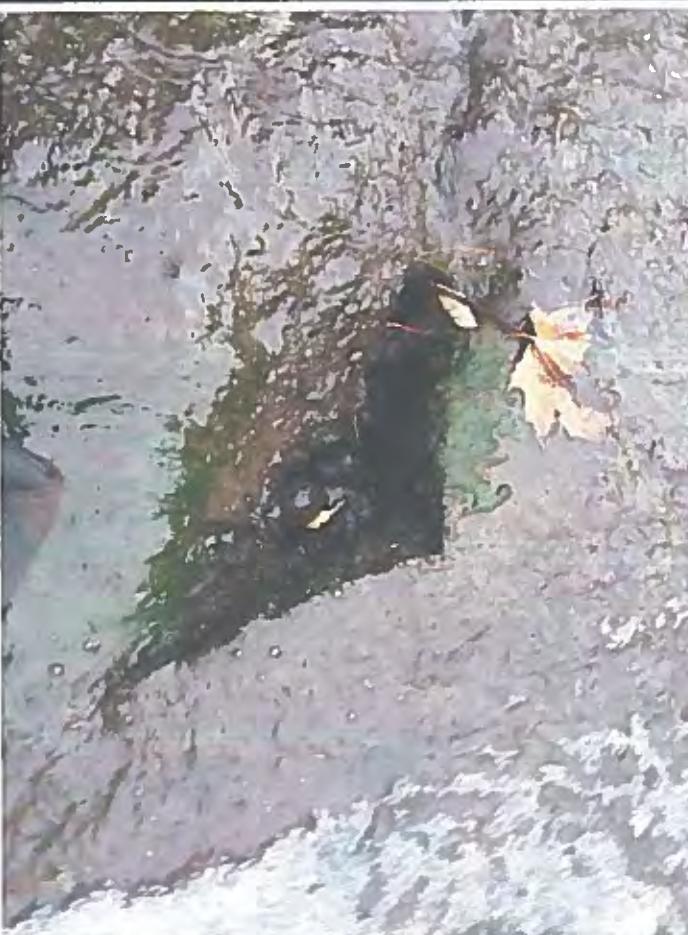
PHOTO # 9

The sill is significantly undermined across the full width of the channel. Undermining varies in height from 150 to 500 millimetres and penetrates under the slab up to 3 metres. The approximate extent of the undermining is also shown on Figure 1. The drilling and probing under the sill indicates that loose rock is supporting the slab where it is not undermined.

Erosion hole in Bay 2
of spillway sill

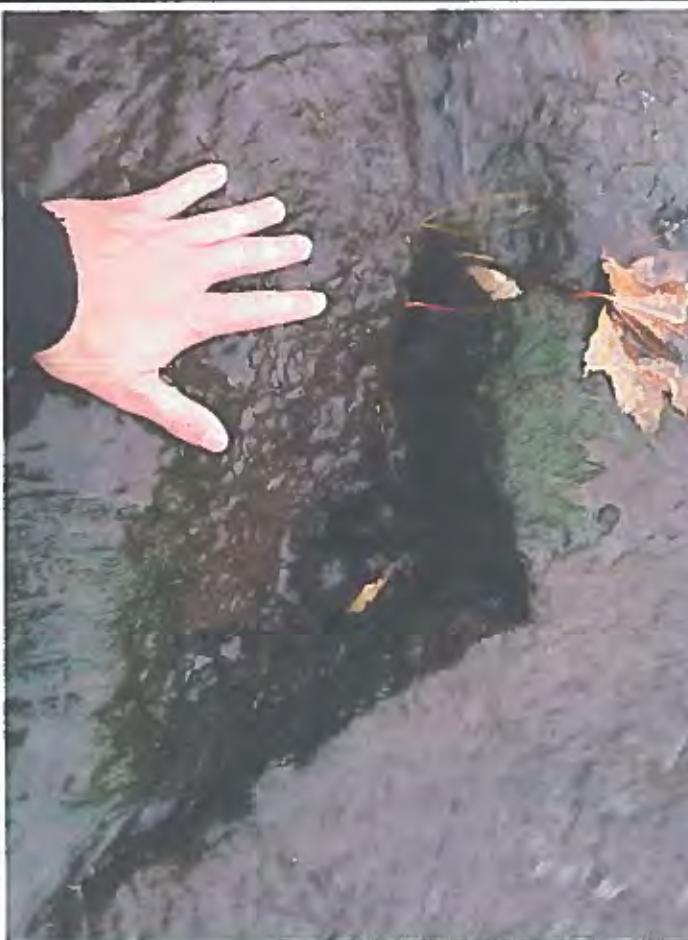
PHOTO # 10

Erosion hole in Bay 2
of spillway sill

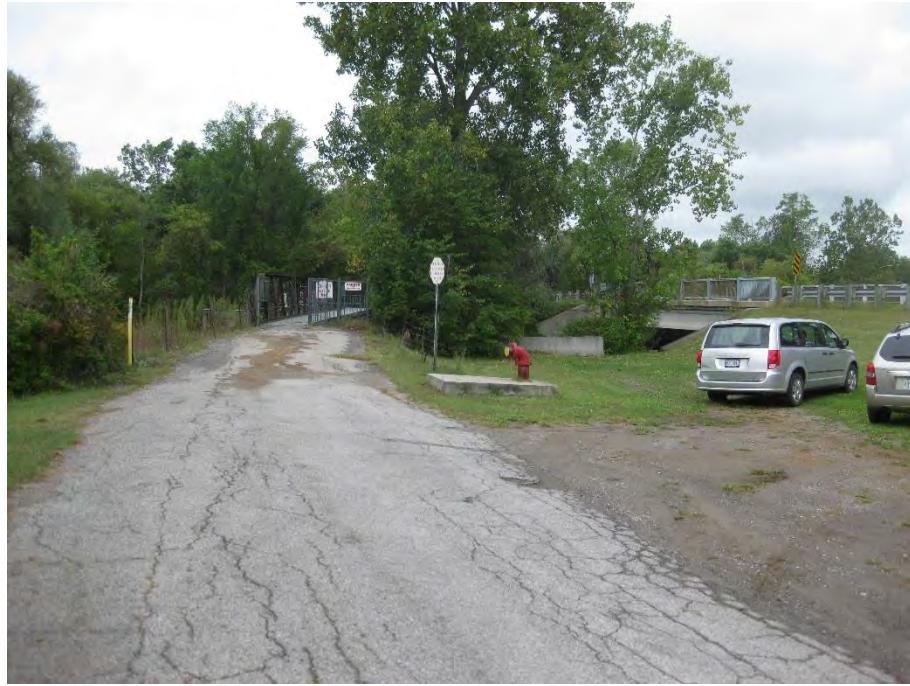
Photo 1: Looking northwest at Teeterville Dam

The embankment that carries County Road 25 over Big Creek upstream of Teeterville Dam is connected and elevated relative to the original earth berm (Photo 1 and 2). Although this extension of the earthen berm now abuts the reservoir, no evidence of seepage or sinkholes was observed between the road embankment and the berm. In addition, no evidence of sinkholes or seepage was identified on the downstream side of the berm on either side of the spillway structure (Photos 3 and Photo 4). The downstream slope on the east side of the structure is vegetated with shrubs and tall grass.

Note: County Road 25 upstream of dam

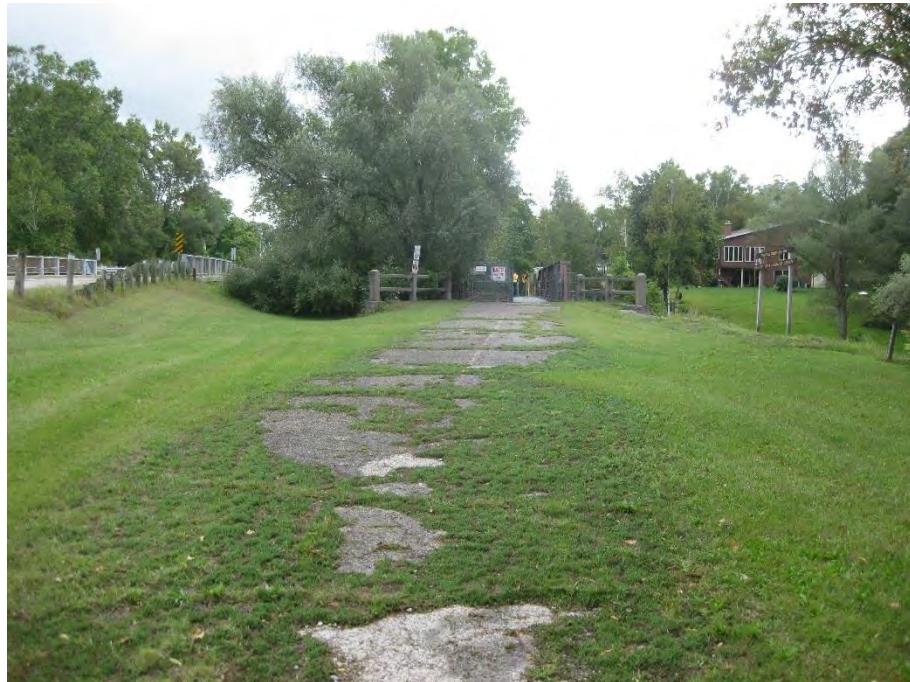
Photo 2: Looking southeast at Teeterville Dam

Note: County Road 25 upstream of dam

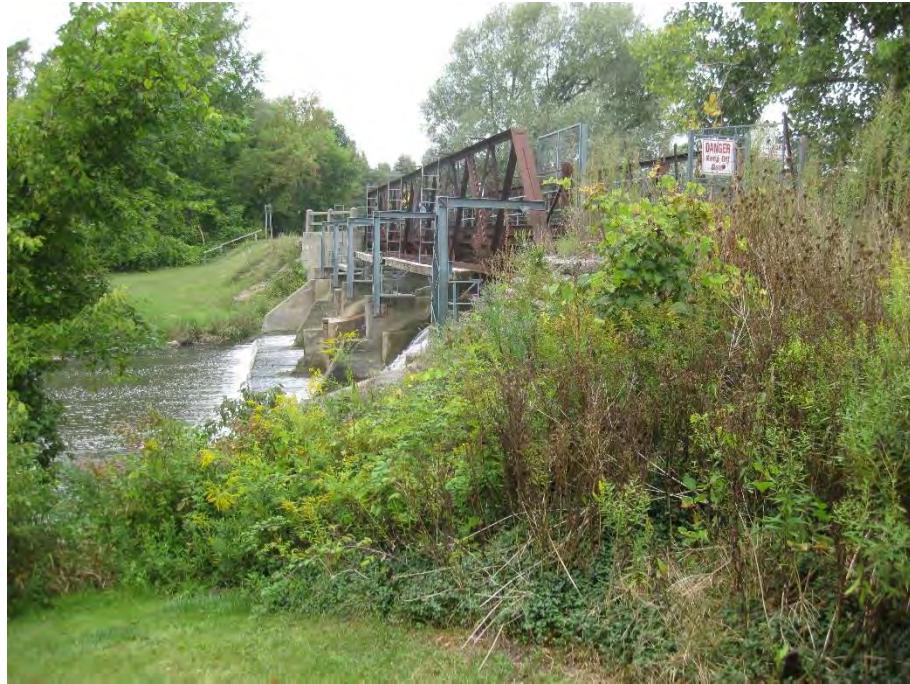
Photo 3: Looking northwest along downstream slope

Note: Highly vegetated southeast slope; Non-vegetated northwest slope

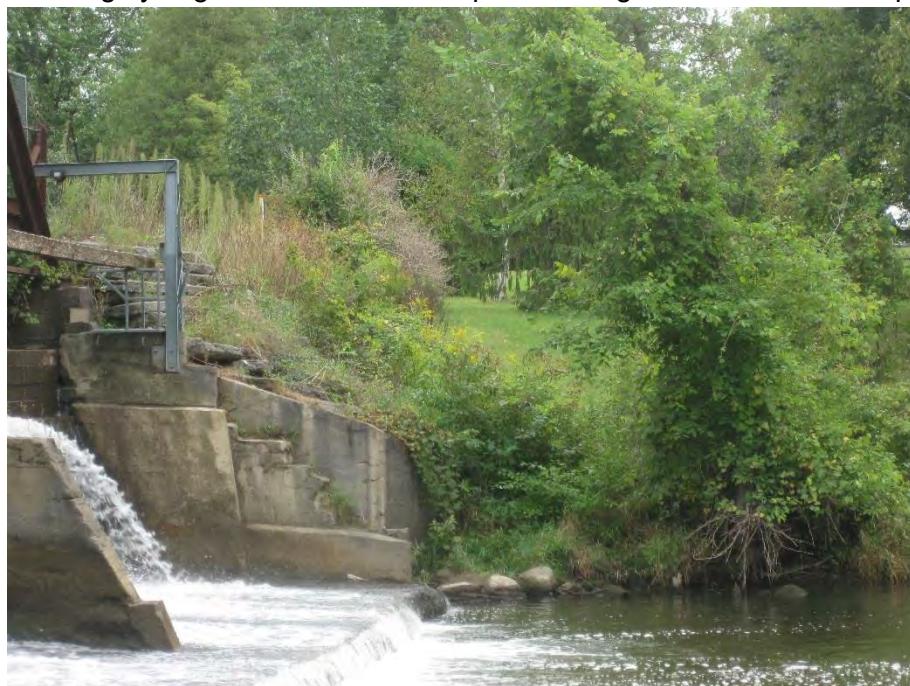
Photo 4: Looking southeast along downstream slope

Note: Highly vegetated southeast slope

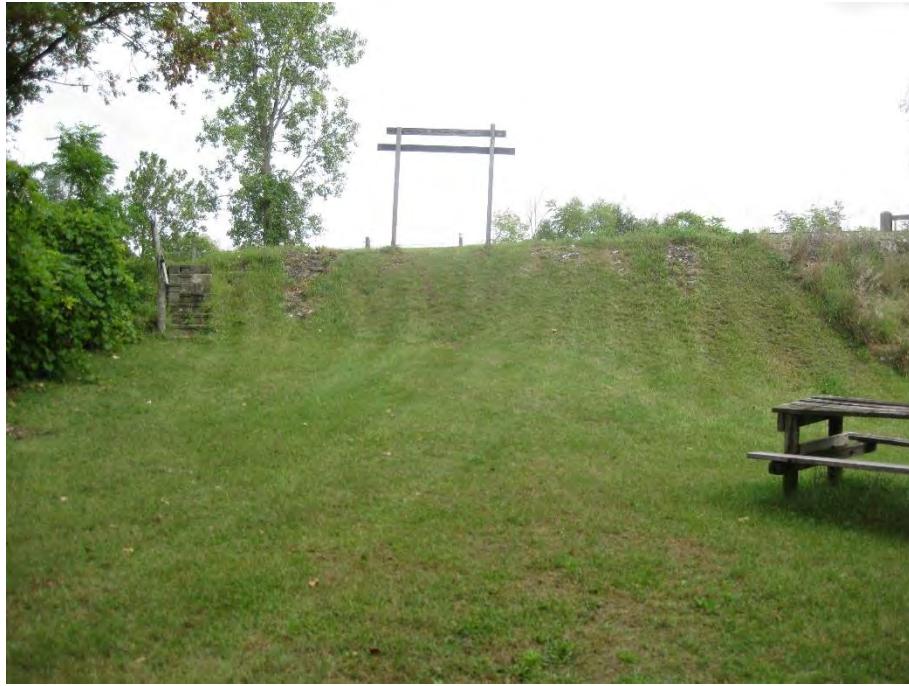
Photo 5: Looking north at northwest downstream slope

The northwest downstream slope shows evidence of erosion from run-off at the crest of the slope (Photo 5 and 6). A loss of material was also observed at the downstream wingwall on the northwest side as a result of run-off (Photo 7). Seepage between the concrete wingwall and pier was also observed at this location (Photo 8).

Note: Eroded patches in the grass due to run-off

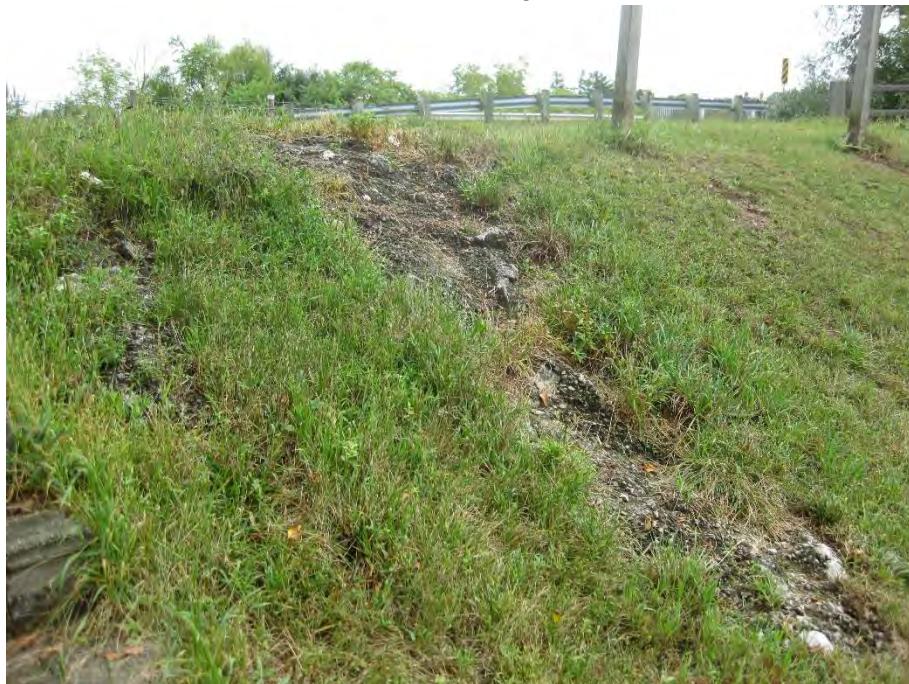
Photo 6: Looking north at northwest downstream slope

Note: Close up image of erosion

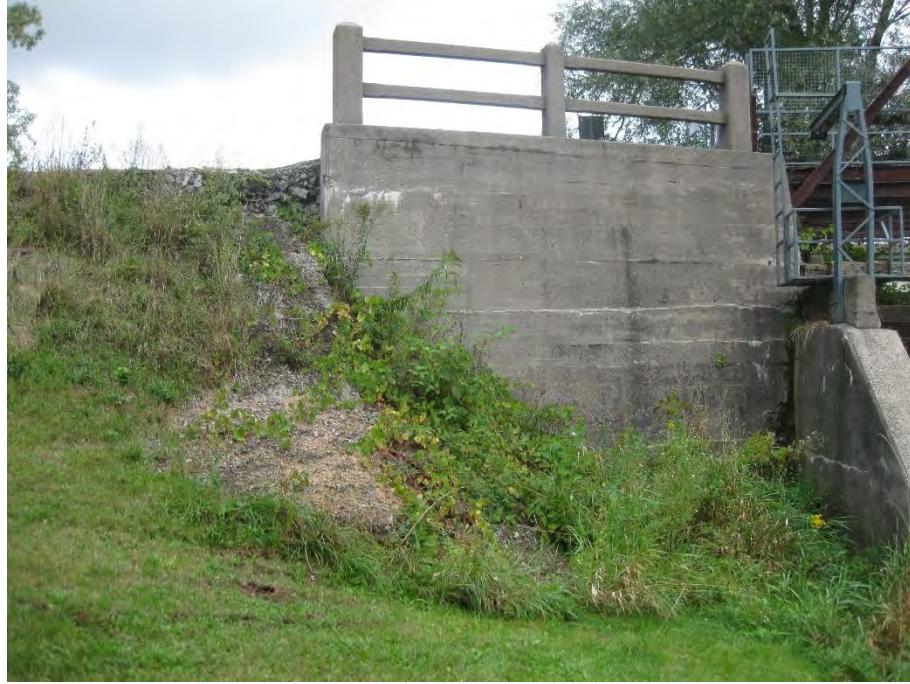
Photo 7: Looking north at northwest downstream wingwall

Note: material loss at top corner; Slump at bottom of slope

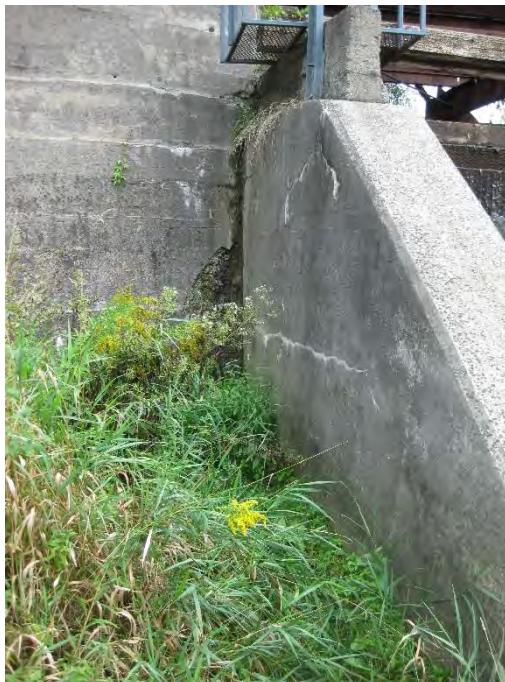
Photo 8: Looking north at northwest downstream wingwall

Note: Seepage between concrete wingwall and pier
